COLORADO CULTURAL RESOURCE SURVEY

# Architectural Inventory Form

1. Resource number: 5PE8279
2. Temporary resource number:
3. County: Pueblo
4. City: Pueblo
5. Historic building name:
6. Current building name: RTS Resources, LLC.
7. Building address: 118-118.5 West 3rd Street
8. Owner name and address: Anthony G. and Lindsey M. Nibert, 118 W. 3rd Street, Pueblo, Colorado 81003-3225

48. Report title: Steel City's Barometer: A Survey and Context of Downtown Pueblo's History and Architecture.

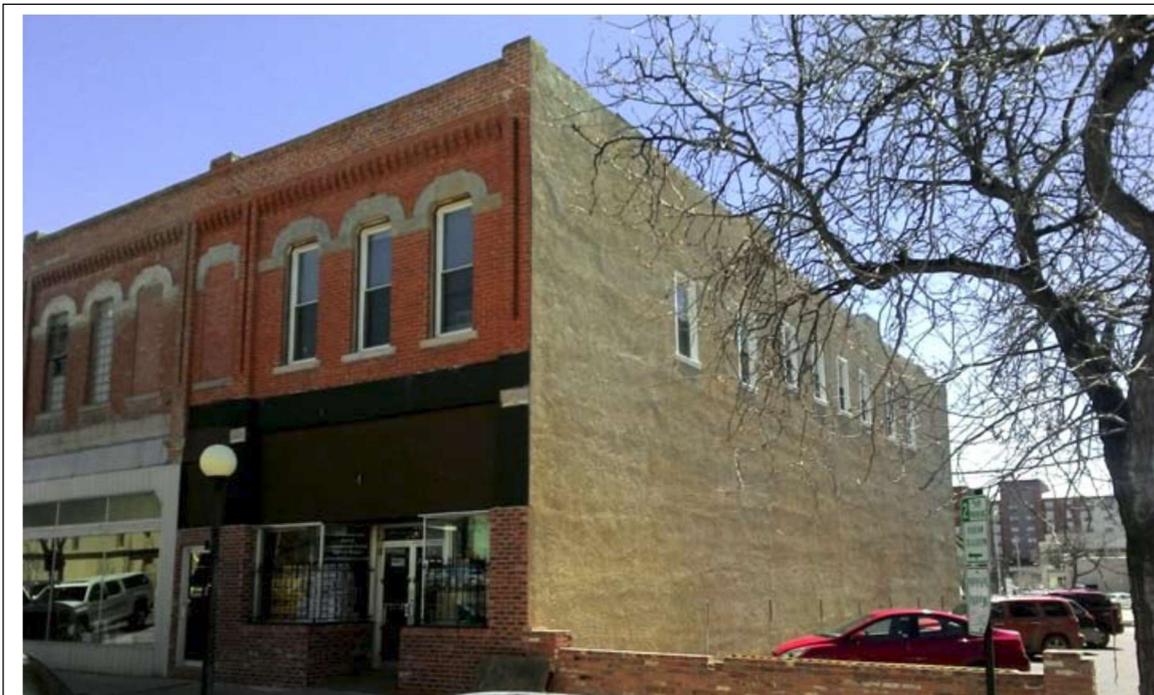
**Western Façade: First Floor.** Both floors of the western façade are covered with stucco. There are no windows on the first floor. It is unclear when the first floor of this building was exposed by the demolition of the neighboring building. **Second floor** has eight, one over one windows that start about 15 feet south of the north wall. The first two windows south of the north façade are shorter and set lower in the wall than the other six. The last two windows are about 10 feet north of the south façade. None of these windows have visible lintels. They do have stone sills. They might be original as the neighboring building was only one story.

5PE8279 – 118 W. 3rd Street. Northern and western façades. Facing southeast. Photo ID: 5PE8279a. March 2016.

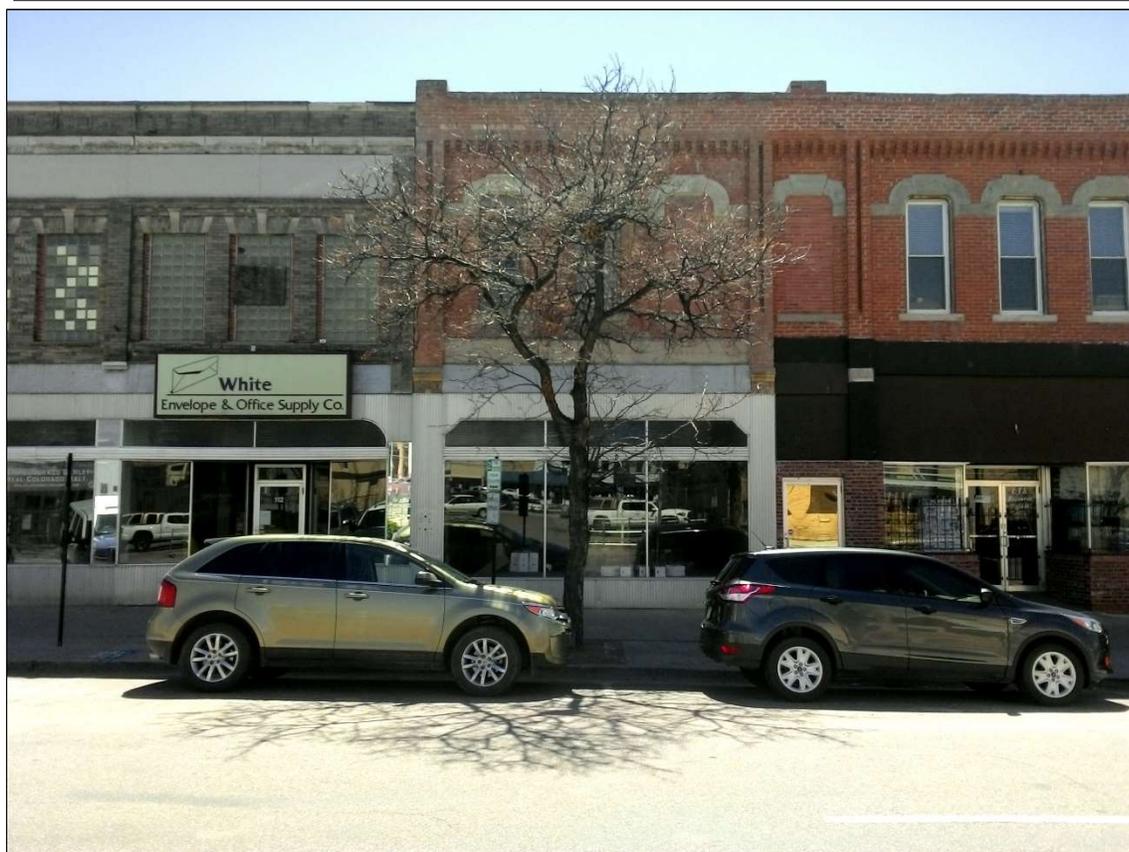
**Northern Façade:** The original wall cladding of 5PE8279 was red brick with multi-block, limestone lintels over the second story windows. At one time the lintels were decorated with incised lines in an Eastlake-style design which is faintly visible on two lintels. The first and second floors are divided by a beltcourse of limestone, currently only visible on the eastern half. The first floor has seen several modifications, and the dates are unknown for all of them. The western half retains its recessed main entry, however the display windows and the doors they flank were replaced in perhaps the 1970s. The current display windows are stationary with aluminum frames, and cast iron-looking bars that cover the lower half of the windows. They are approximately 2 feet 6 inches above the ground, and are taller than the door by about 1 foot. The bulkhead under the current display windows, as well as to the left and right of these windows, is not original and likely added when the windows and doors were changed. This new bulkhead is slightly wider than the original brick pilasters - one on the northwest corner and one on either side of the central entrance to the second floor. These pilasters define the original commercial spaces as well as the stair and hall to the second floor. The western storefront's double door is glass and aluminum, has a narrow transom window, and cast iron-looking bars covering two thirds of the doors. A wooden shake shed roof was added in probably the 1970s and covered the western half from the top of the current display windows to the top of the beltcourse. It was removed between 2007 and 2012 and replaced with stucco. Stucco also covers the beltcourse and the pilasters. A glass and aluminum door leading to the central stair and hall is set flush with the new brick that continues from under the display windows of the western storefront. The eastern half of the first floor has a long association with 112-114 W 3rd Street. It is covered with the same aluminum and plate glass, a modification that dates to about the 1950s. The second floor has also been modified but retains more of the original design elements. Each store front has three one over one hung windows spaced equidistant from each other and the pilasters that define the edges. There was a single window in the central hall and stair area. All of the windows on the second floor are wood framed with rounded corners. They all have a limestone sill, and an arched limestone lintel that becomes part of a beltcourse of limestone. The center sections of the stone lintels are flat along the top and flanked by arched stones. The lintels in the center of each storefront, as well as the lintel in the center section, are not a smooth arch. The windows on the western storefront appear to be nearest the original condition. The window in the central hall and stair has been filled in with brick, as has the western-most window on the eastern storefront. This may have happened at two different times as the bricks do not match. Nor do they match the new brick on the first floor of the western storefront. The remaining two windows on the eastern storefront were infilled with glass blocks. For a time, both sides were painted. It appears the paint was removed from the western storefront between 2007 and 2012. There is a corbeled cornice that runs the full length of the building that is not interrupted by the pilasters that define the sections. Above the corbel is a brick parapet which does not have the same spacing as any of the other brickwork.

5PE8279 – 118 W. 3rd Street. Northern façades. Facing south. Photo ID: 5PE8279a. March 2016.

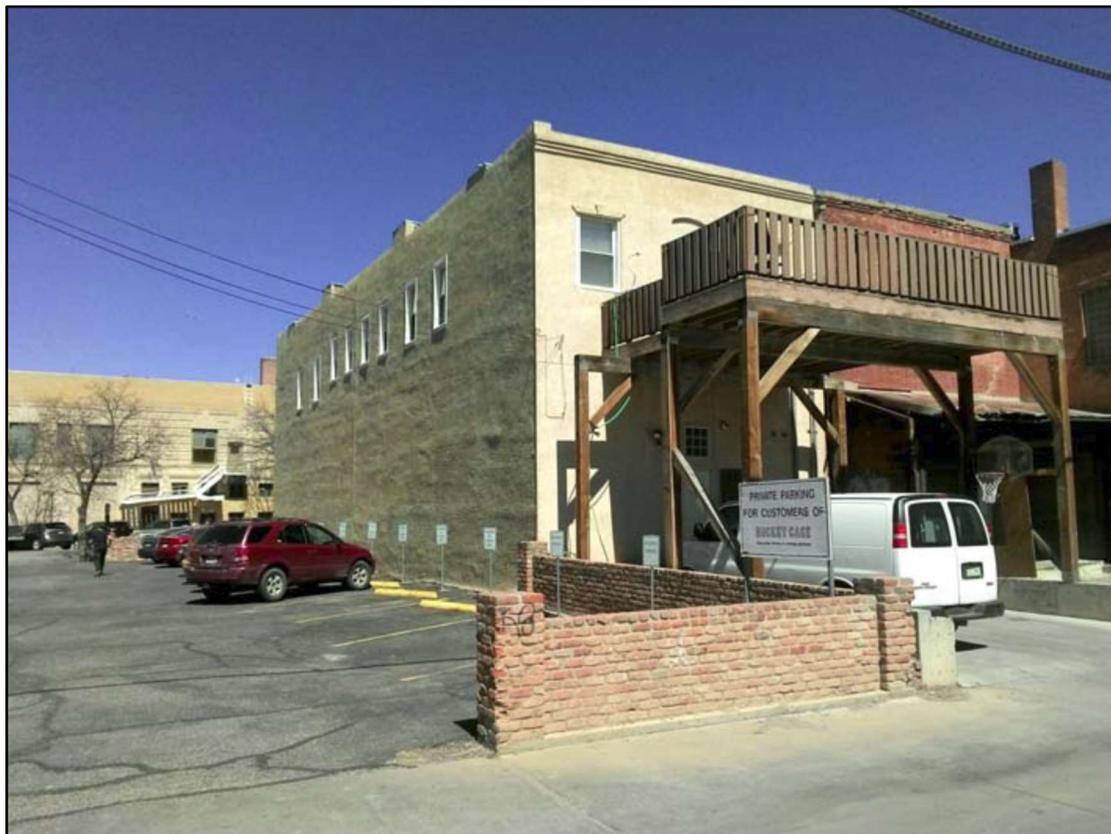
**Southern Façade:** The western half of the southern façade is covered with stucco. There is a two-story deck framed in wood that provides access to additional living space and covered parking. It is not known when the deck was added. There are no windows on the first floor. There is a man door in the center of the wall with a glass block transom. On the second floor is a door in the center of the wall that accesses the deck. The door has an arched lintel made of a single brick course. This door is flanked by one over one hung windows. These windows have a flat lintel with a central capstone. The eastern side had unpainted brick on both floors. First floor has a loading dock with a half gable roof supported by wood posts. On the far west side of the first floor a door has been filled in with brick. This door may have opened into the central hall. To the east of that there is a freight sized door. On second floor, there is also a bricked-in door on the far west side. Most of this wall is a glass block window, likely added when it became associated with 112-114 W. 3rd Street. There is a corbelled brick pediment along the top of the wall that runs the full length of the building, interrupted by a downspout in the center of the wall.

5PE8279 – 118 W. 3rd Street. Western and southern façades. Facing northeast. Photo ID: 5PE8279b. March 2016.

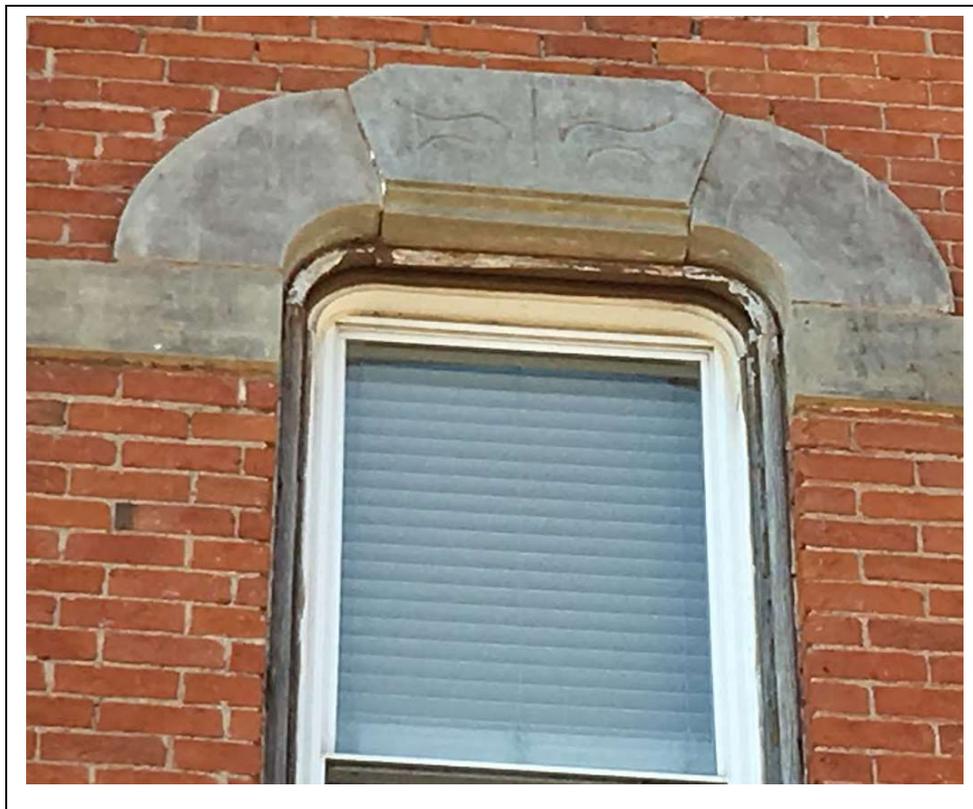
5PE8279 – 118 W. 3rd Street.  
Northern façade/second story  
window. Facing south. Photo  
ID: 5PE8279c. June 2017.

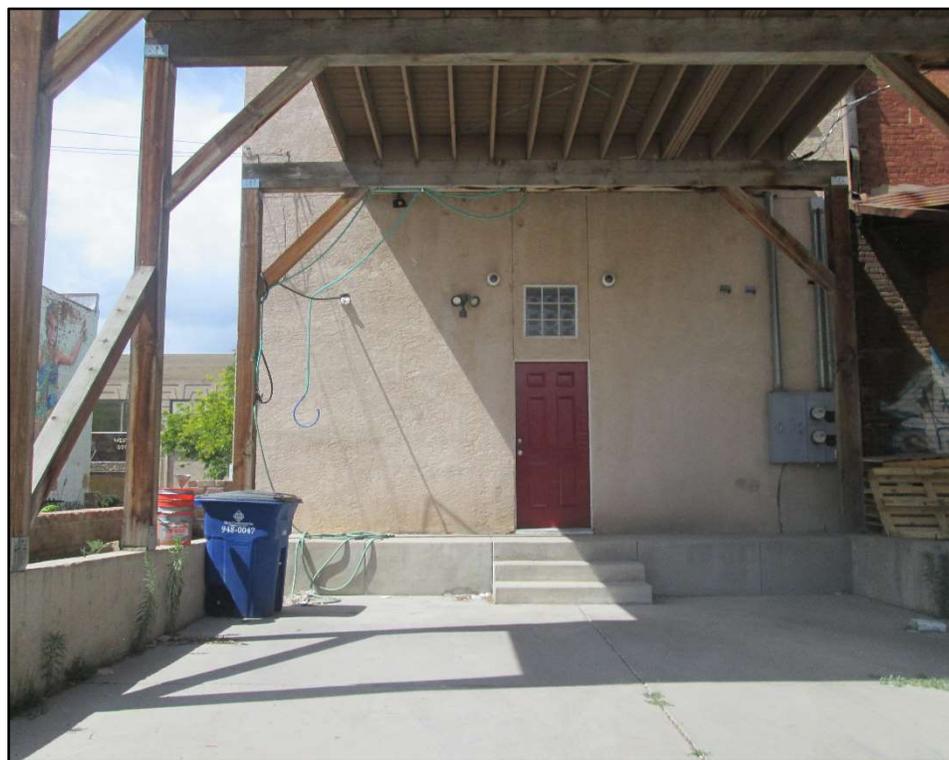
5PE8279 – 118 W. 3rd Street. Southern façade, facing north. Photo ID: 5PE8279d.  
June 2017.
