COLORADO CULTURAL RESOURCE SURVEY

Architectural Inventory Form

1. Resource number: 5PE.2253
2. Temporary resource number: FN12
3. County: Pueblo
4. City: Pueblo
5. Historic building name: Clevenger Building
6. Current building name: Connect School
7. Building address: 620 N. Santa Fe Ave
8. Owner name and address: LDC Santa Fe Family LLLP, 503 N. Main St., Suite 5, Pueblo, CO 81003

48. Report title: Historic Downtown Property Survey, City of Pueblo, Pueblo County, Colorado

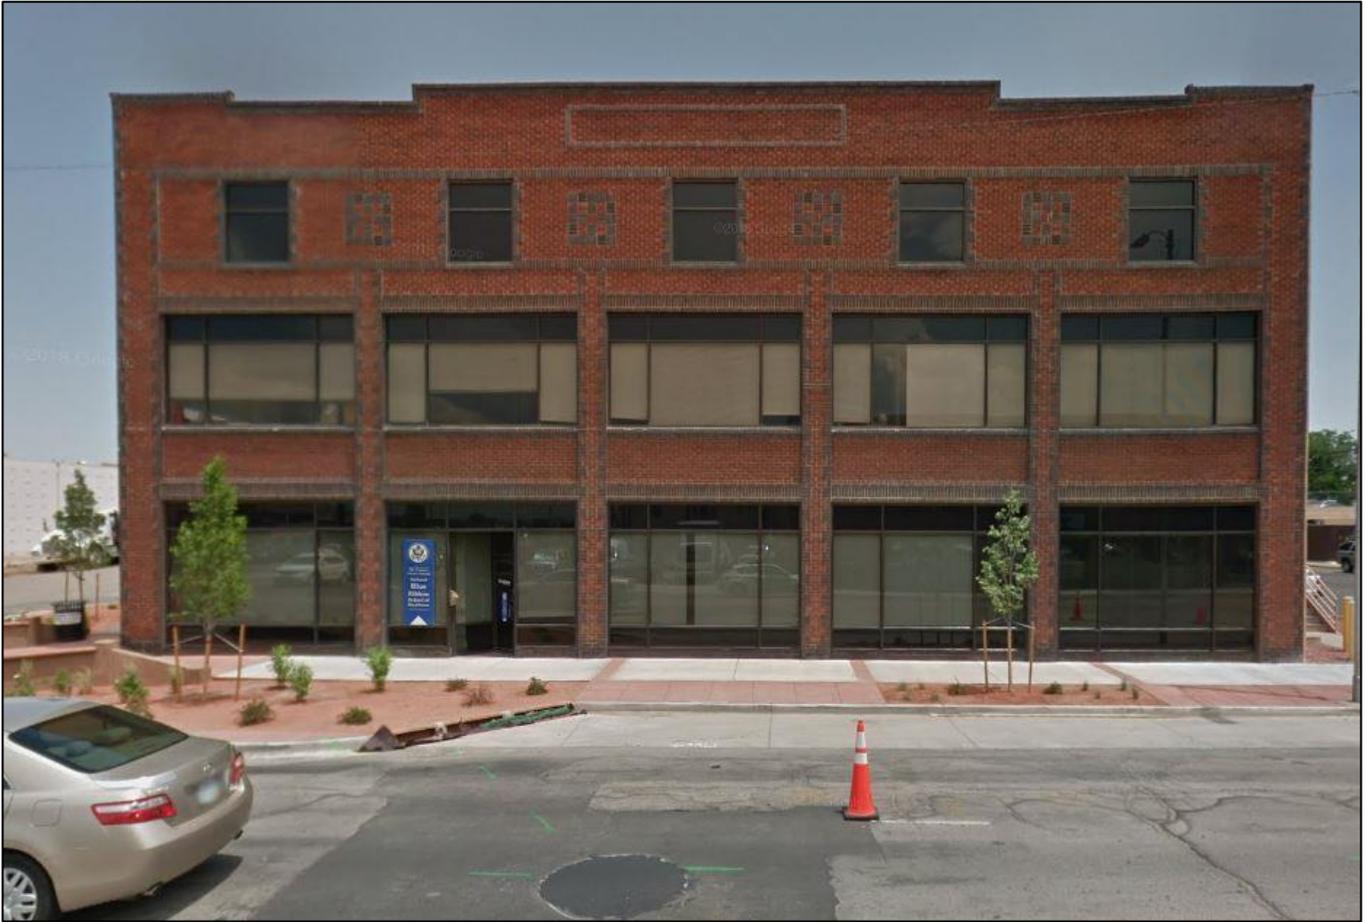
620 N. Santa Fe Ave. facing east showing west wall. Courtesy of Google Maps.

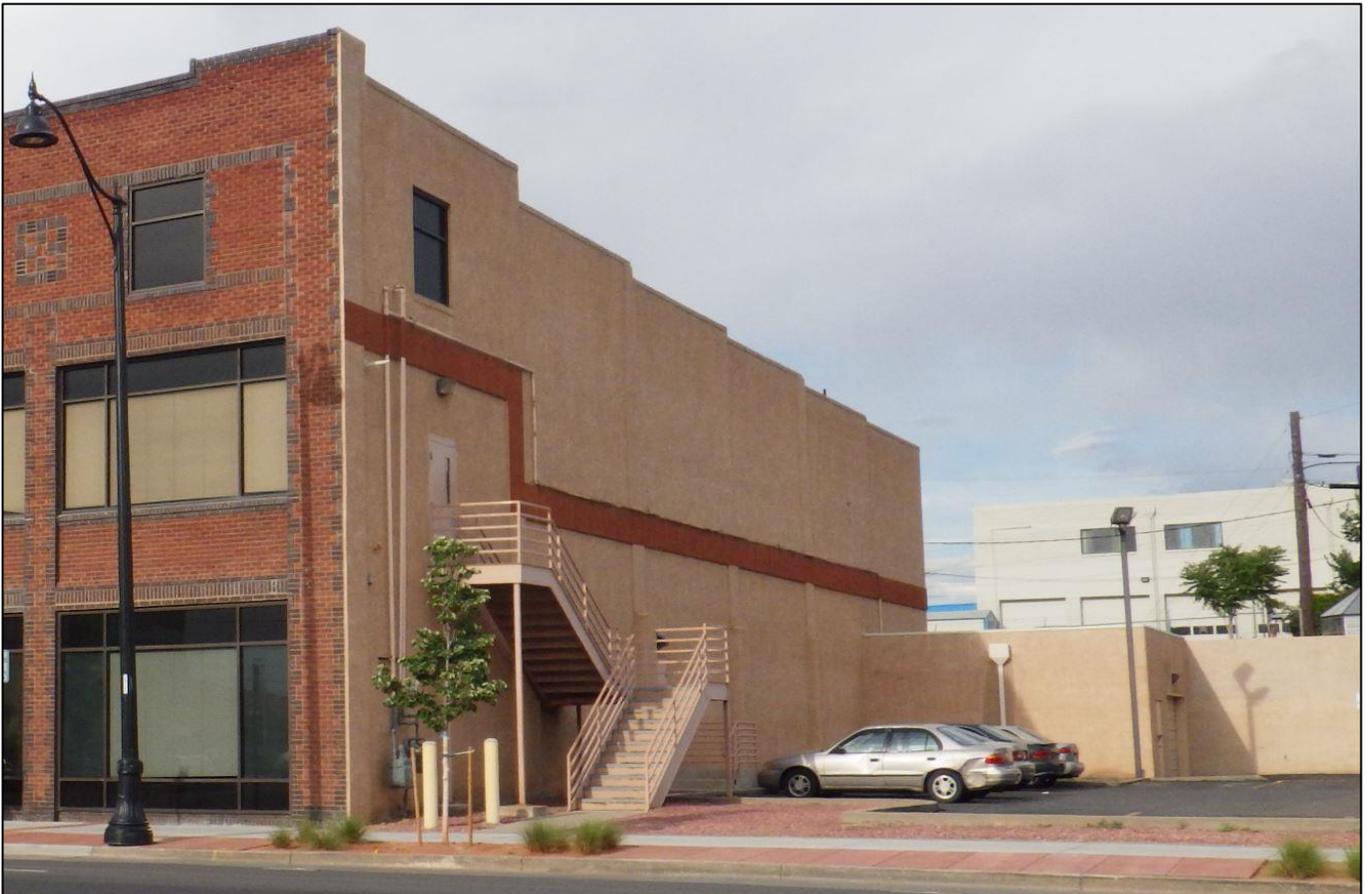
Resource Number: 5PE.2253
Temporary Resource Number: FN12
620 N. Santa Fe Ave. facing northeast.

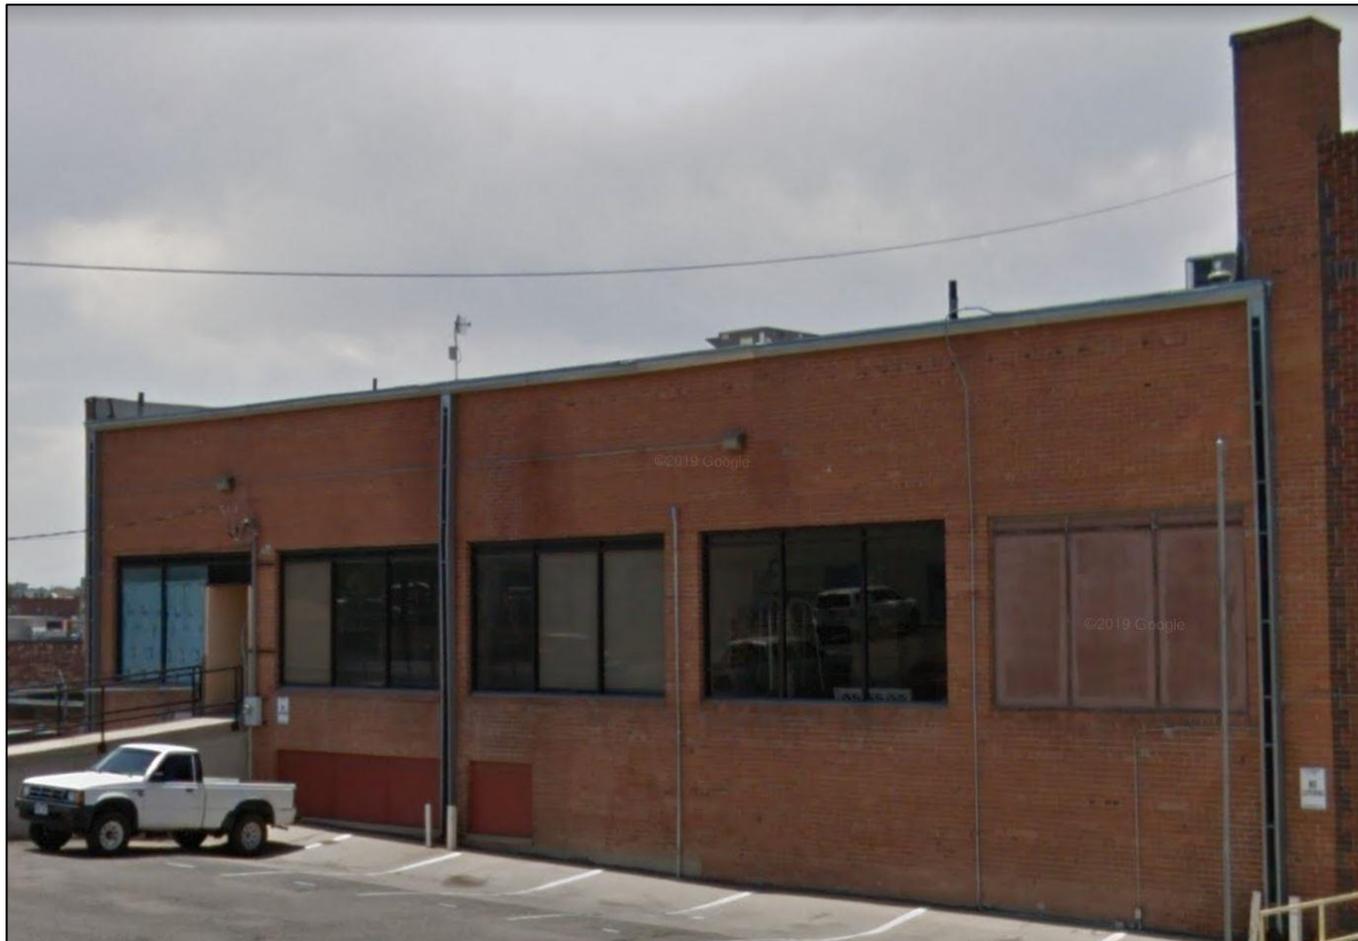
620 N. Santa Fe Ave. facing southwest showing east wall. Courtesy of Google Maps.

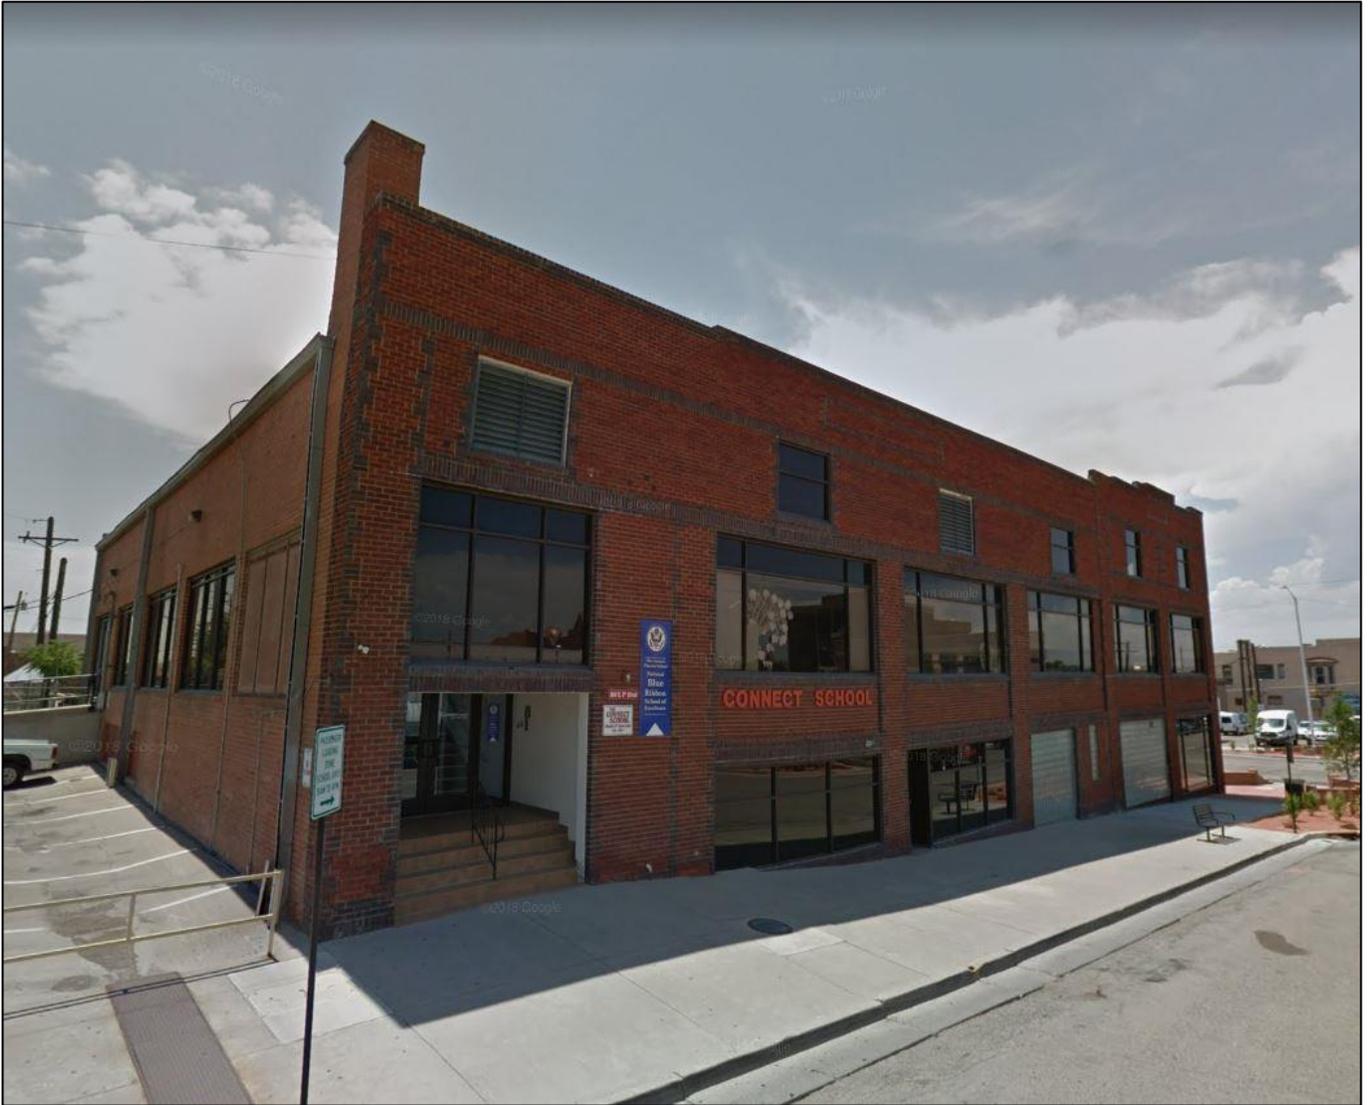
620 N. Santa Fe Ave. facing south showing north wall. Courtesy of Google Maps.

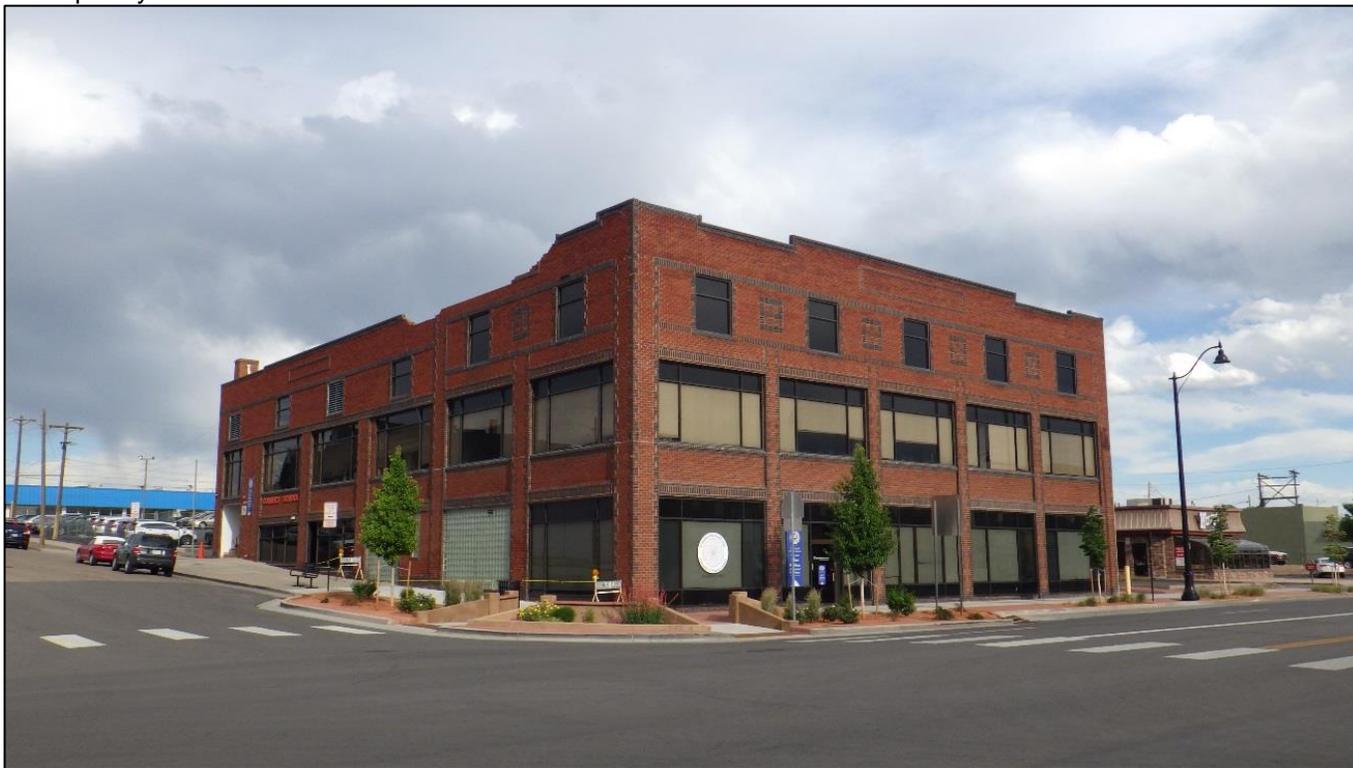
620 N. Santa Fe Ave. facing southeast. Photograph from June, 2019 survey. Note damaged parapet along north wall.

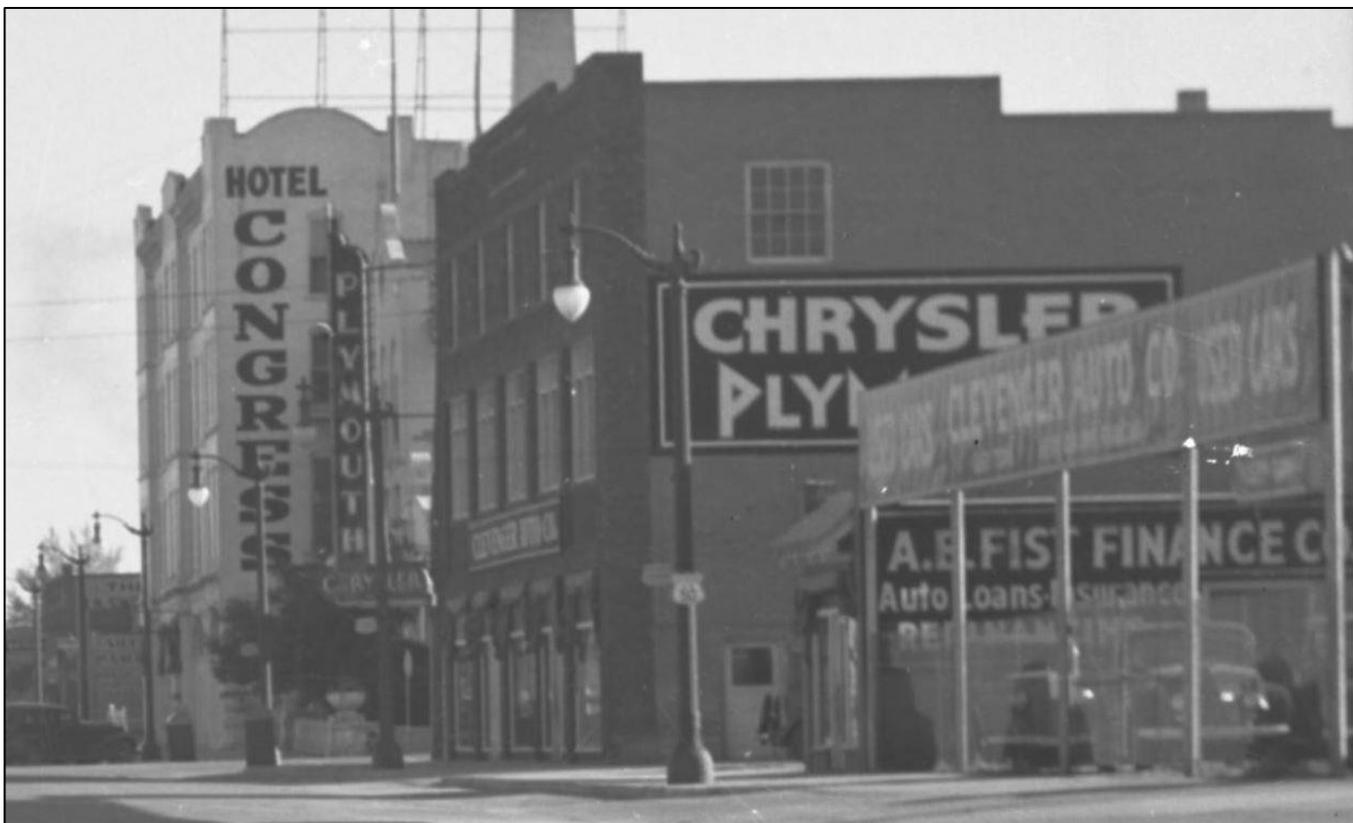
Detail of "Santa Fe Avenue and Sixth Street, 1938." June 27th, 1938. Note 5PE.2253/Clevenger Building in mid-ground. Looking northwest. Identifier No. P-480.

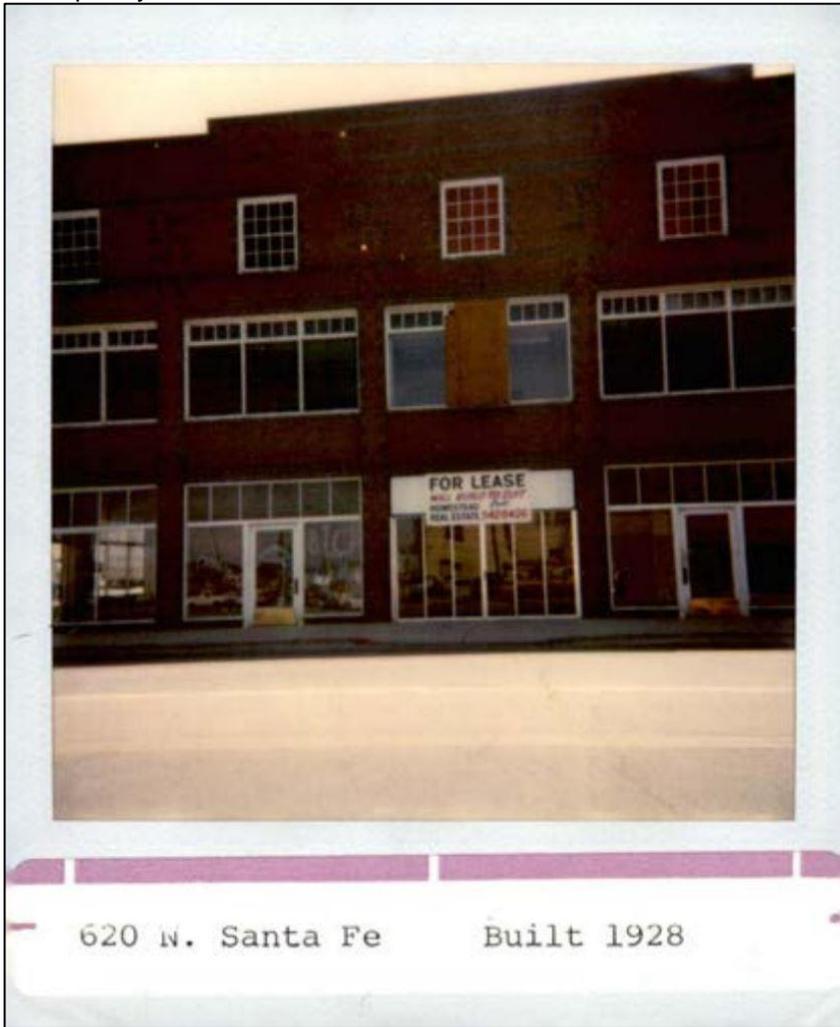
"620 N. Santa Fe." 1988? Courtesy of the Colorado Office of Archaeology and Historic Preservation. Site Form for 5PE.2253.
