COLORADO CULTURAL RESOURCE SURVEY

Architectural Inventory Form

1. Resource number: 5PE8246
2. Temporary resource number:
3. County: Pueblo
4. City: Pueblo
5. Historic building name: MacIndoe Plumbing
6. Current building name: N/A
7. Building address: 110-110.5 W. 2nd Street
8. Owner name and address: MMK LLC, 5648 Terracina Place, Pueblo, CO 81005-5582.

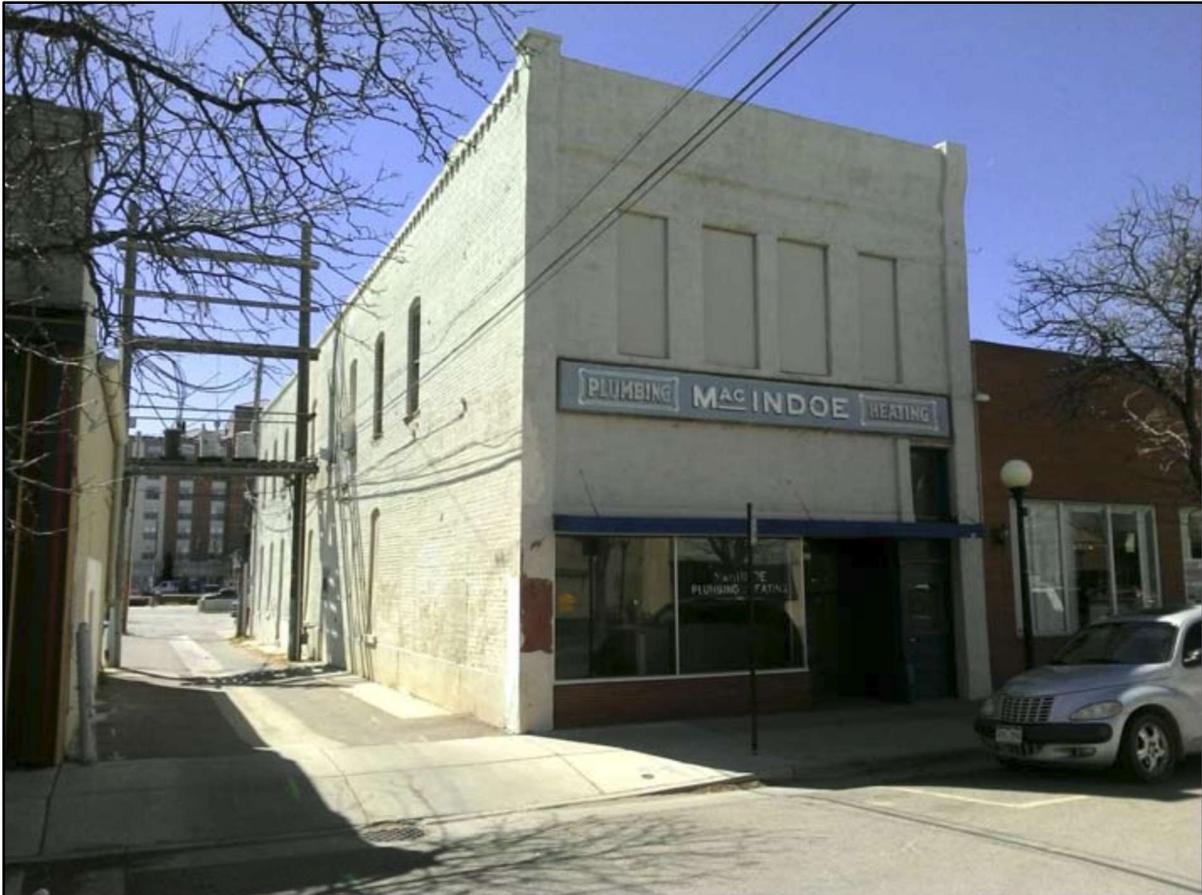
5PE8246 – 110-110.5 W. 2nd Street. MacIndoe Plumbing. Looking southwest. North and east façades. Photo ID: 5PE8246a. March 2016.

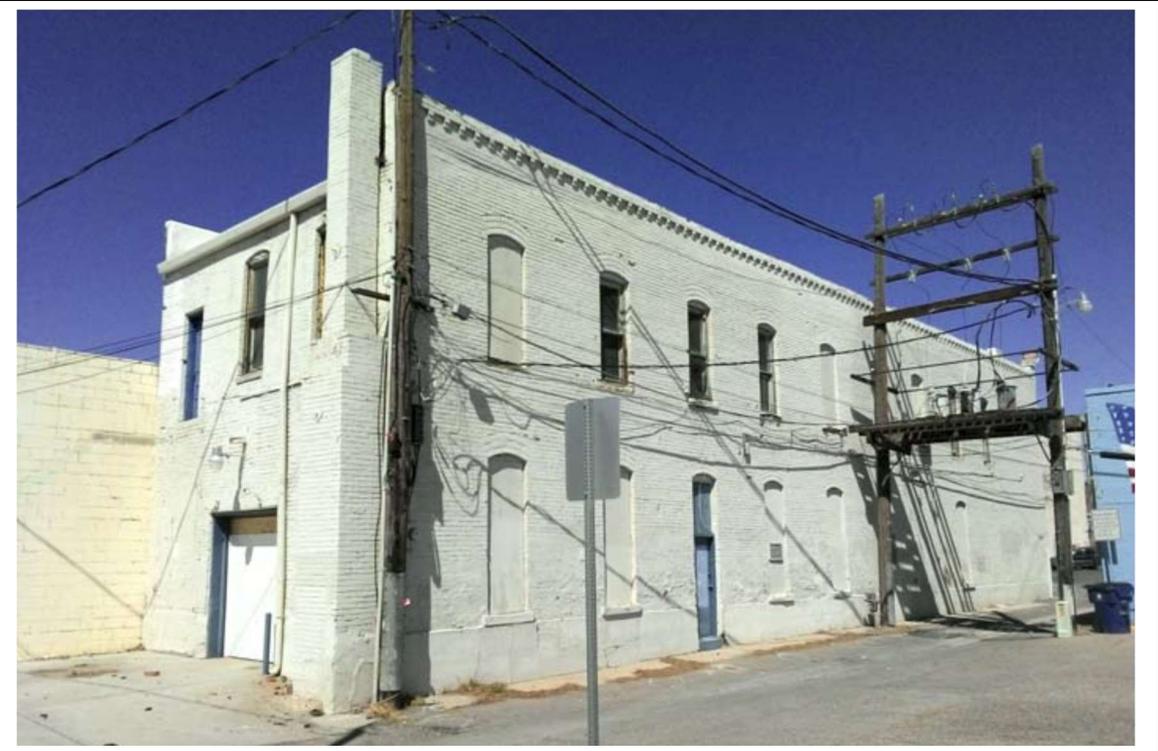
5PE8246 – 110-110.5 W. 2nd Street. MacIndoe Plumbing. Looking northwest. South and east façades. Photo ID: 5PE8246b. March 2016.

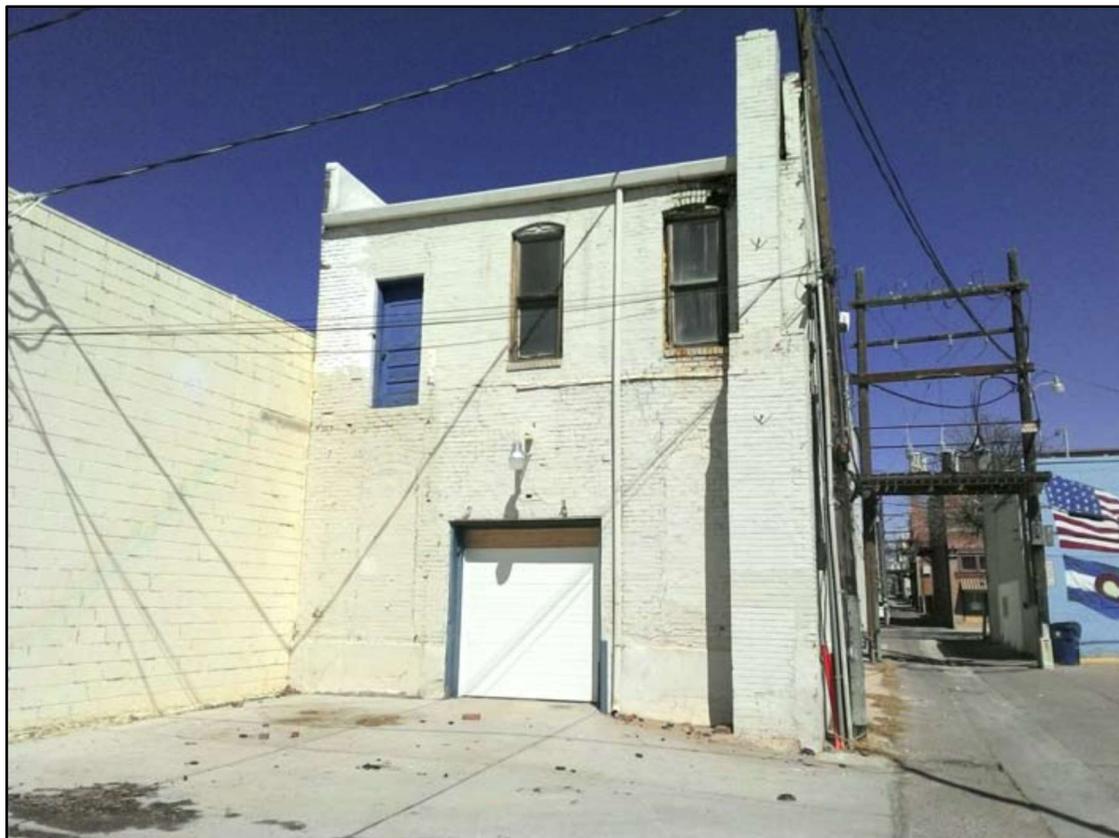
5PE8246 – 110-110.5 W. 2nd Street. MacIndoe Plumbing. Looking northwest. Southern façade. Photo ID: 5PE8246c. March 2016.

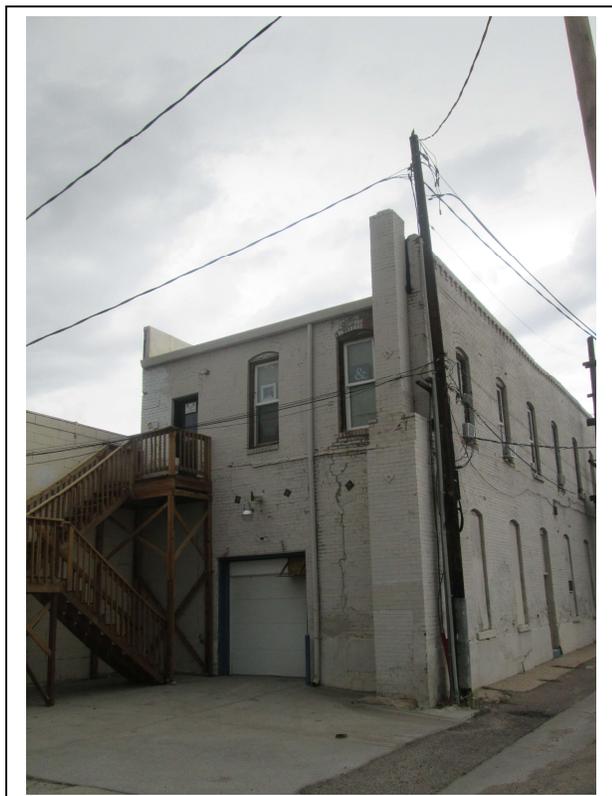
5PE8246 – 110-110.5 W. 2nd Street.
MacIndoe Plumbing. Looking northwest.
Southern façade. Photo ID: 5PE8246d. June
2017.
