COLORADO CULTURAL RESOURCE SURVEY

## Architectural Inventory Form

1. Resource number: 5PE.8491
2. Temporary resource number: FN8
3. County: Pueblo
4. City: Pueblo
5. Historic building name: Pueblo Bank & Trust
6. Current building name: PB&T
7. Building address: 301 W. 5<sup>th</sup> St.
8. Owner name and address: Pueblo Bank and Trust, PO Box 639, Pueblo, CO, 81002

48. Report title: Historic Downtown Property Survey, City of Pueblo, Pueblo County, Colorado

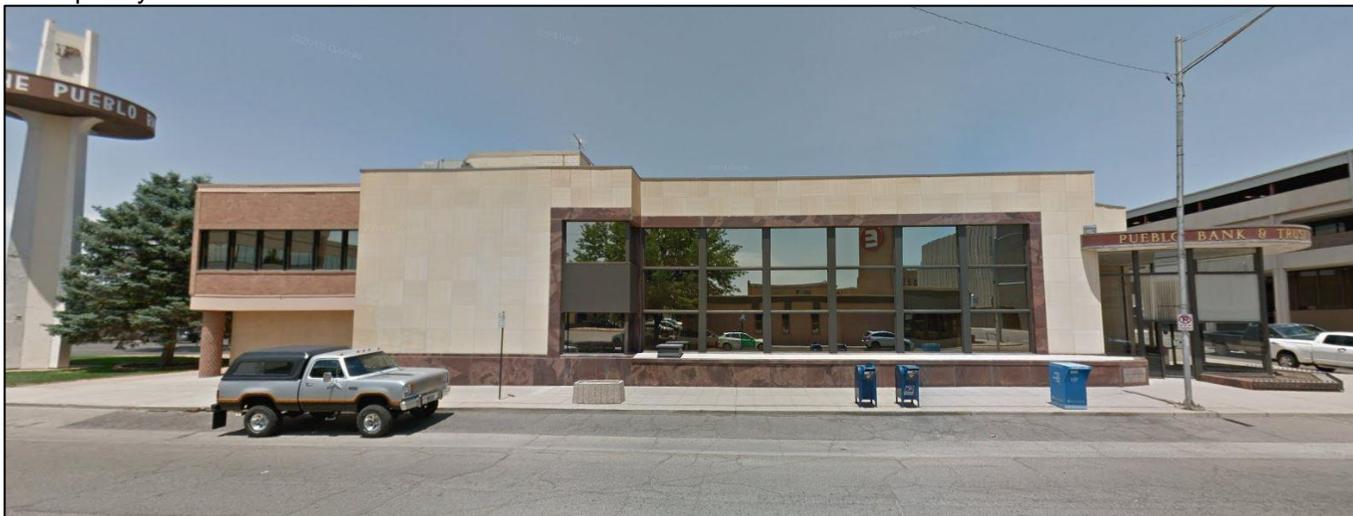
The building's south wall is composed of three wall components and the curved surface of the glass rotunda at its eastern corner. The furthest west of these components is a brick box on the building's second story supported below by a circular brick pier and a blank concrete wall that are set back and beneath on the first story. This wall intersects with a rectangular buttress before diving into a two-story projecting boxy wall, paneled in limestone with a base of red marble. In the small space between the buttress and the limestone wall, is a small fixed glass window, framed in a dark-coated aluminum. The brick wall above is split by a long aluminum-framed ribbon window covering its entire surface. This is divided into six individual panes by vertical members. The western (left) two-thirds of the limestone wall are devoid of apertures; however, the eastern third is opened by the beginning of a two-story window wall framed in aluminum and edged in the same red marble as the base of the wall. From the limestone wall, the window wall dives back into the main block of the building and continues along its surface until stopping short of the rotunda. In total, it contains 24 panels divided by vertical members into 8 segments, and then horizontal members into a subsequent panels. Although 22 of these panels are glazed in a reflective dark glass, 2 of the panels in the window wall's easternmost (left) 2 segments are metal clad to hide an internal division between the first and second stories. Continuing from the limestone wall to the rotunda is a long planter box since covered over in concrete pavers.

301 W. 5<sup>th</sup> St. facing north and showing south wall. Courtesy of Google Maps.

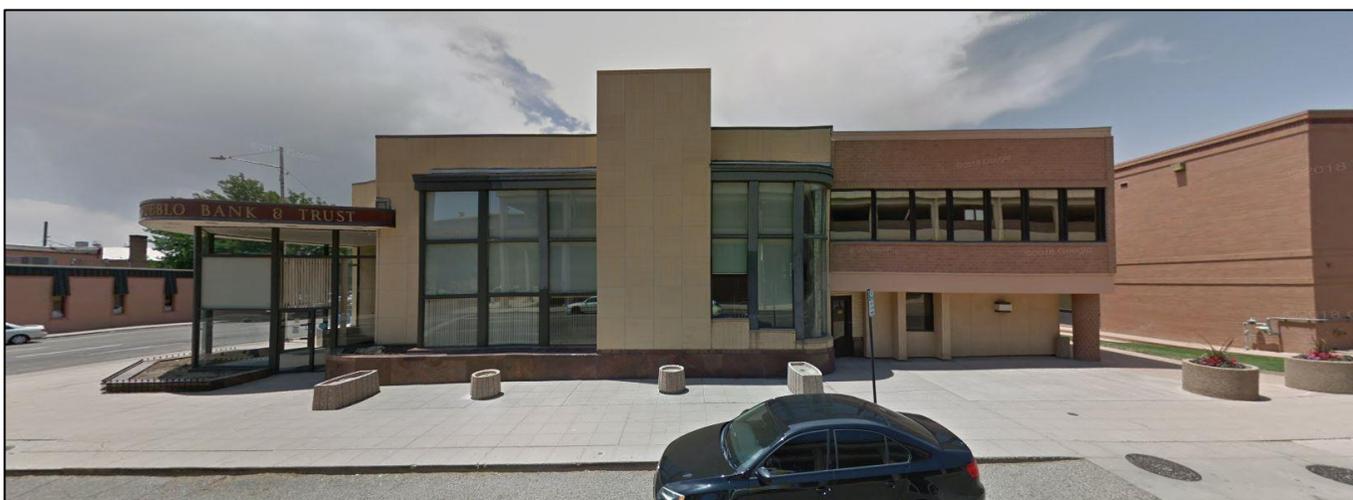
The east wall of the bank is comprised of roughly four intersecting components, in addition to the rotunda on its southeastern corner. The largest of these is a simple limestone wall abutting the rotunda and extending to a similar floating brick wall in the building's northeastern corner. Similar to the wall, this brick wall sits atop a recessed concrete wall with its corner supported by a cylindrical brick pier. The concrete wall is broken by two rectangular buttresses between which is a rectangular aluminum-framed fixed-pane window. Still beneath the brick wall, an aluminum framed full-glass door is set into a recessed entry surrounded by white brick. The brick wall protruding above this contains an aluminum-framed ribbon window composed of seven individual panes separated by vertical members. Also protruding from the large limestone wall are two separate window walls on either side of a single limestone pillar that itself protrudes out from the building and extends beyond the line the parapet. The windows to either side of this consist of a single bayed window wall split by a limestone pillar.

301 W. 5<sup>th</sup> St. facing west and showing east wall. Courtesy of Google Maps.

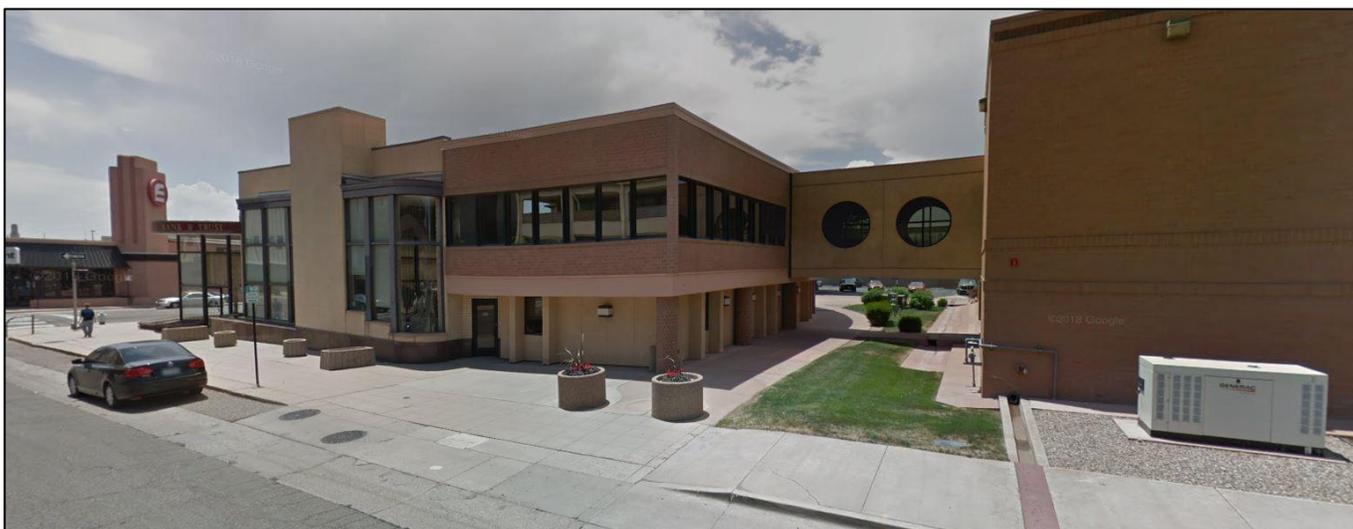
301 W. 5<sup>th</sup> St. facing southwest and showing west and part of northwest wall. Note sky bridge to adjacent building. Courtesy of Google Maps.

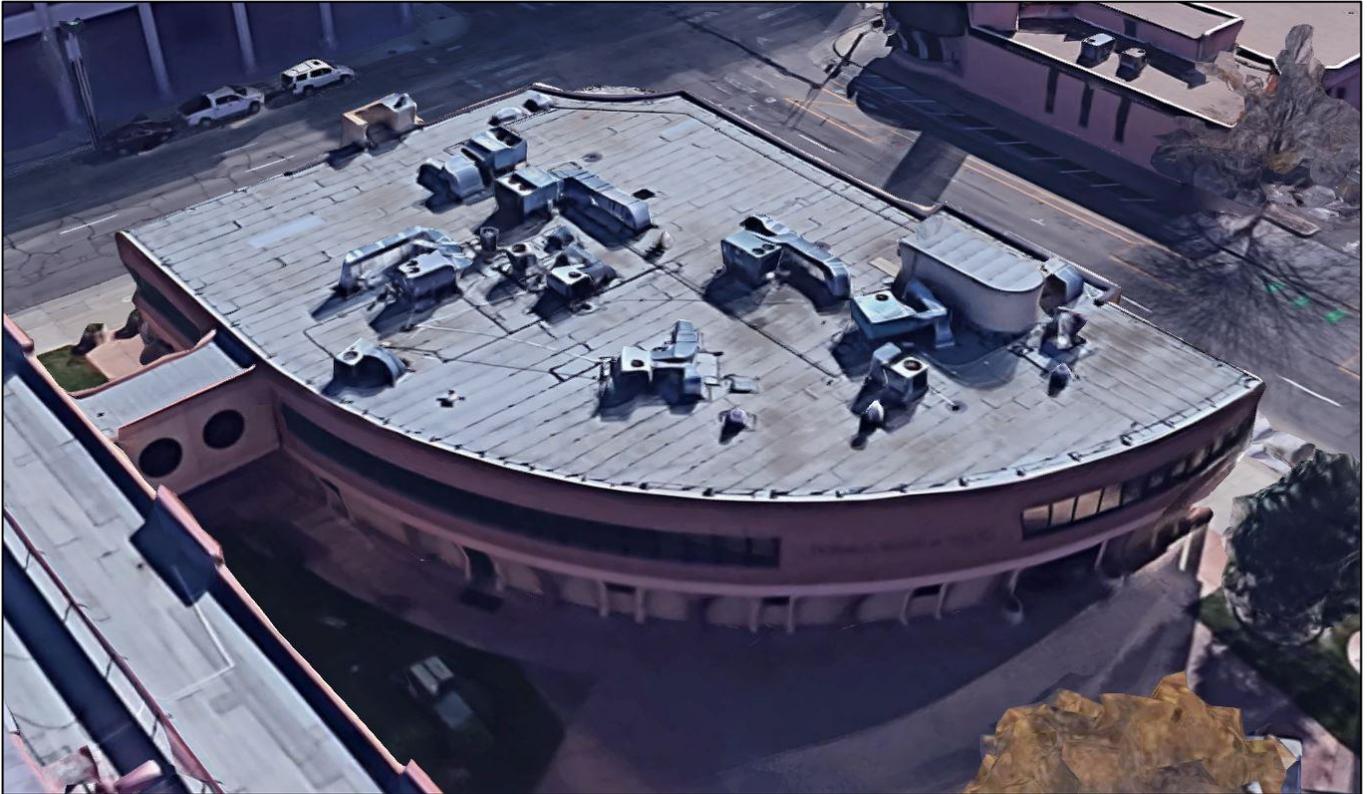
The curved northwestern wall connects the two brick walls on the south and east walls with a similar floating brick wall on its second story. This is supported on the ground story by ten cylindrical brick piers in front of a recessed concrete wall, totaling nine bays. All bays are nearly identical. In these, two concrete buttresses frame a vertical aluminum-framed fixed-pane window in the center of the bay. To either side of each buttress, a wall sconce is located between the buttress and its neighboring brick pier. Unlike the other bays, the fourth

301 W. 5<sup>th</sup> St. facing southeast and curving northwest wall. Courtesy of Google Maps.

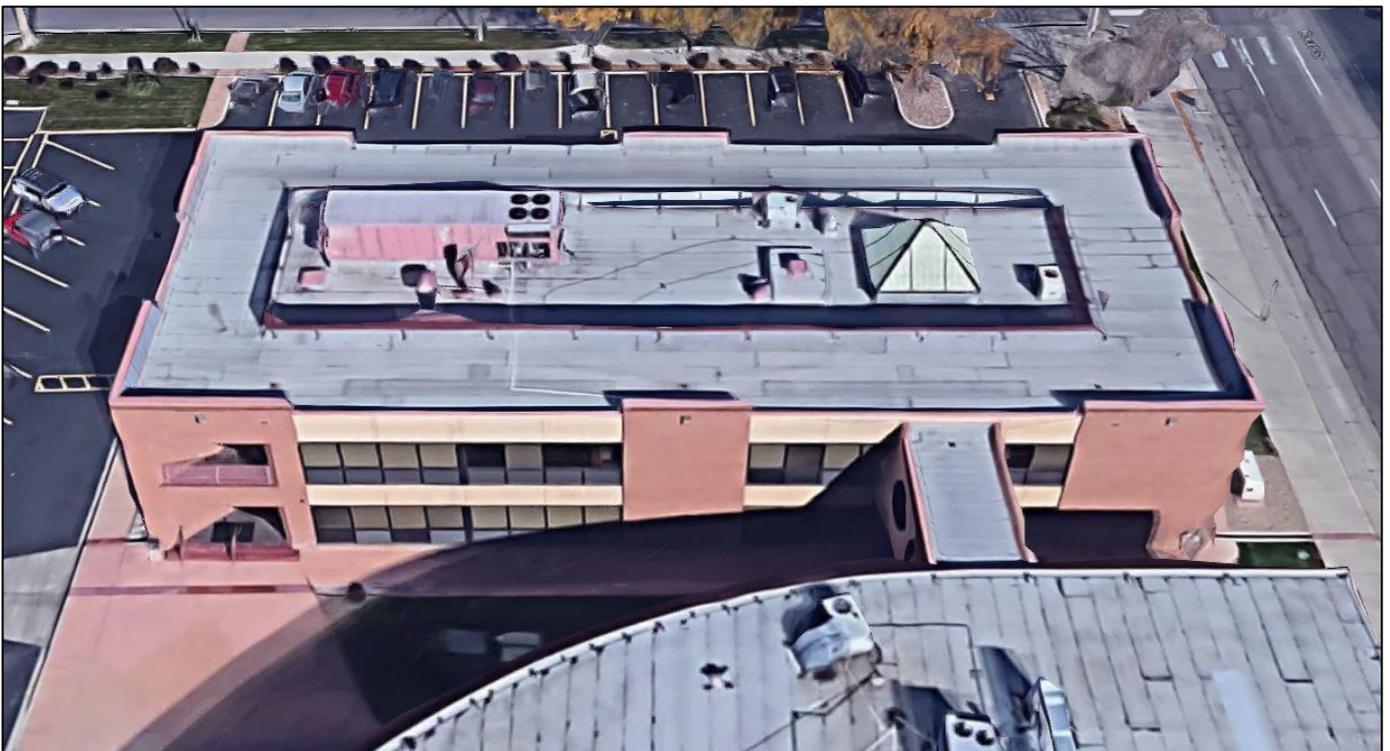
Attached office block of 301 W. 5<sup>th</sup> St. facing north and showing south wall. Courtesy of Google Maps.

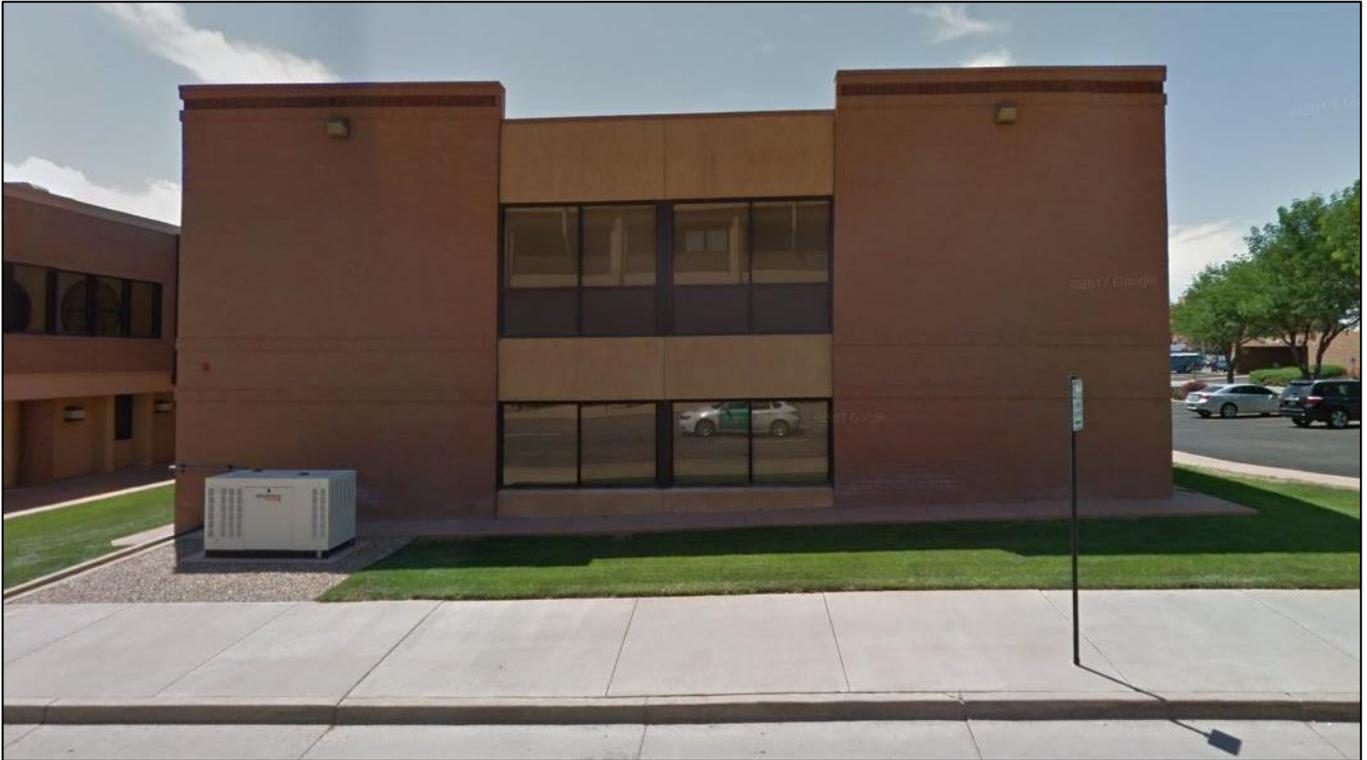
Attached office block of 301 W. 5<sup>th</sup> St. facing west and showing east wall. Courtesy of Google Maps.

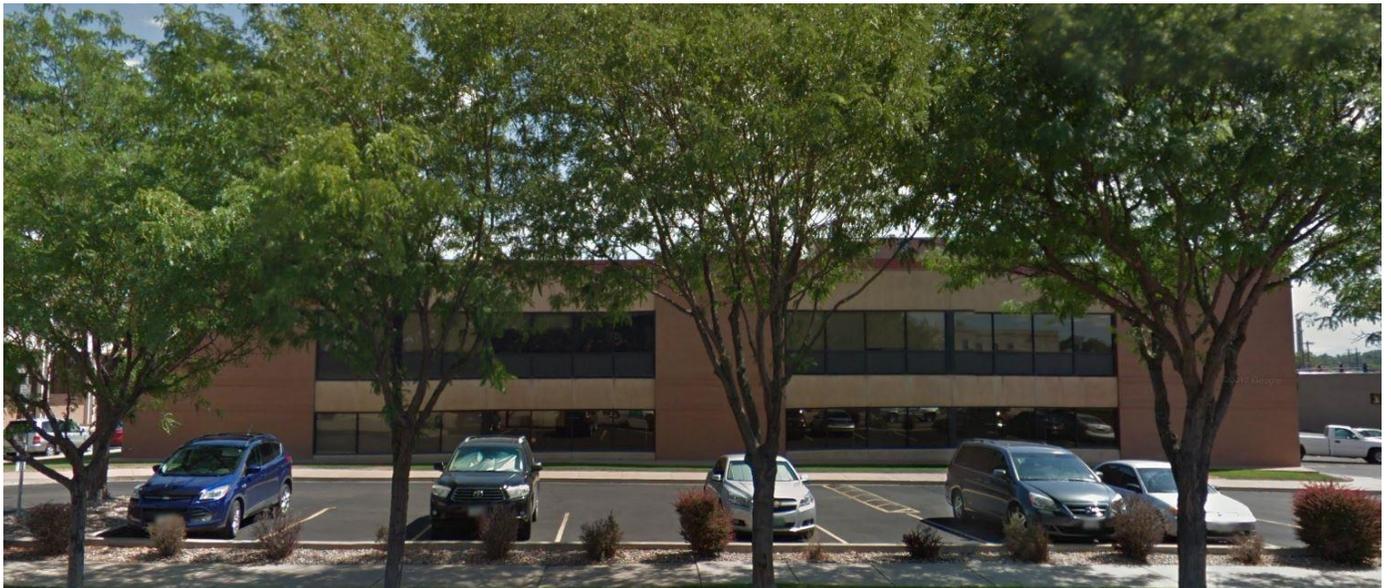
The block's long north wall follows this arrangement precisely with two blank brick pavilions at both corners and one more in the center. In the two spaces between these are placed the alternating bands of stucco and ribbon windows in which each upper bank of windows is composed of eight individual plates with eight glass spandrel panels. The lower banks are composed of only the eight panels. The western wall is similarly arranged with bookending brick pavilions separated by window banks of four plates and four spandrel panels. The panels of the ground story window bank are filled by stucco. The block's south wall is similar to the north wall however unlike the north wall, the building's ground story windows contain spandrel panels. The easternmost banks of windows on the first and second story are disrupted by the sky bridge which connects to the building at its second story. Directly beneath this in the lower bank of windows, the third and fourth plates/panels have been filled by a set of double aluminum-framed full-glass doors with sidelights. Echoing the circulation of the sky bridge, a poured concrete walkway connects this lower entrance to the main bank building. The south wall's westernmost brick pavilion is pierced by recessed angled entries on the first and second stories. The lower entry is externally accessed by a wide set of two stairs which lead into the recess and a window wall composed of three aluminum-framed plate glass panels and an aluminum-framed full-glass door topped by a transom. A window wall in the upper recess echoes the lower wall's arrangement however the recess is enclosed by a metal balustrade. Finally, the office block's short eastern wall is identically composed to its western wall. Although not visible from the street, aerial imagery shows a variety of utility equipment placed on the building's roof and a pyramidal glass skylight centered in the building's eastern half.

Attached office block of 301 W. 5<sup>th</sup> St. facing south and showing north wall. Courtesy of Google Maps.

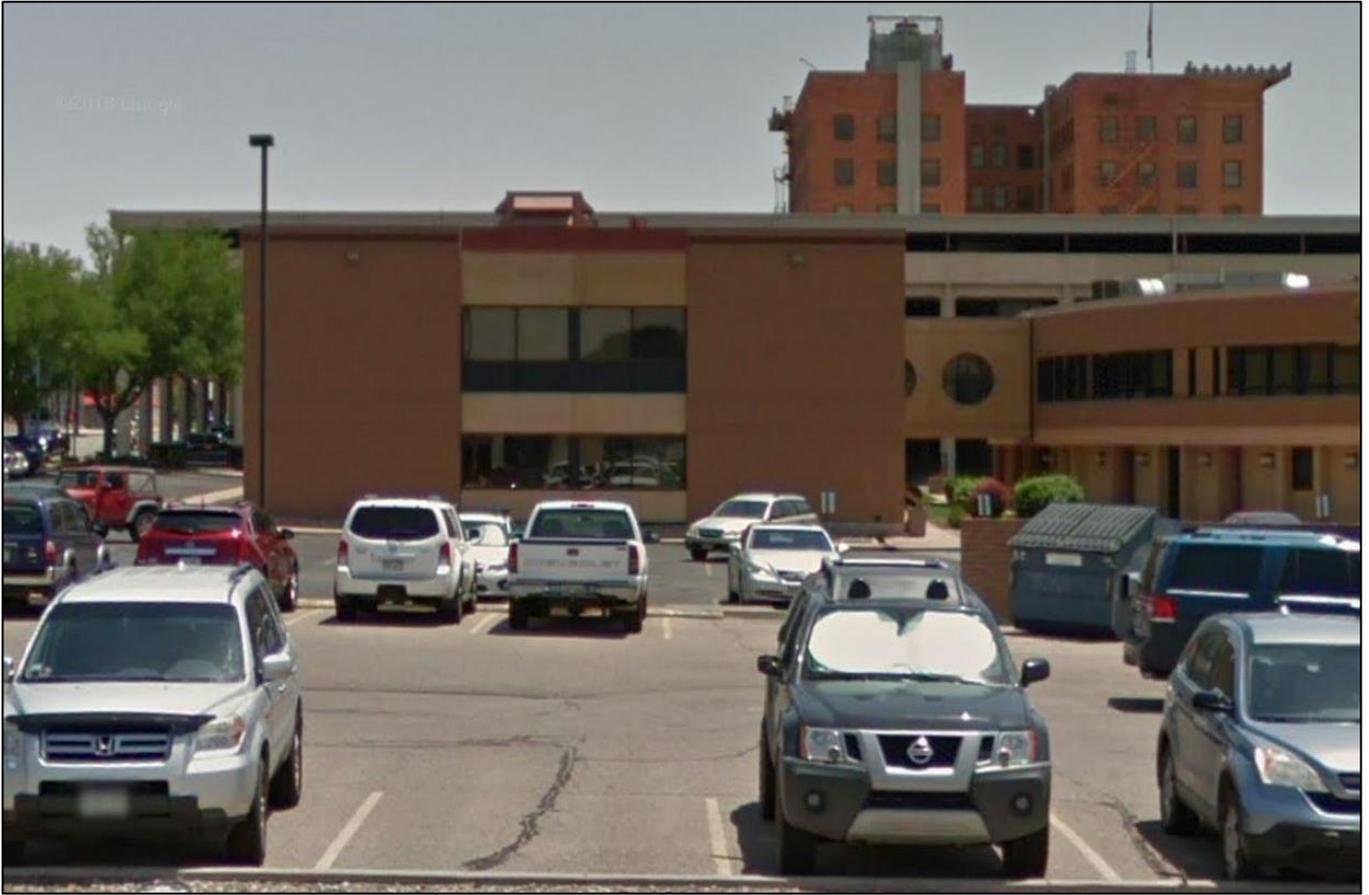
Attached office block of 301 W. 5<sup>th</sup> St. facing east and showing west wall. Courtesy of Google Maps.

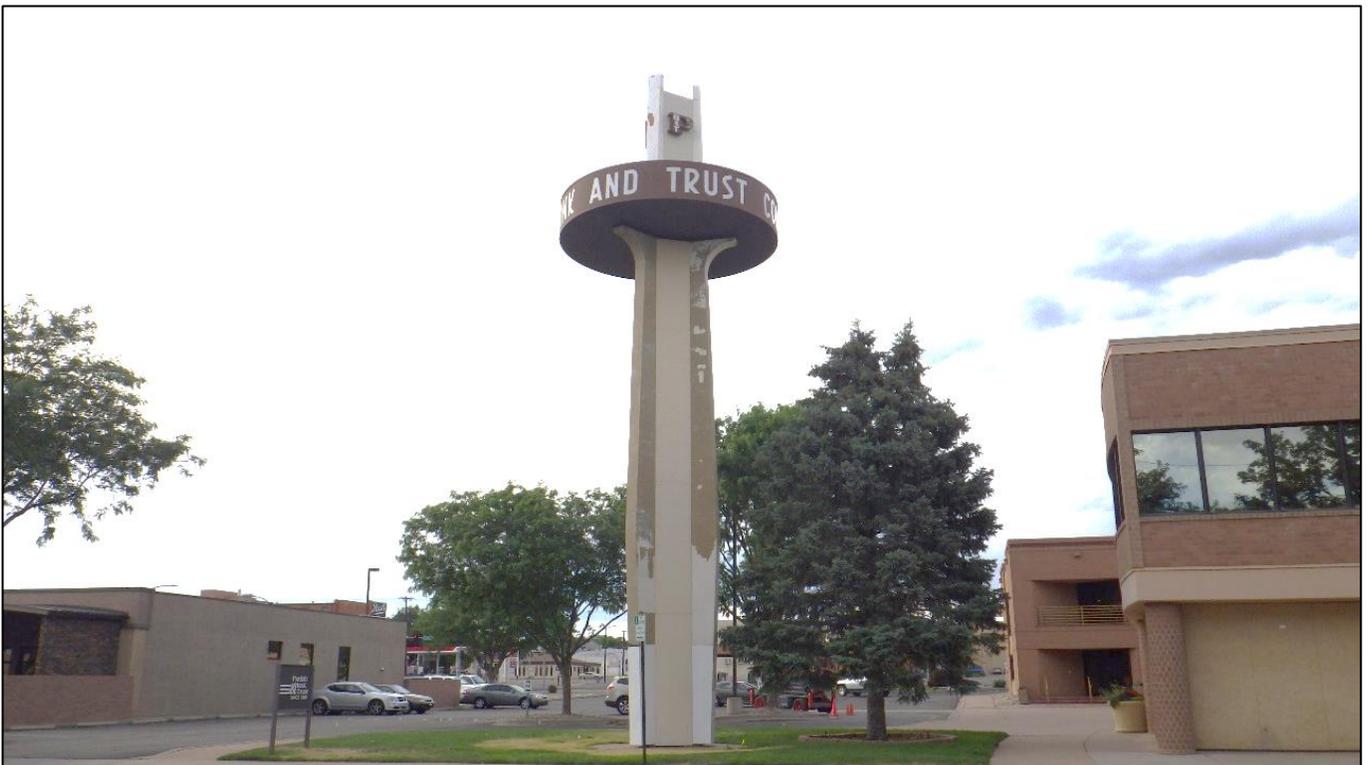
Beyond the southwestern corner of the building, a three-story concrete sign rises above the bank complex. Placed on a concrete slab foundation, the sign is constructed from a triangular pier with fin-like buttresses extending from each of the three corners up the shaft of the pier. Approximately three-quarters from the shaft's top is a large drum bearing the name of the bank on its ribbon-like sides. Documentary evidence indicates that this drum once rotated. The top quarter of the pier extends above the drum with a large "P" located at the top of each of its three sides.

301 W. 5<sup>th</sup> St. facing north and showing detail of Pueblo Bank & Trust sign

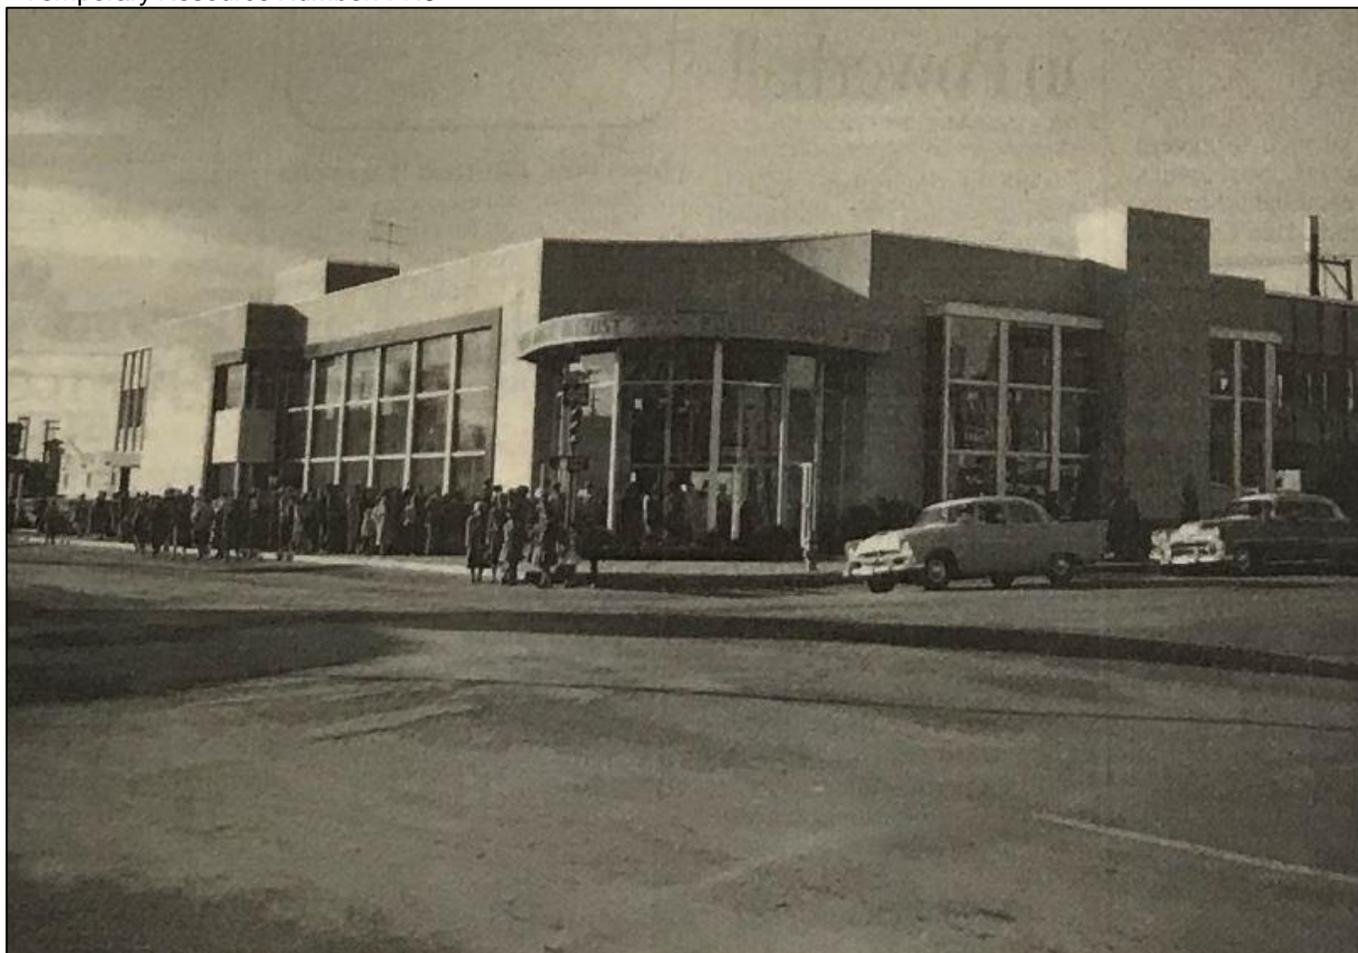
Pueblo Savings Bank during open house in November of 1960. Note bright aluminum window walls and exterior paneling on far building corners. Courtesy of PB&T.

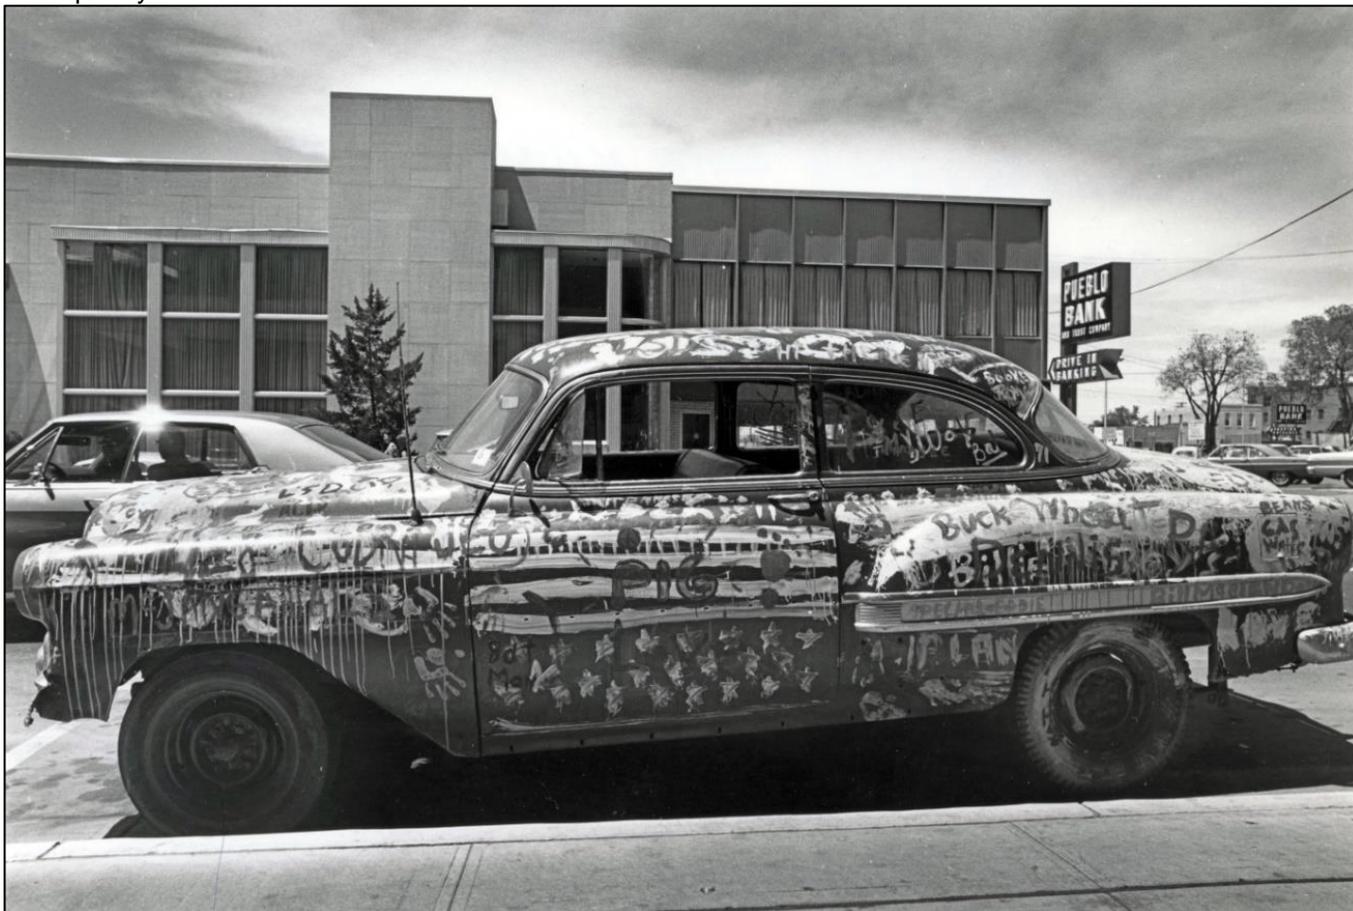
Decorated car in front of Pueblo Bank & Trust facing west showing east wall. 1960s? Note bright aluminum window wall and paneling on corner of building. Courtesy of the Pueblo County Historical Society. Image No. PCHS-P-98-1416.
