HPC-001-2022

January 19th, 2022

To: Historic Preservation Commission
From: Wade Broadhead, Planner
Through: Scott Hobson, Director of Planning and Community Development
Location: **107 S. Union Avenue**
Applicant: Kelly Sparker
Owner: Precariously Gregarious
Year Built: 1886
Resource Name Orman and Crook Armory Block/ Sam Nelson Furniture
Legal Description: Lots 17 and 18, Block 60, South Pueblo
Zone District: **HB, Historic Business District**

Request: **Reveal & replace windows, transom, storefront, , doors, and add a new rear deck and various alley façade modifications.**

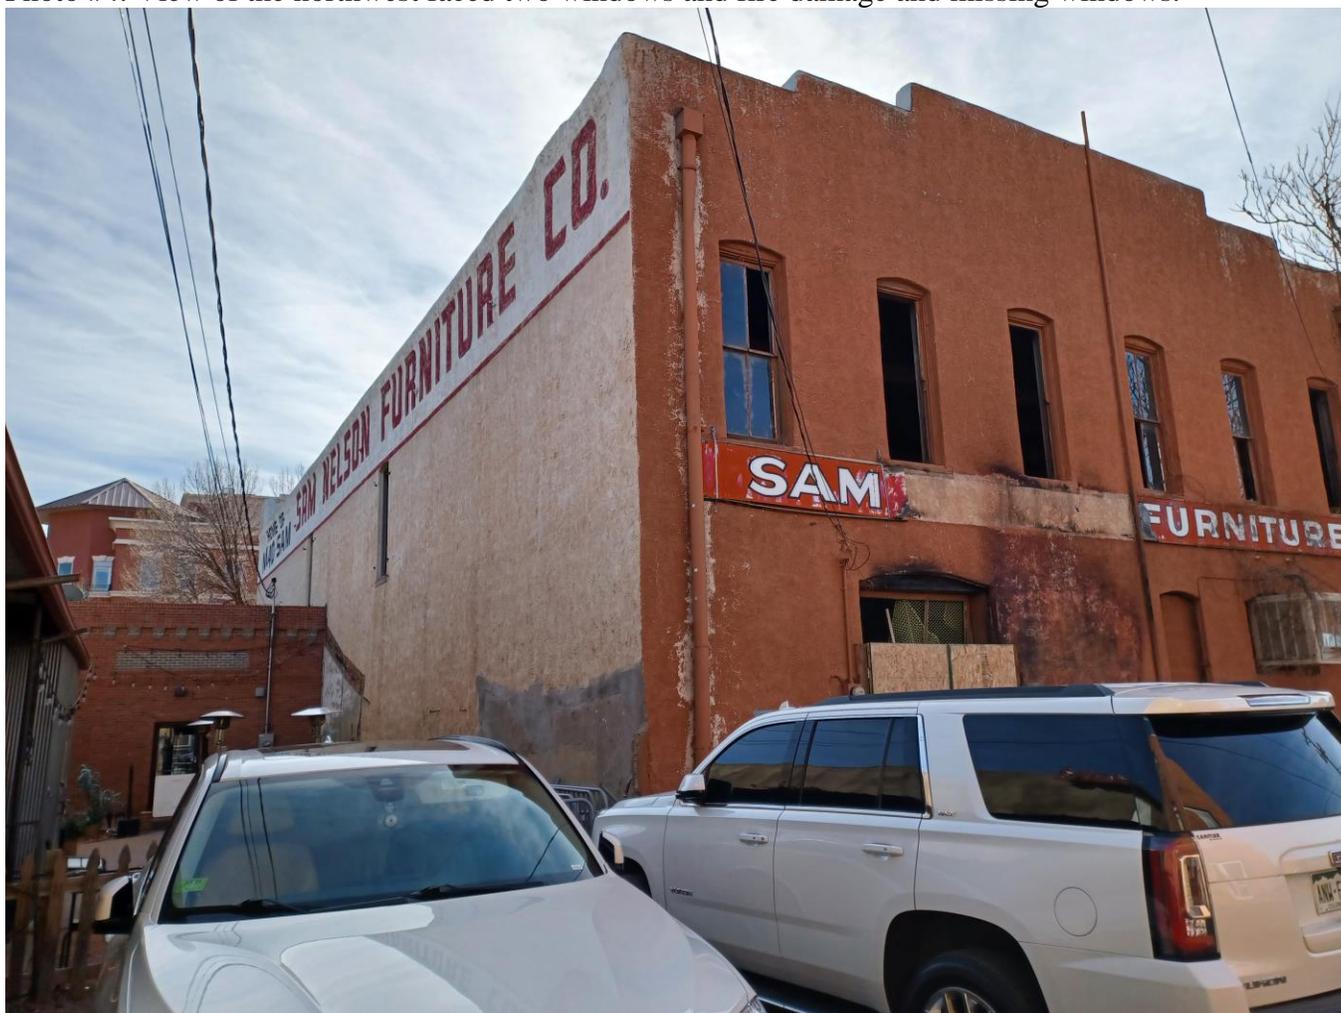
this time. The new front brick façade is not original and now protrudes out from where the original wall would have been. More recently there was a fire along the rear façade and the rear windows were removed, and damage was done to the walls (see photos below).

Photo #4. View of the northwest faced two windows and fire damage and missing windows.

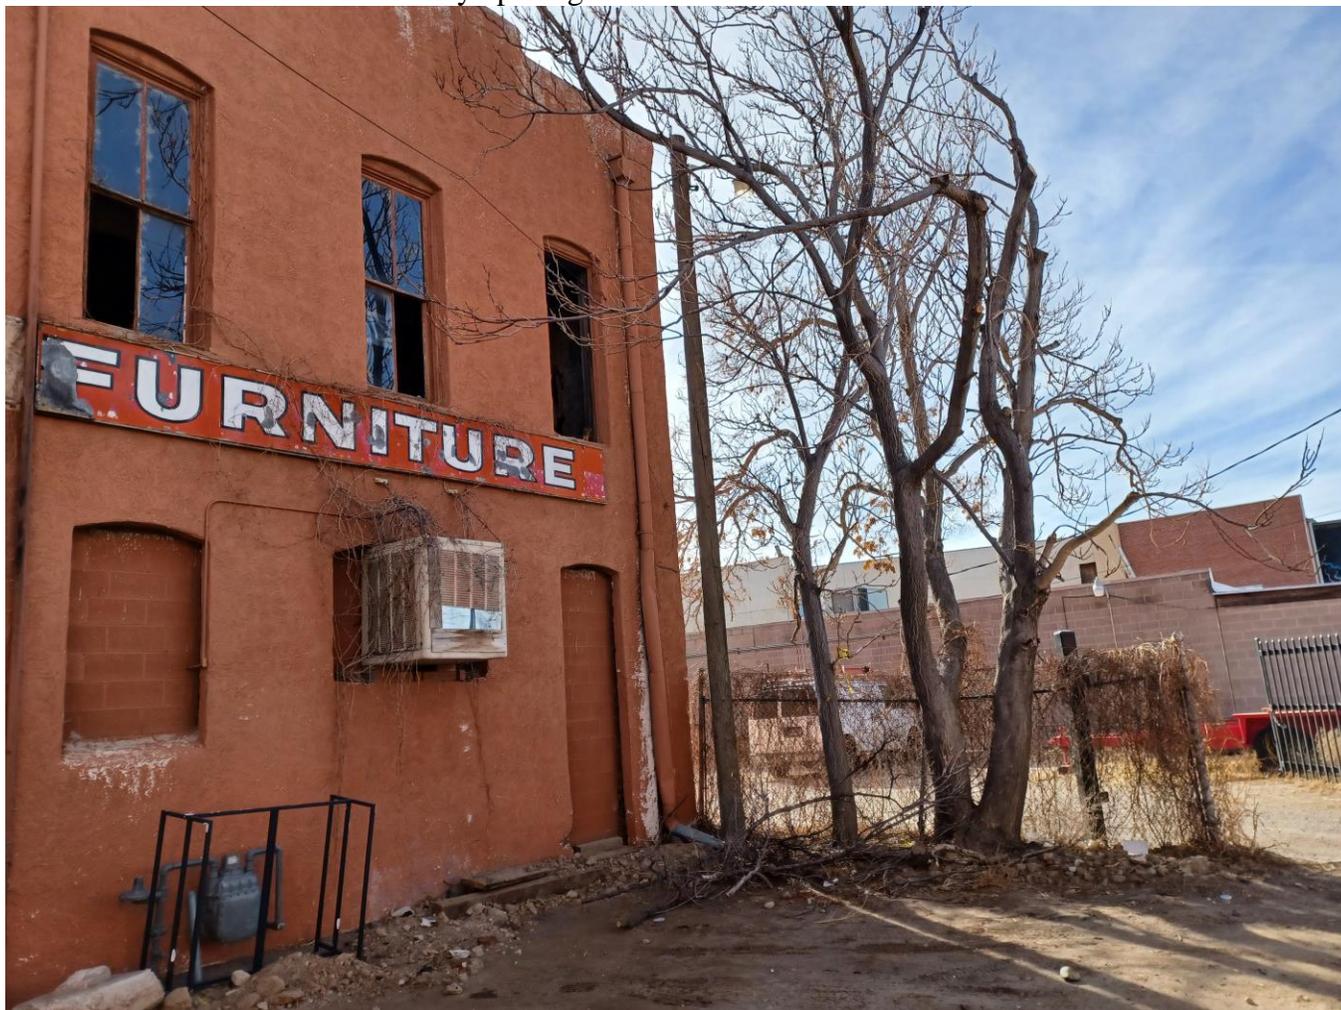
Analysis: This proposed open air deck is sited along the alley on the back façade which has suffered extensive fire and renovation damage. The second story currently has six windows and the middle door will be converted to a door, while the remaining five windows will be replaced with new windows. The deck will be made from wood with open metal railings. The applicant also plans to relocate the Sam's metal sign from the alley façade wall to the outer railings, keeping it approximately in the same location. The first floor will undergo significant changes. Currently there is a larger freight access opening with fire damage on the left side of the alley façade as well as two blocked in window openings. The plans indicate the freight opening will be covered and a new solid door added to the center of the façade as well as one new style window to accommodate the landing for the second story deck. Gas meters will be installed on the right side for the new residential uses. The first-floor changes are needed for the change in use from large furniture warehouse to mixed use/residential. The first-floor changes do not comply with the guidelines as they completely obscure the freight opening. **Staff recommends the applicant preserve the freight opening framing and add a simplified door, even if it isn't operable.** Staff also recommends the one first story window along the alley to be a simplified two over two or one over one. The proposed window doesn't emulate the original nor provide a simplified design as recommended by the guidelines.

Photo #5. Blocked in first floor alley openings.

1. Front doors be solid wood or wood with rectangular glass panel approved administratively by staff and reported to the HPC at the next meeting.
2. Create an opening and install/preserve door for the rear alley freight door opening. The design does not need to be operable but honor and show the previous freight opening. Applicant submits design to staff to approve administratively. If the design does not comply with this condition, applicant will come back before the HPC.

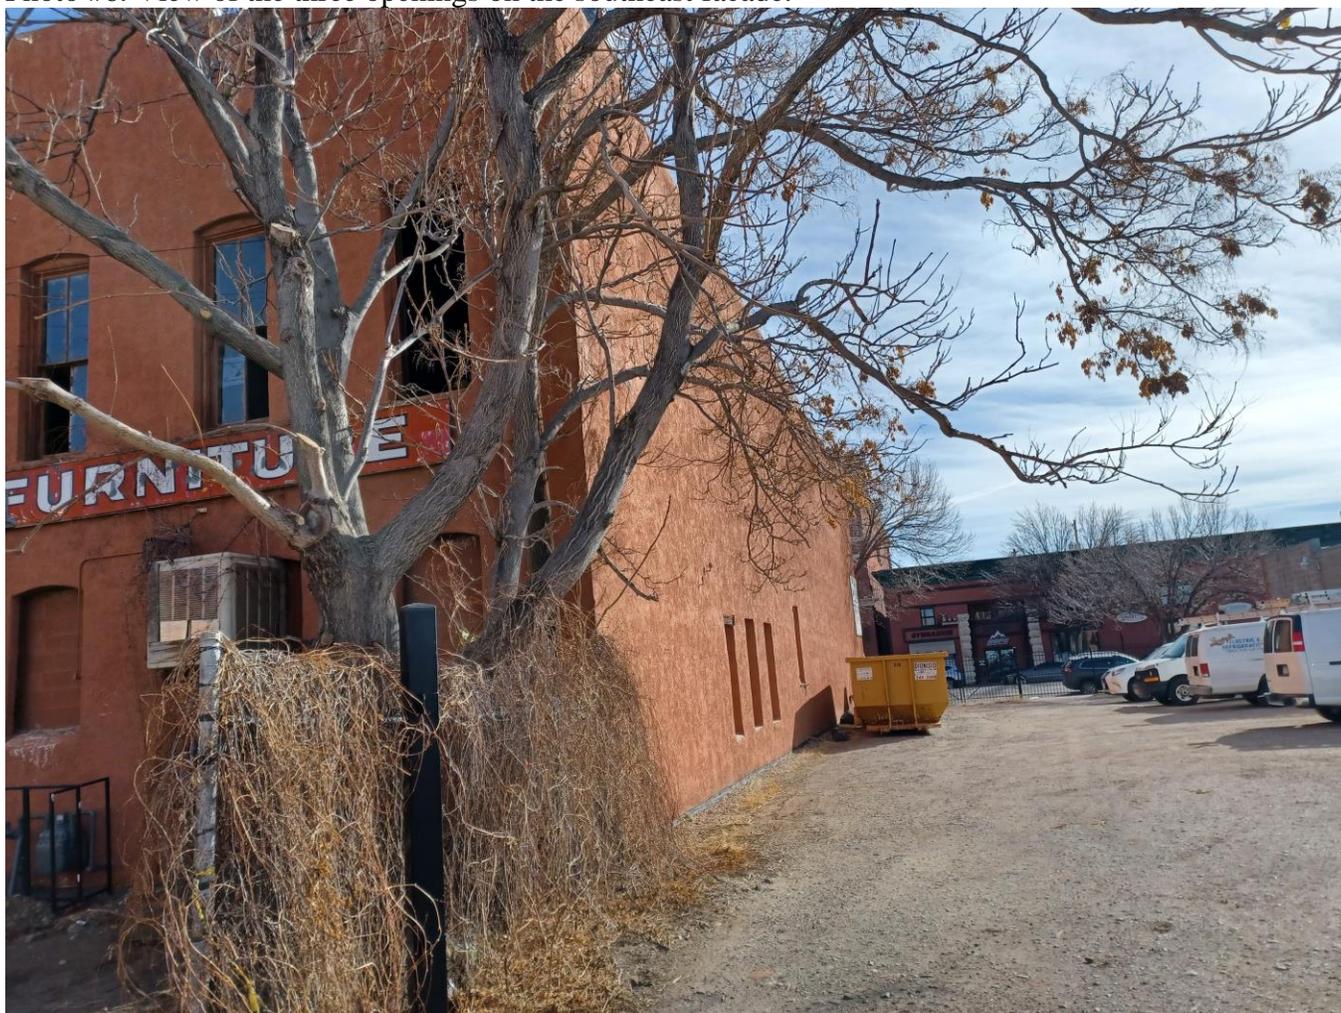
Currently there are only three first floor openings on the southwest elevation and two second story elevation on the northeast elevation. The plans call for ten windows on the southeast side now (five up and five down). Due to the distance to a lot line the openings will need to be plate sprinklers and curtain

Photo #6. View of the three openings on the southeast facade.
