## HPC-22-17 Steel Facade

November 16, 2022

**To:** Historic Preservation Commission  
**From:** Wade Broadhead, Senior Planner  
**Through:** Scott Hobson, Acting Director of Planning and Community Development  
**Location:** 322, 324, and 326 S. Union Ave  
**Applicant:** Fred Gonzales  
**Owner:** Henry Borunda  
**Year Built:** Remodeled 1945  
**Legal Description:** Lot 4, Block 58, South Pueblo  
**Zone District:** HB, Historic Business Zone District

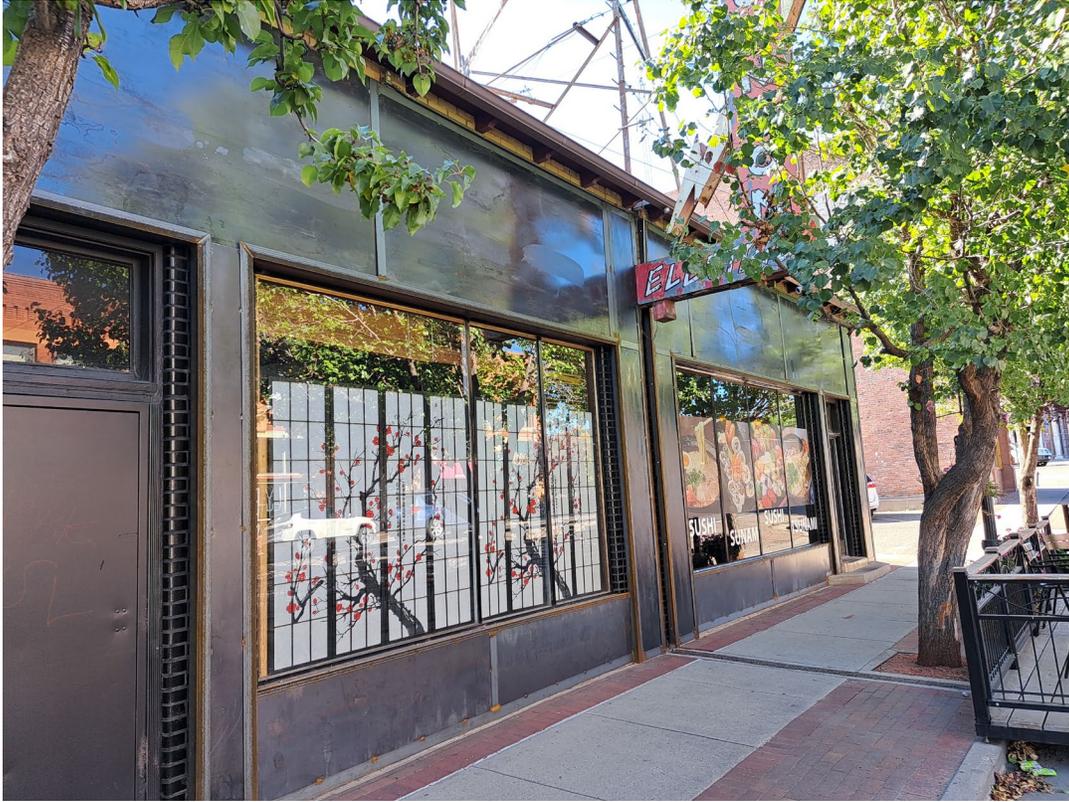
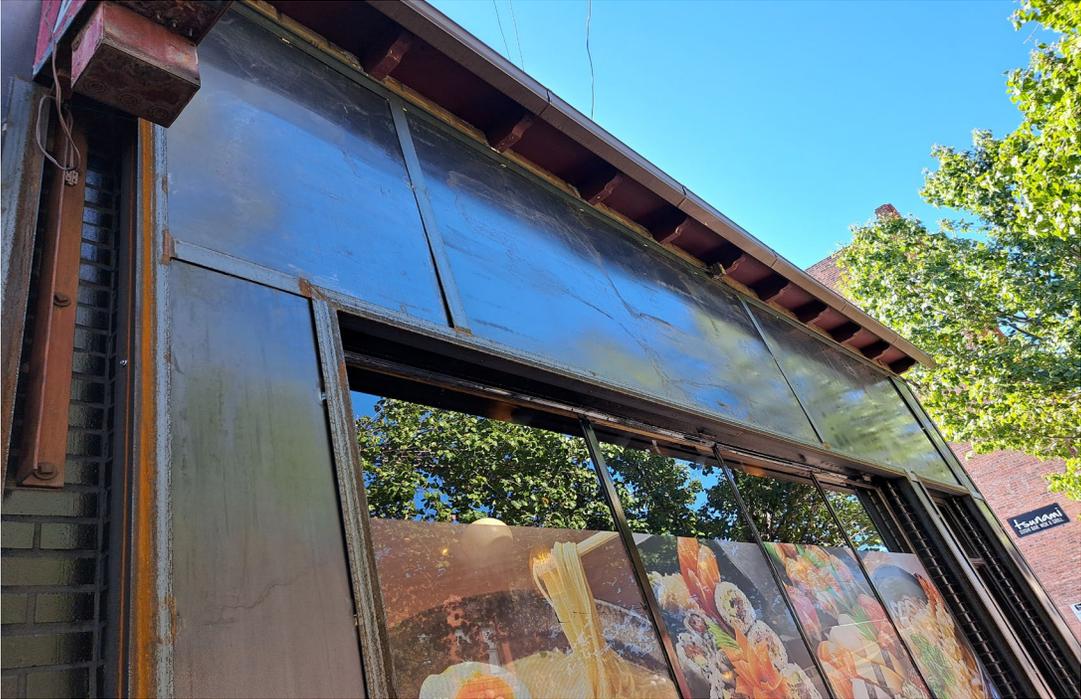
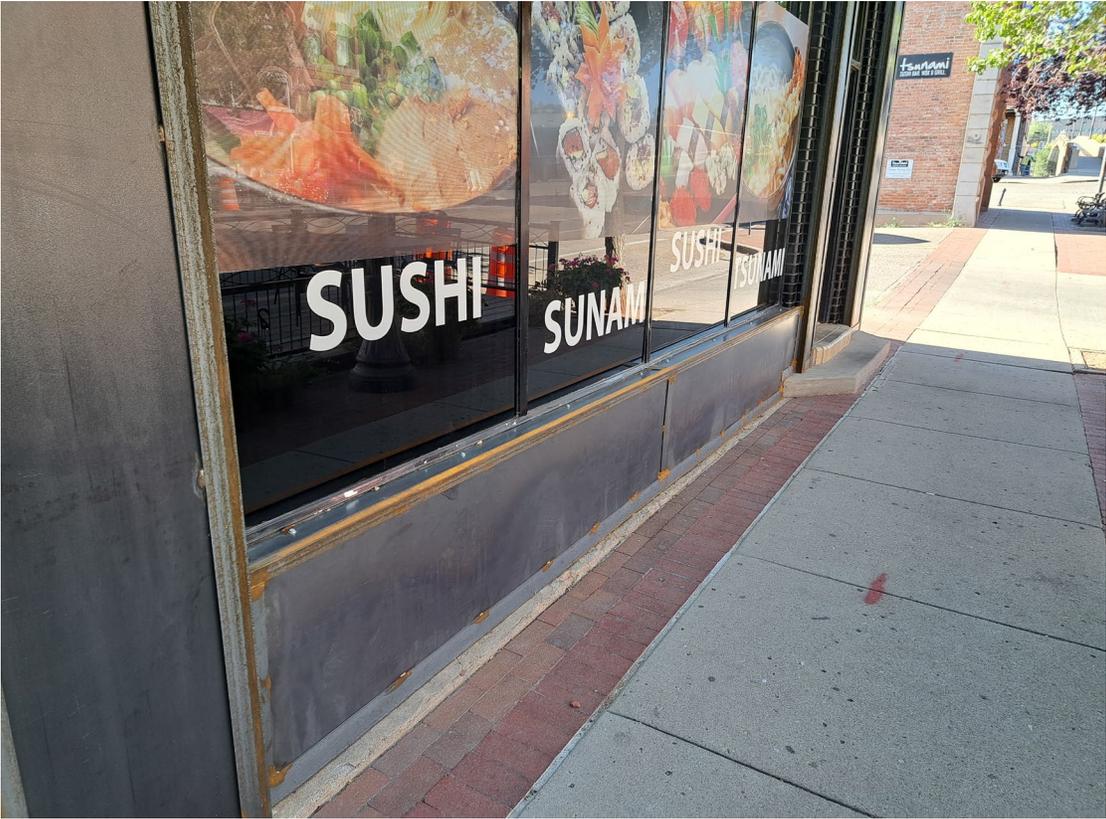
**EXHIBIT B. SITE PHOTOGRAPHS**

*Finding:* The steel panels are welded to each other, glued and screwed to the yellow glazed brick façade. Because construction adhesive and screws were used to apply the steel the steel is not considered independent and removal will damage the yellow brick façade. .

*Finding:* The application of the steel façade, the adhesive, and a number of screws will damage the underlying brick and block when removed.

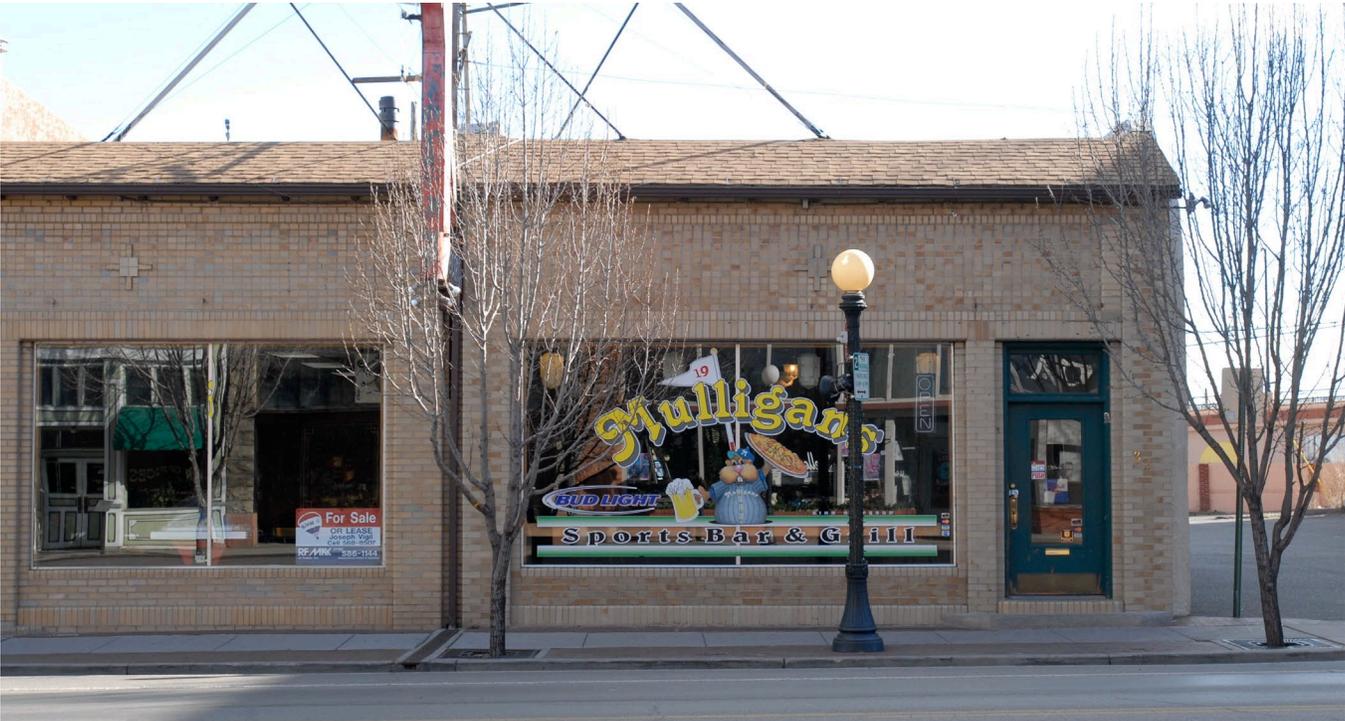
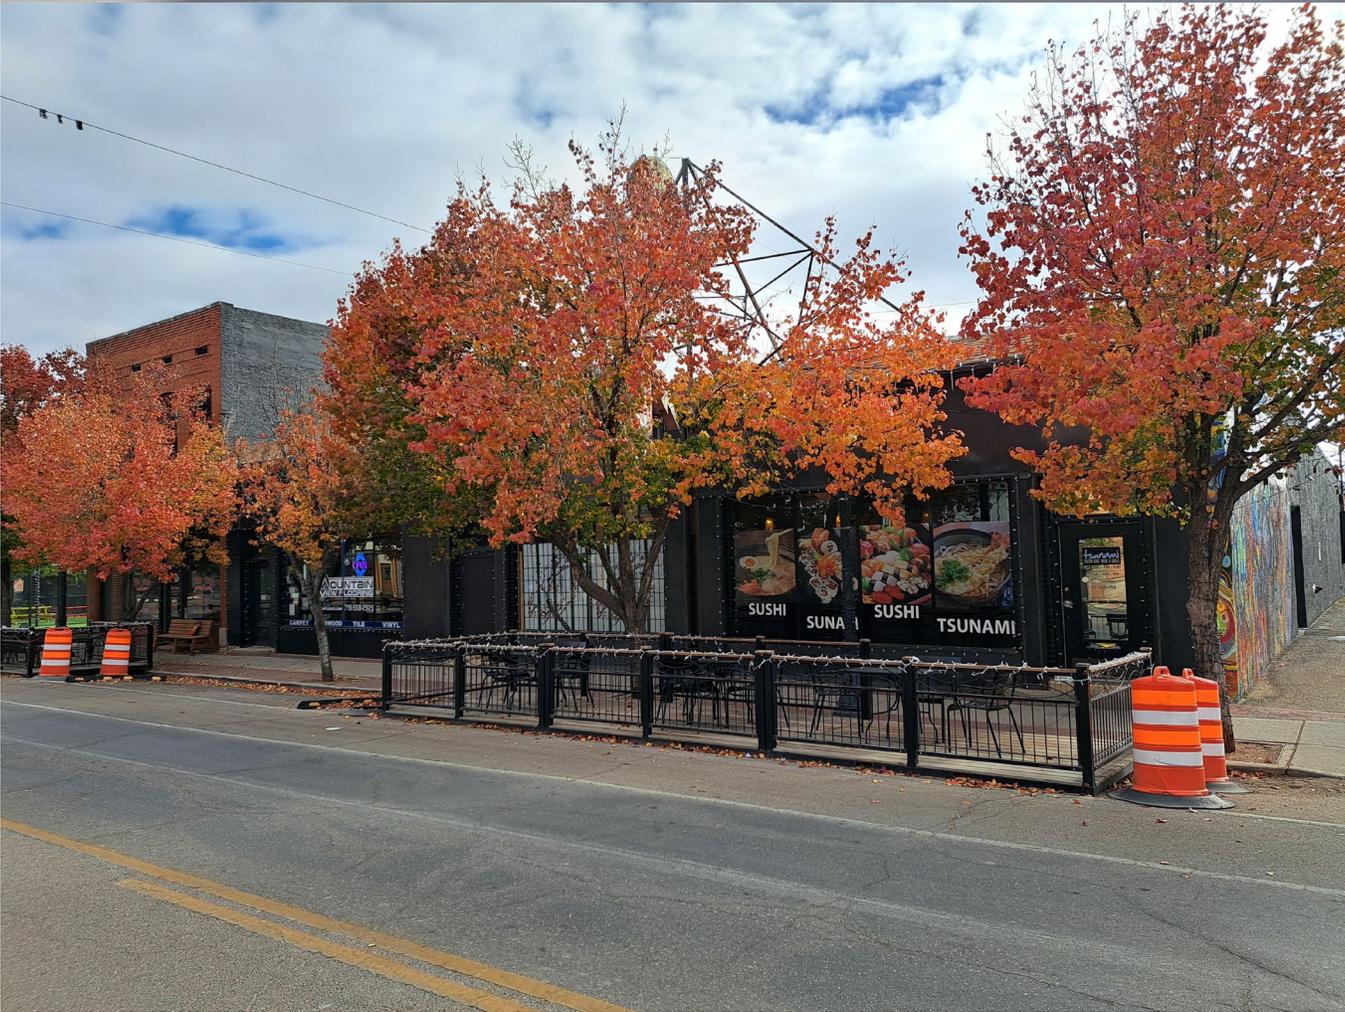
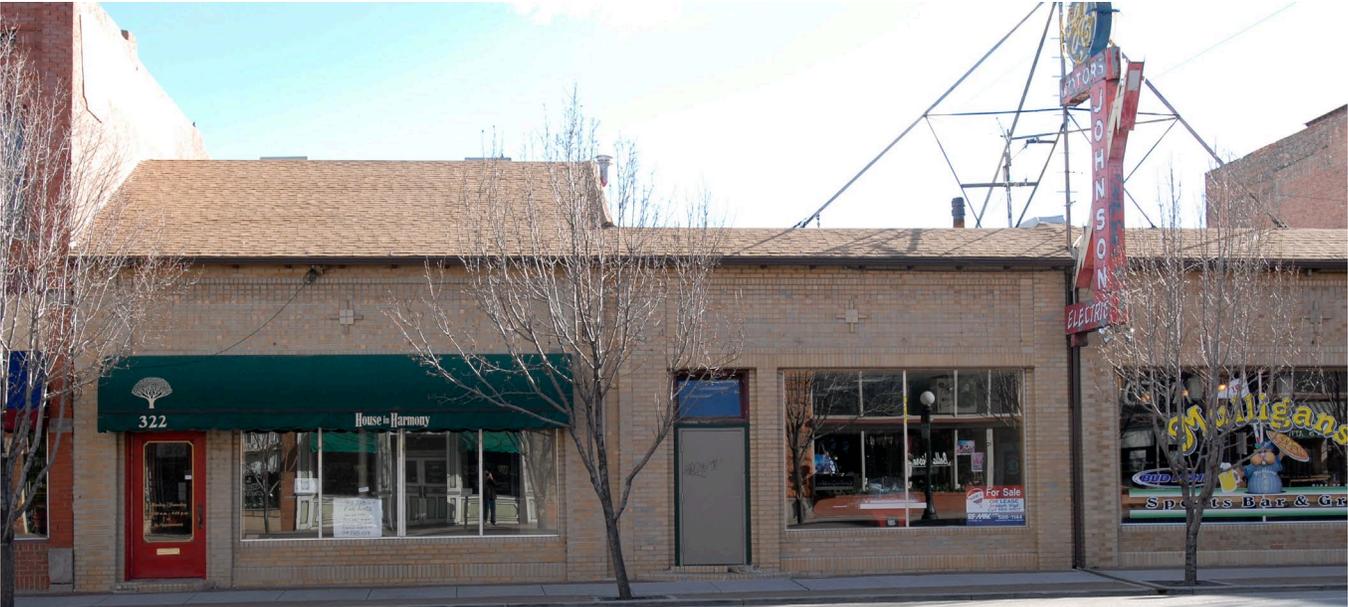
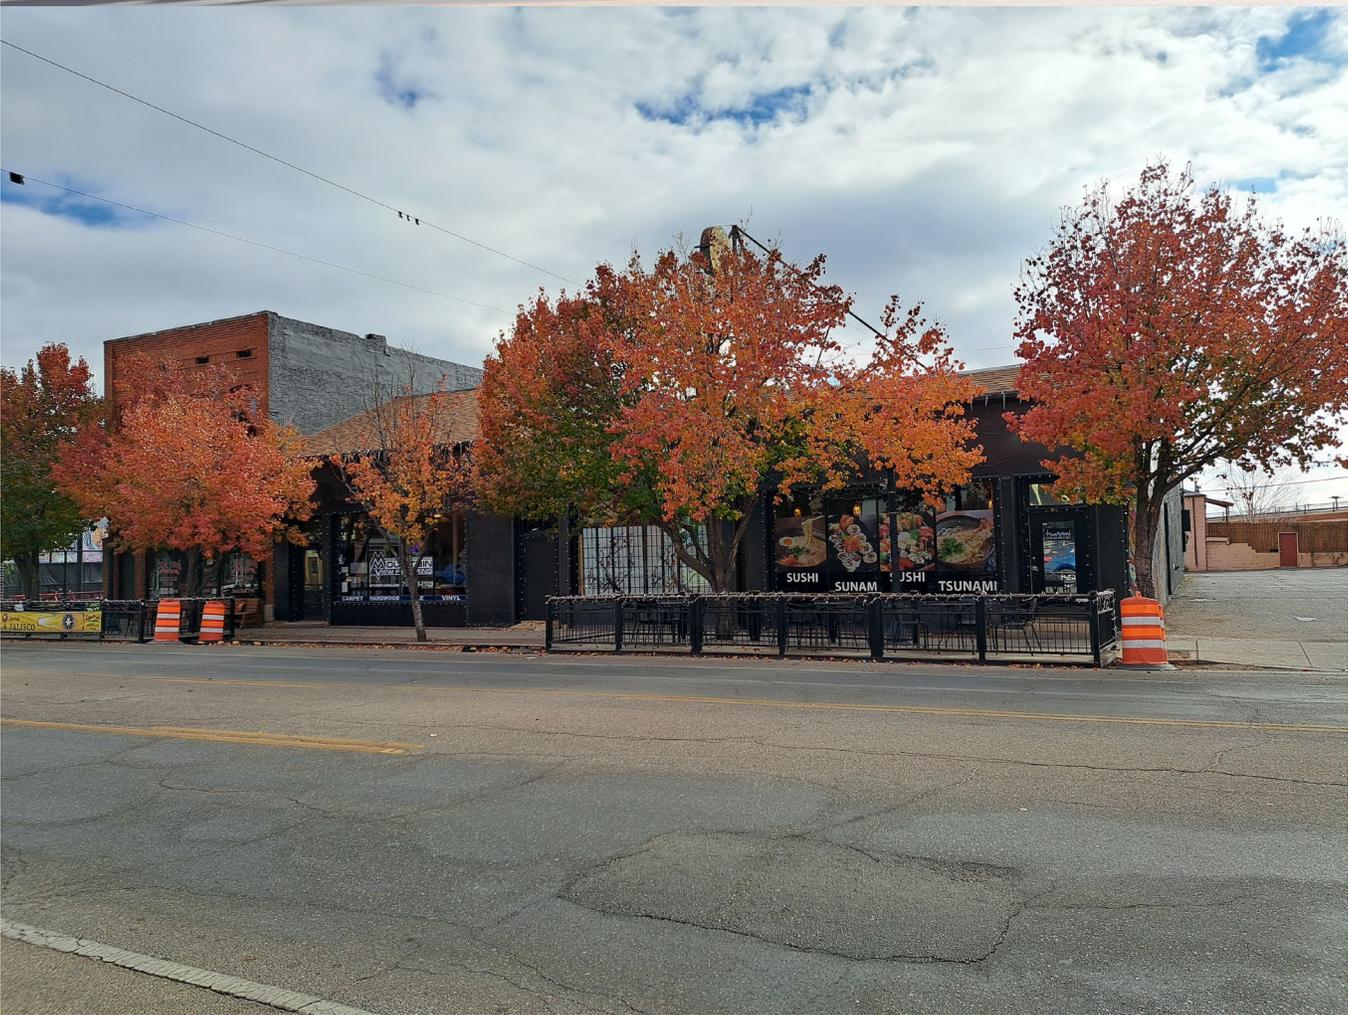
Photos of the storefronts Circa 2007 and November 2022 Conditions

*Finding:* The steel façade system covers up the storefront elements that were differentiated through various types of brickwork outlining a transom area and window display surrounds made with brick. All original detailing on the storefront has been obscured.

*Finding:* The steel façade system has covered the 1945 façade and all architectural detailing. Furthermore, the installation may have seriously damaged the original storefront façade and brick.

The proposed steel façade does not conform to the Pueblo Historic Business District Guidelines or Standards of Appropriateness; therefore, a COA cannot be issued, and modifications shall be removed. The owner may submit a revised application with modifications to the steel façade to meet the criteria of the HB Guidelines and Standards of Appropriateness.
