# Architectural Inventory Form

1. Resource number: 5PE1198
2. Temporary resource number:
3. County: Pueblo
4. City: Pueblo
5. Historic building name: Whitcomb Block/Pueblo Savings & Trust/Clark's Western Wear
6. Current building name: Not applicable (unoccupied)
7. Building address: 300 North Main Street
8. Owner name and address: BC Scotsons, LLC, 300 N. Main Street, Pueblo, CO 81003

48. Report title: Steel City's Barometer: A Survey and Context of Downtown Pueblo's History and Architecture.

49. Date(s): June 2017

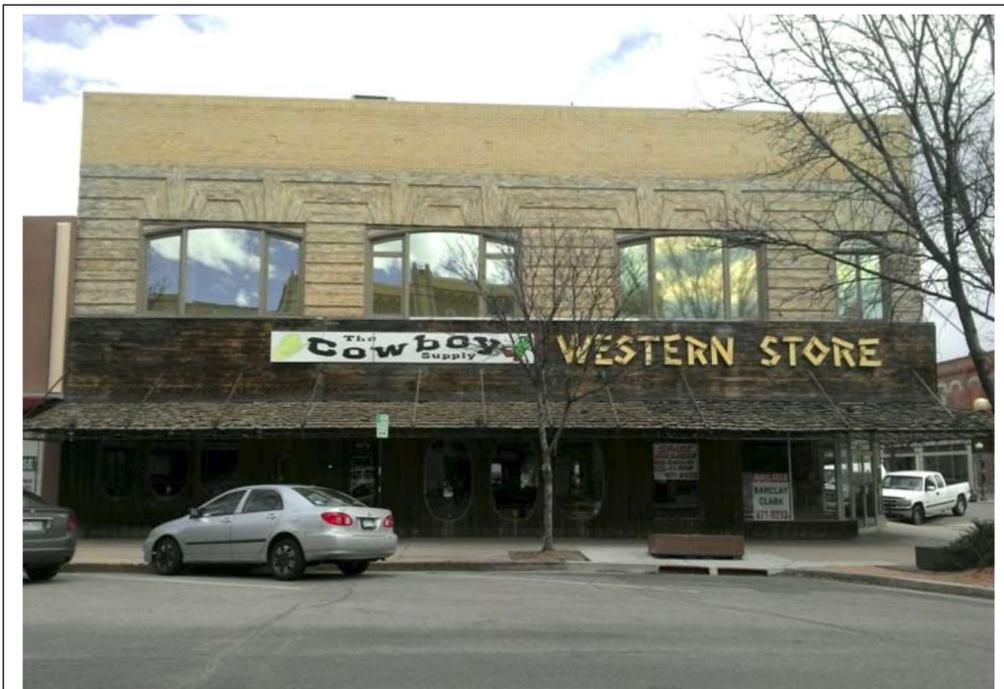
5PE1198 – 300 North Main Street. Looking east at western façade. Photo ID: 5PE1198a. March 2016.

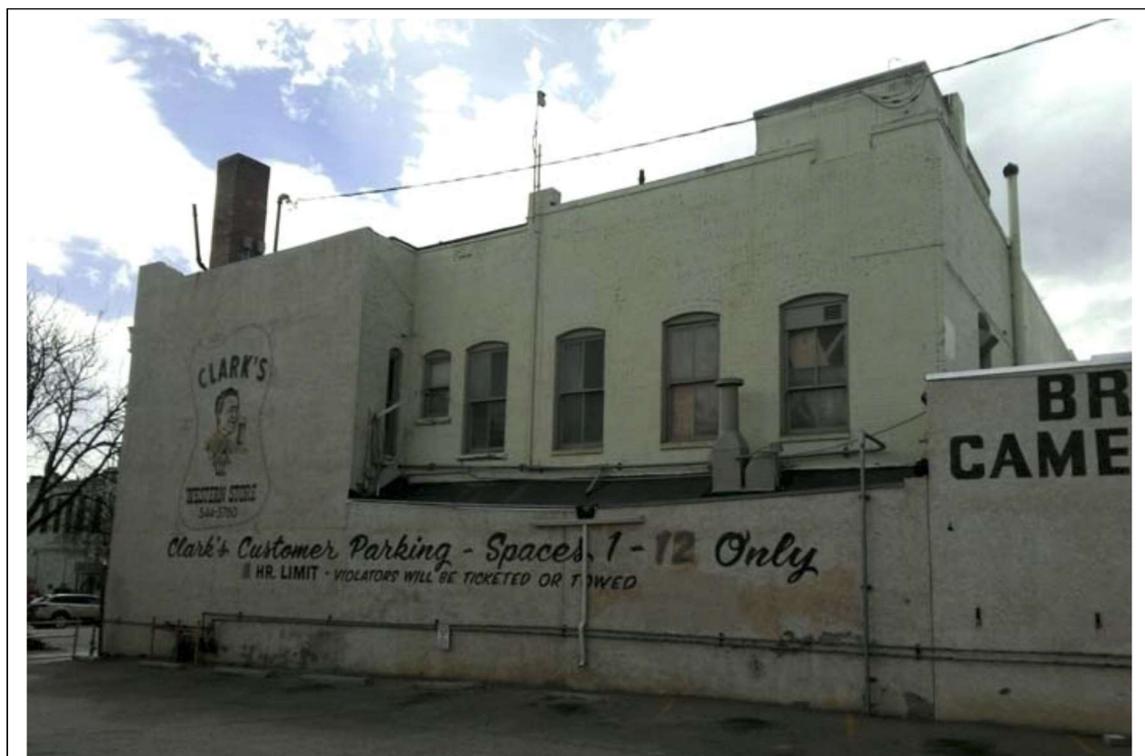
5PE1198 – 300 North Main Street. Looking southeast at eastern façade. Photo ID: 5PE1198b. March

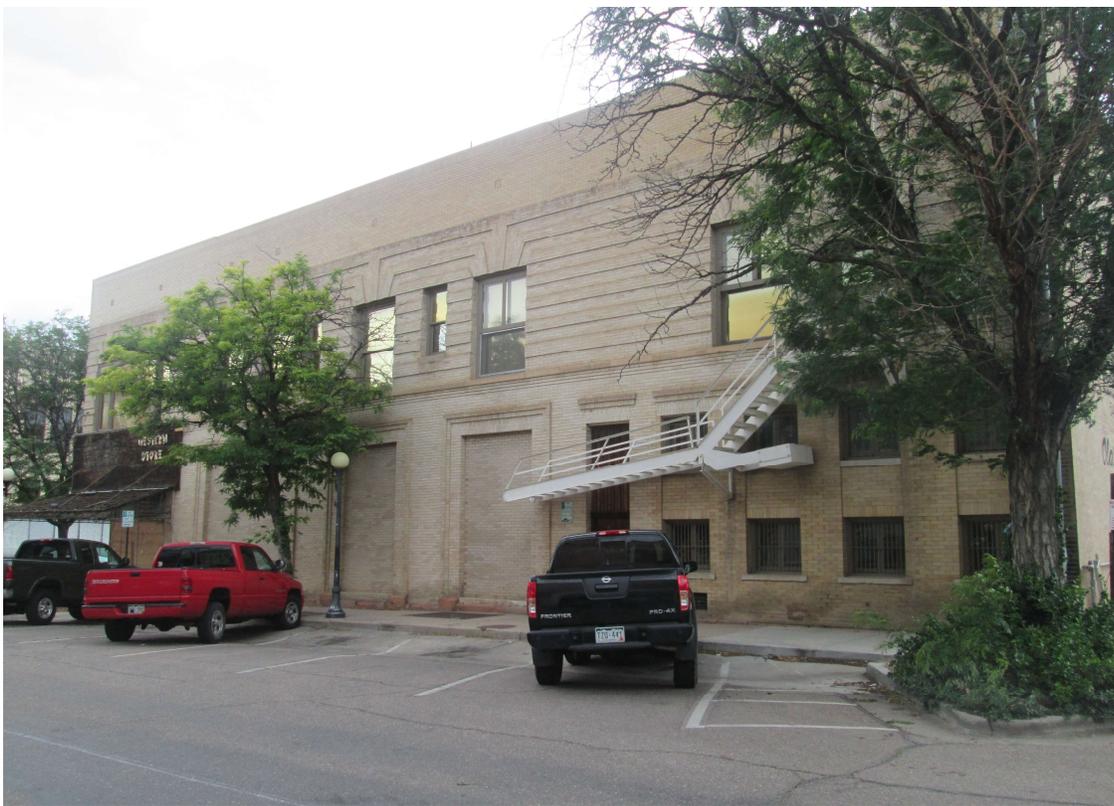
5PE1198 – 300 North Main Street. Looking northwest at southern façade. Photo ID: 5PE.1198c. June 2017.

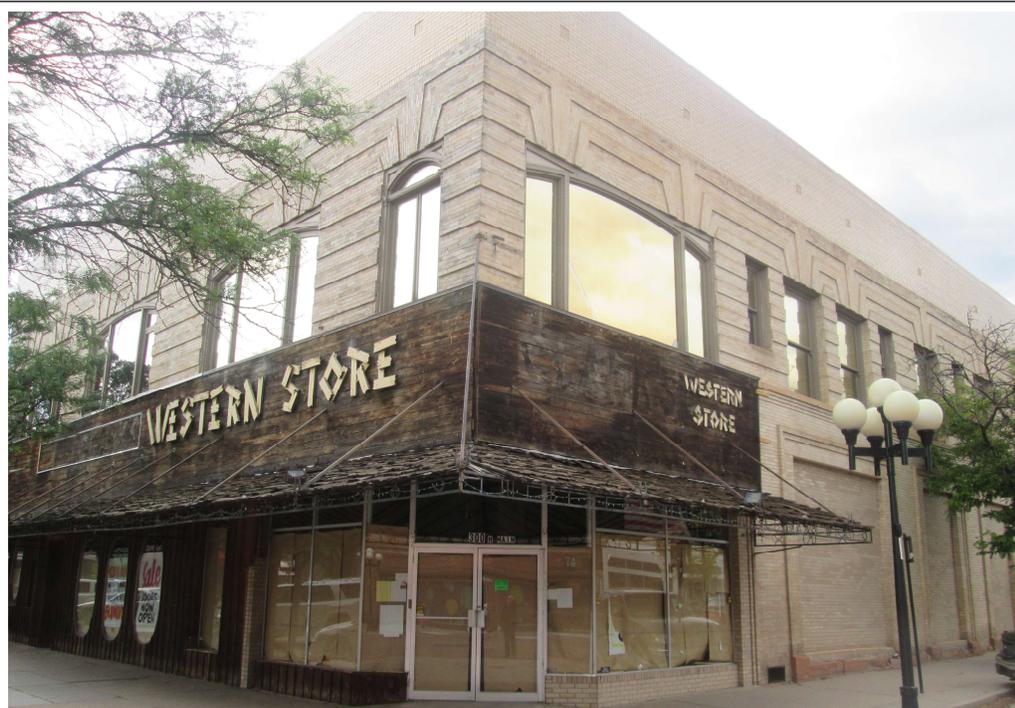
5PE1198 – 300 North Main Street. Looking southeast at eastern and southern façades and main entry. Photo ID: 5PE.1198d. June 2017.

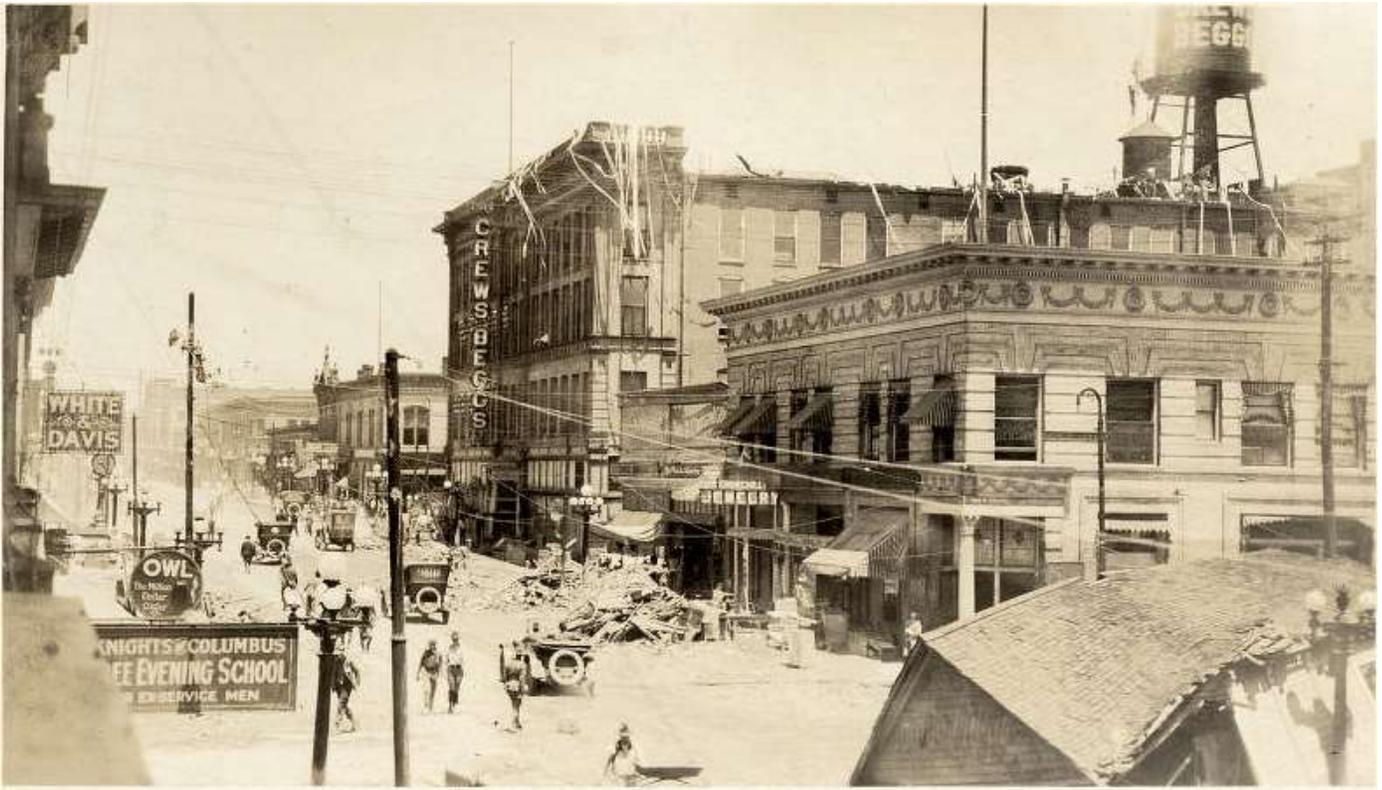
**WE** reproduce the Architect's drawing of our new building as it will appear when completed within the next sixty days. The interior is now in the hands of the decorators and should be completed by February first. Customers are now admitted thru the Main Street entrance. There will be found many new conveniences and everything that goes with a modern banking room.

29. Construction history (include description and dates of major additions, alterations, or demolitions): According to Pueblo County appraisal records, 5PE1198 was completed in 1896. The Pueblo Savings and Trust added a terra cotta exterior during 1921-1922. A clay bed near Denver provided the material for the tiles and bricks. A 1921 photograph shows decorative floral swag motifs and an ornate cornice on the parapet of the building which were likely installed as a part of this renovation. Although the brickwork remains, the cornice and swag were removed between 1922 and the previous 1983 survey; in 2017 the property looks much as it did in 1983. In 1926, the bank's management announced its intention to install a bronze and glass 8.0 × 10.5-foot clock on the building's southeast corner. The cornice, but not much other detail, is still distinguishable in an aerial photograph from the beginning of the 1950s. However, in 1952, the city granted permission to Pueblo Savings and Trust to reconstruct the building's interior and install a new front; the estimated cost of renovations came to \$2,000. In another early to mid-1950s aerial photograph of Pueblo, the cornice is absent. Clark's Western Store

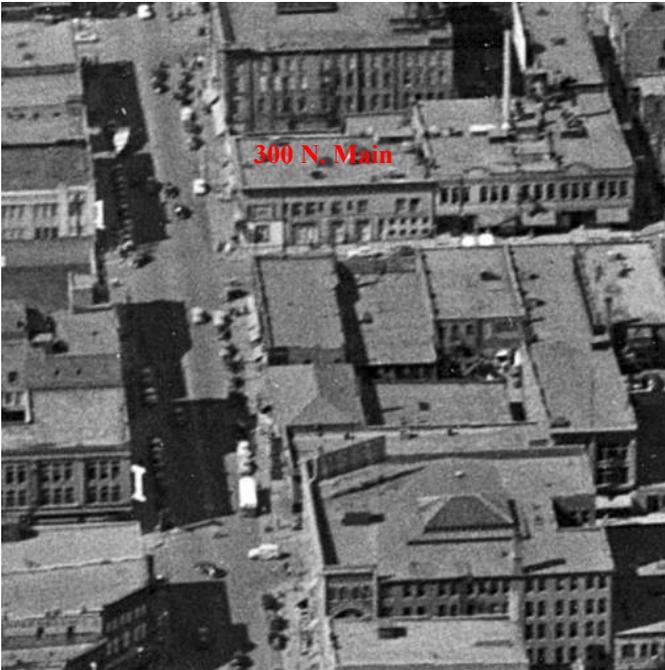
Aerial view from the early 1950s with cornice visible. Image from the Pueblo City-County Library District:  
<http://cdm16620.contentdm.oclc.org/cdm/singleitem/collection/myfirst/id/834/rec/5>

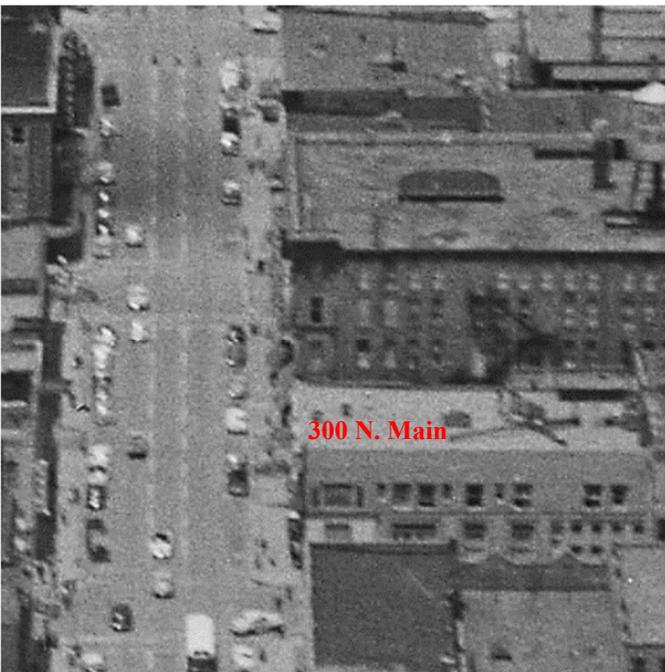
Aerial view from the early to mid-1950s based on latest car styles that are distinguishable; no cornice visible. Image from the Pueblo City-County Library District:  
<http://cdm16620.contentdm.oclc.org/cdm/fullbrowser/collection/p16620coll3/id/51/rv/singleitem/rec/28>
