COLORADO CULTURAL RESOURCE SURVEY

Architectural Inventory Form

1. Resource number: 5PE2219
2. Temporary resource number:
3. County: Pueblo
4. City: Pueblo
5. Historic building name: Pueblo City Hall
6. Current building name: None
7. Building address: 614-616 North Main Street, Pueblo, Colorado 81003
8. Owner name and address: Louie Carleo, 503 N. Main Street, Suite 5, Pueblo, Colorado 81003-3130.

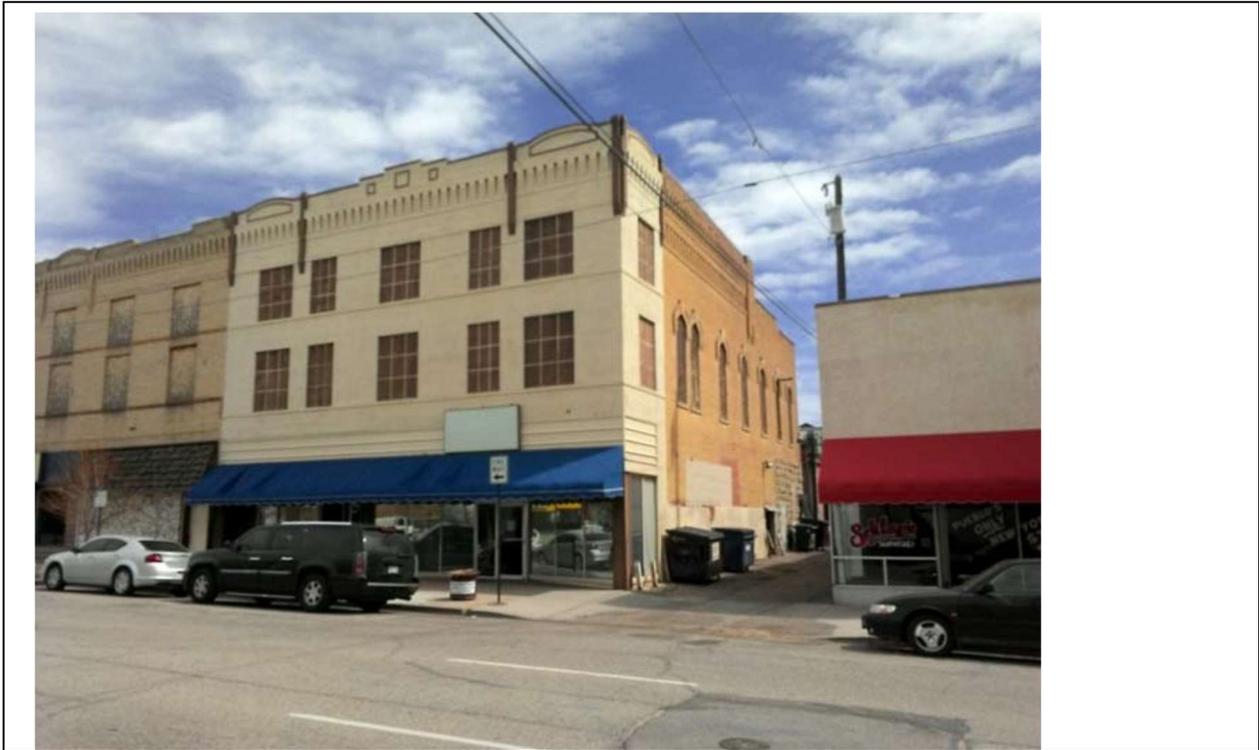
5PE2219 – 614-616 North Main Street. Looking northeast and western and southern façades. Photo ID: 5PR2219a. March 2016.

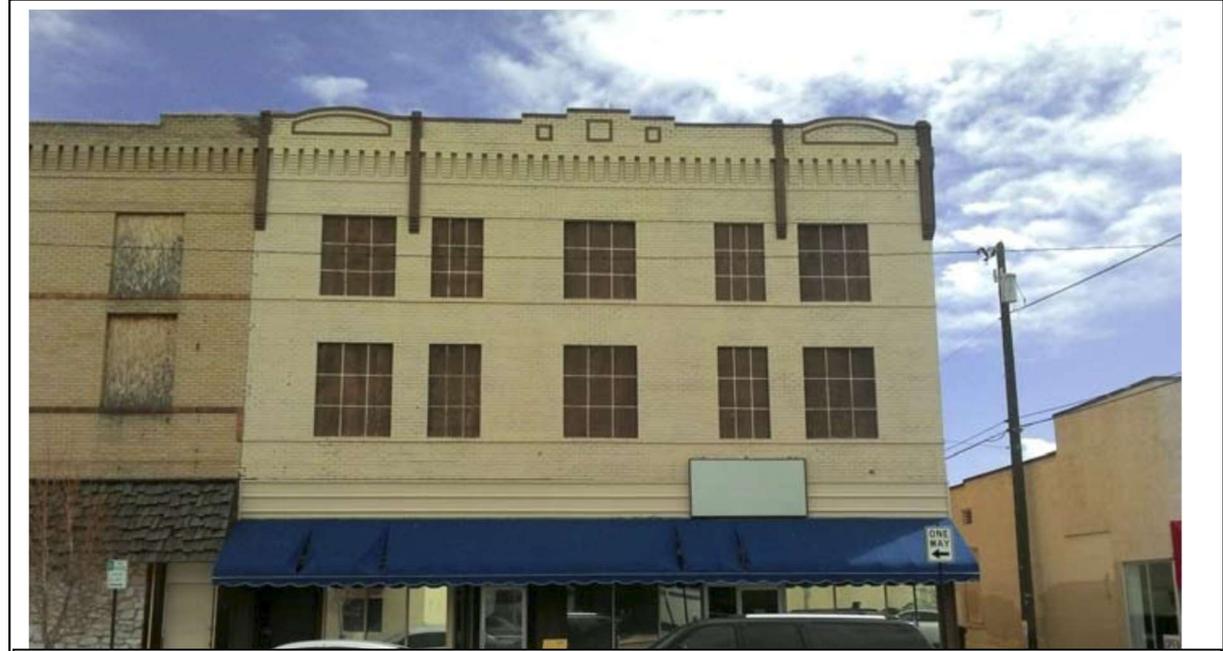
5PE2219 – 614-616 North Main Street. Looking east at western façade. Photo ID: 5PE2219b. March 2016.

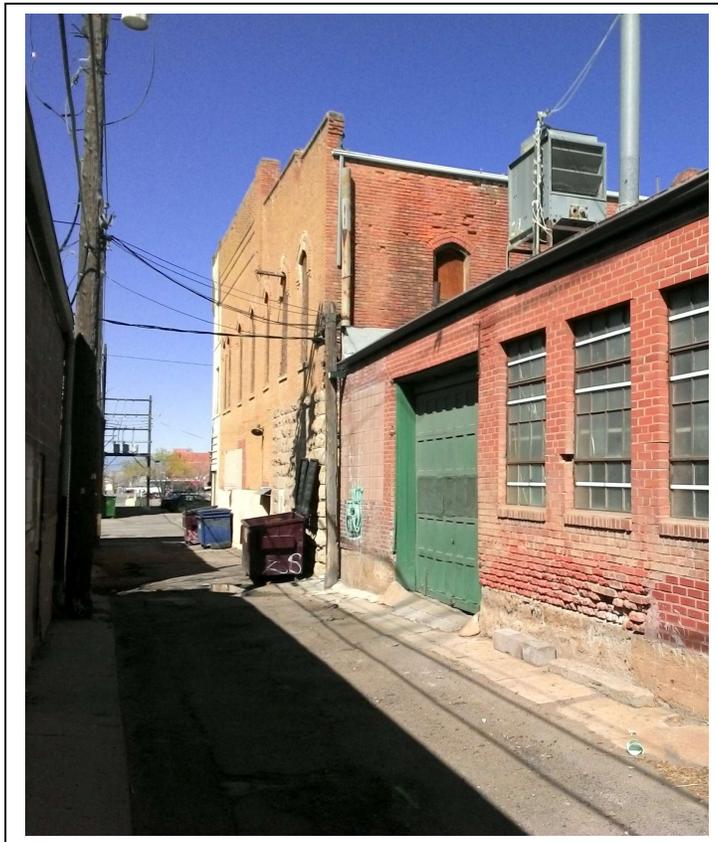
5PE.2219 – 614-616 North Main Street. Looking northeast at southern and eastern façades. (Note: This is as much of the eastern façade that is visible from looking northeast.) Photo ID: 5PE2219c. March 2016.

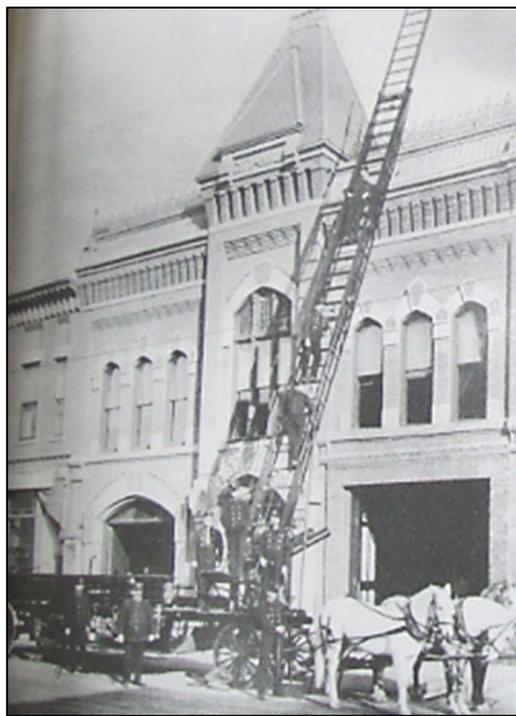
Image from when the building housed the City offices, prior to remodeling. Courtesy of the Pueblo City – County Library District, Special Collections.
