# Architectural Inventory Form

1. Resource number: 5PE8221
2. Temporary resource number:
3. County: Pueblo
4. City: Pueblo
5. Historic building name: John Ballast Jewelers/Edelstein Brothers Cigar Store
6. Current building name: Solar Roast Coffee
7. Building address: 214-226 North Main Street, Pueblo, Colorado 81003-3235
8. Owner name and address: MEJ 4 Properties LLC, P.O. Box 8477, Pueblo, Colorado 81008-8477

48. Report title: Steel City's Barometer: A Survey and Context of Downtown Pueblo's History and Architecture.

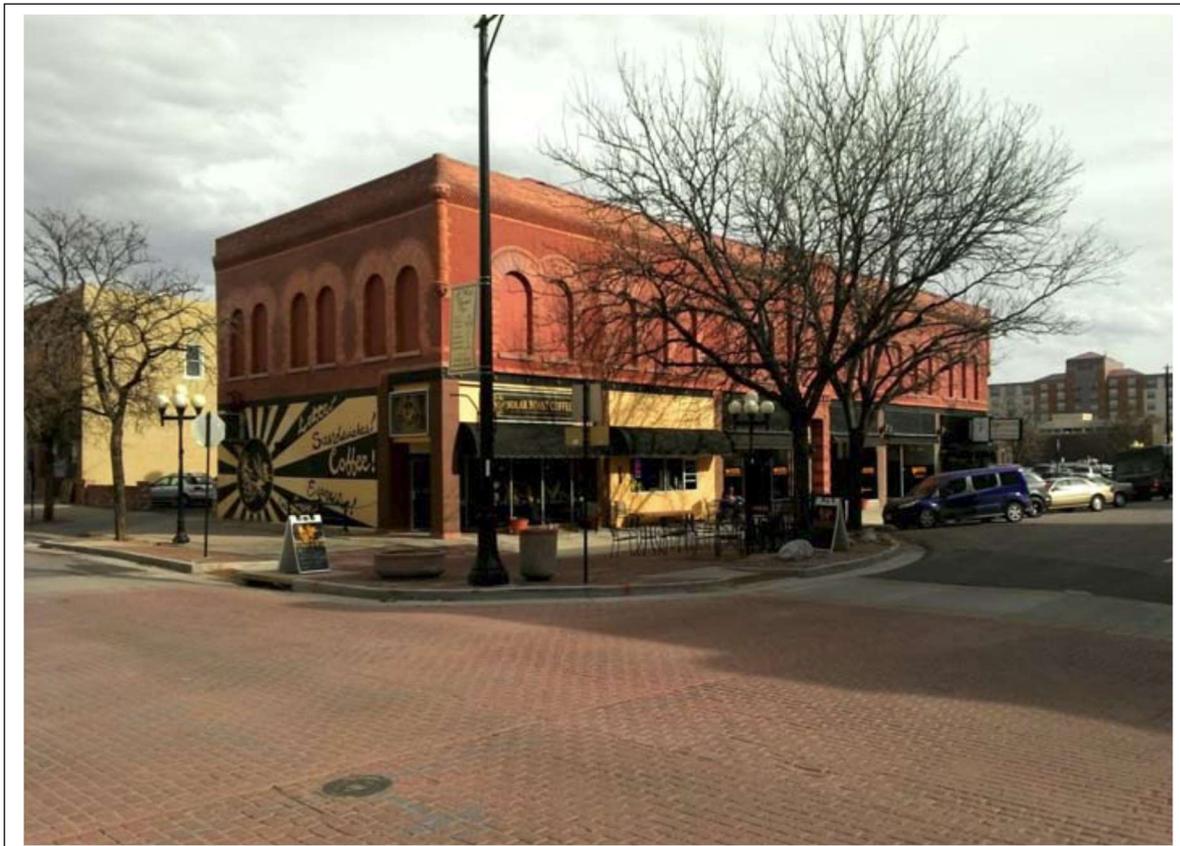
**Western Façade:** A “textbook” nineteenth century commercial structure, this façade has a recessed central entry to the hall and stairs, flanked by storefronts with recessed entries and display windows. There is a belt course of brick through the center of the building. Square stones set like dentils form the belt course above the central entry. The roof is flat with a brick parapet. Below the parapet is a brick corbel in a checkerboard bond that sits on top of a second belt course of stone. First Floor: 5PE8221’s length accommodates three storefronts on either side of the central entry. The central entry has one step up to the level of the current door. The recessed area of this entry was likely rusticated stone as seen in 2007 Google street view. The 2012 Google street view also shows rusticated stone; since then the door has been surrounded with multicolored rectangular stone; historic-looking lighting sconces now flank the door just above the top, and a transom window has been added about a foot above the door. It would appear that none of the storefront’s recessed doors or display windows are original. However, the alteration to these storefronts recall the original height of the entries even if the upper windows or decorative areas have been obscured. The storefront on the northwest corner retains its diagonal entry and the display windows are about 1 foot above the sidewalk typical of nineteenth century display windows. The next storefront has been completely enclosed, fenestrated with two modern stationary windows, and a one over one hung window, all with aluminum frames. These two storefronts have striped, arched, cloth-covered awnings. The third storefront has a central recessed door with display windows on either side and a striped, shed style cloth awning the same size as the fourth storefront. The fourth storefront has double doors to the west and a display window to the south. The fifth storefront has a single recessed door to the west and a display window to the south. The sixth storefront has a recessed door to the west and recessed display window for most of the length of the unit. The fifth and sixth storefronts also have shed roof awnings. Second floor: All of the windows have been filled in and the fill has been covered with stucco. These windows are Romanesque, with rusticated stone round arches and stone window sills. A belt course connects all of the window sills. The windows are twins and triplets. But in the spirit of American Romanesque eclectic, these windows do not form a symmetrical pattern. From the north the sets are two, three, two, one, two, three, and three. Between the sets are exposed bricks that may or may not be original, and have in the past been alternatively painted or covered with stucco. Above the window in the central entry section are bricks laid in a checkerboard pattern, followed by the first belt course, then a decorative brick pattern forming small columns the width of the checkerboard corbel, then another belt course, then a columned corbel and finally the pediment. On both the northwest and southwest corners of second floor are carved corner pieces, containing faces and natural elements.

**Northern Façade: First floor:** There may have been display windows facing 3rd Street. If so they have been covered for a long time, and the wall is covered with a mural advertising for the current tenant. On the northwest corner it is clear that the columns have been replaced in the area of the corner recessed door into the first storefront. The second floor has three paired windows with Romanesque arches of rusticated stone. All of the windows are filled in. Unlike the southern façade where the pediment is stepped, the pediment is continuous at the height of the western façade.

5PE8221 – 214 N. Main Street. Northern and western façades. Looking southeast. Photo ID: 5PE8221a. March 2016.

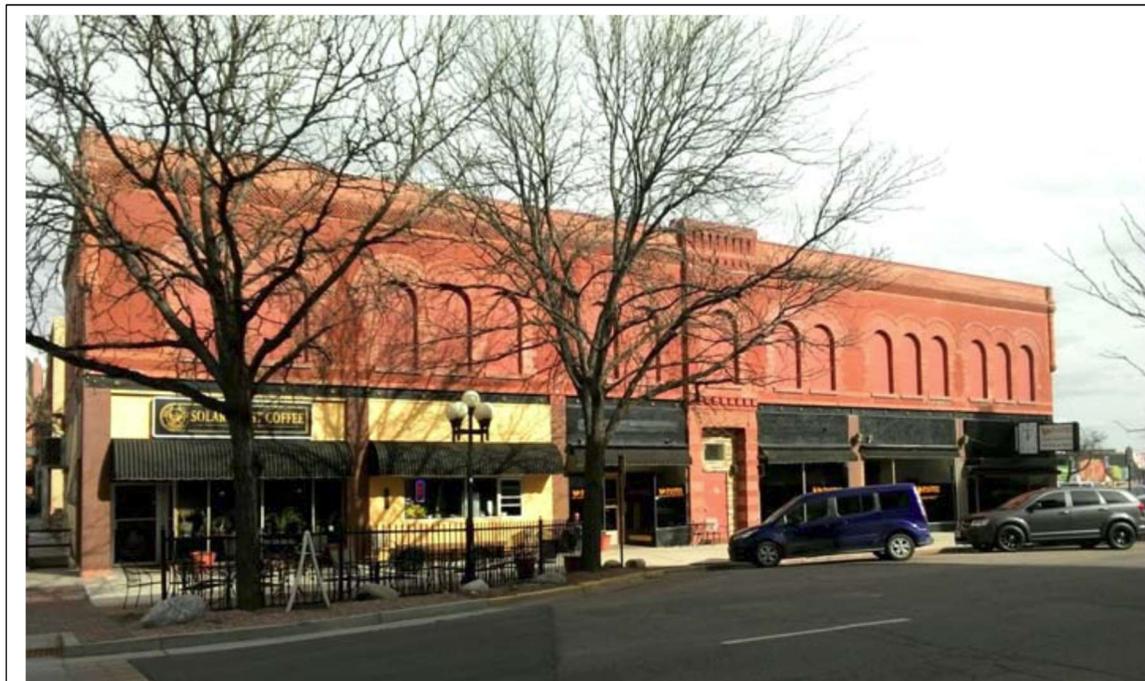
5PE8221 – 214 N. Main Street. Northern façade. Looking southeast. Photo ID: 5PE8221b. March 2016.

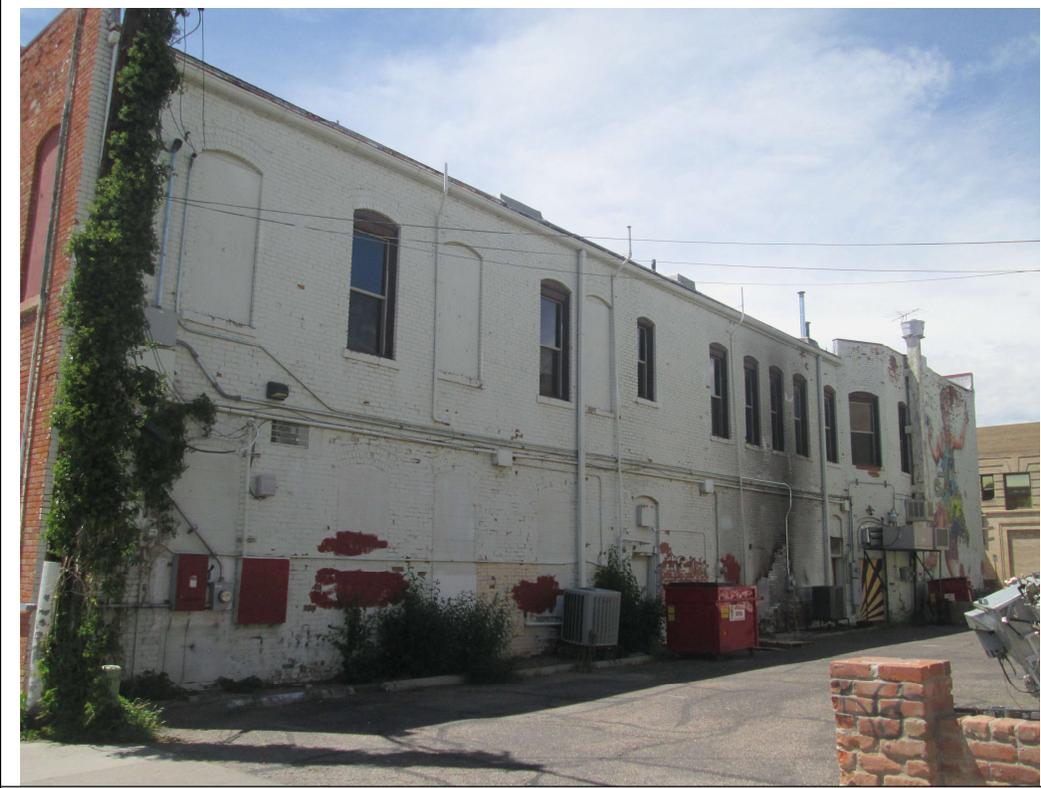
**Southern Façade: First Floor:** There are no open fenestrations on the first floor of the southern façade. It would appear that a brick wall was added on the southwest corner. The brick is of a different size and color and block the view of the original stone quoins on that corner. In the center of the wall is a fenestration that is filled

**Eastern Façade:** There are two usable doors on first floor, and no usable windows. One door appears to be in the fourth storefront, and the other appears to correspond with the second storefront. This second door is located where the wall has a slight angle to the northeast making the building not quite rectangular. Second floor: The windows on second floor have brick arched lintels, and stone sills. Only three of the 13 windows are covered. The rest remain one over one hung. The windows are not equidistance apart. On the southeast corner is one filled-in window, the space of a window, a pair of windows with one usable and one filled-in, a space of a window, another pair one usable and one filled in, a window a little shorter and thinner than the rest, another space the size of a window, then five windows set close all usable, the window in the area where the wall is angled, and one window, and finally wall that is not fenestrated (but covered with a mural) for the last 10 or more feet. Electrical conduit and junction boxes form a belt course in the center of building from the southeast corner to the angled wall. There are two air conditioning units about 6 feet off the ground and above the door at the angle of the wall.

5PE8221 – 214 N. Main Street. Eastern and southern façades. Looking northwest. Photo ID: 5PE8221c. June 2017.

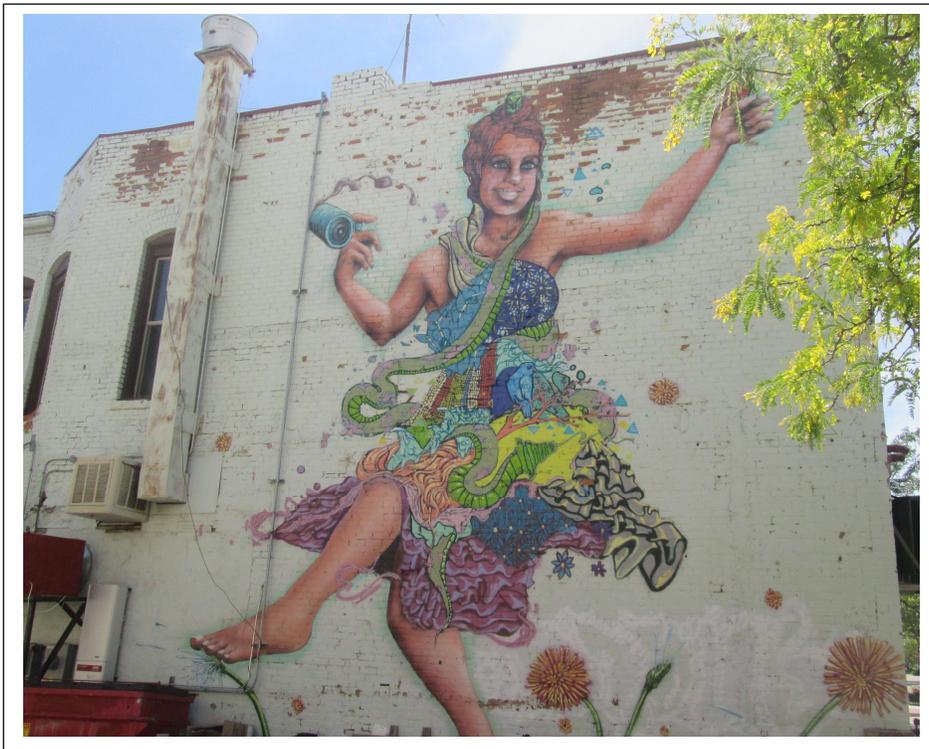
in about 10 feet above the sidewalk. A second fenestration was filled in near the southeast corner starting about 7 feet off the ground. Second Floor: There are three windows on the second floor. A single Romanesque arch window is a couple of feet east of the southwest corner and has been filled in. In the center of wall, there is an open one over one hung window with a brick arch lintel. Near the southeast corner is a filled in window with a brick arch. All three windows have a stone sill. The pediment on this façade is at three heights.

5PE8221 – 214 N. Main Street.  
Southern façade. Looking west.  
Photo ID: 5PE8221e. June 2017.

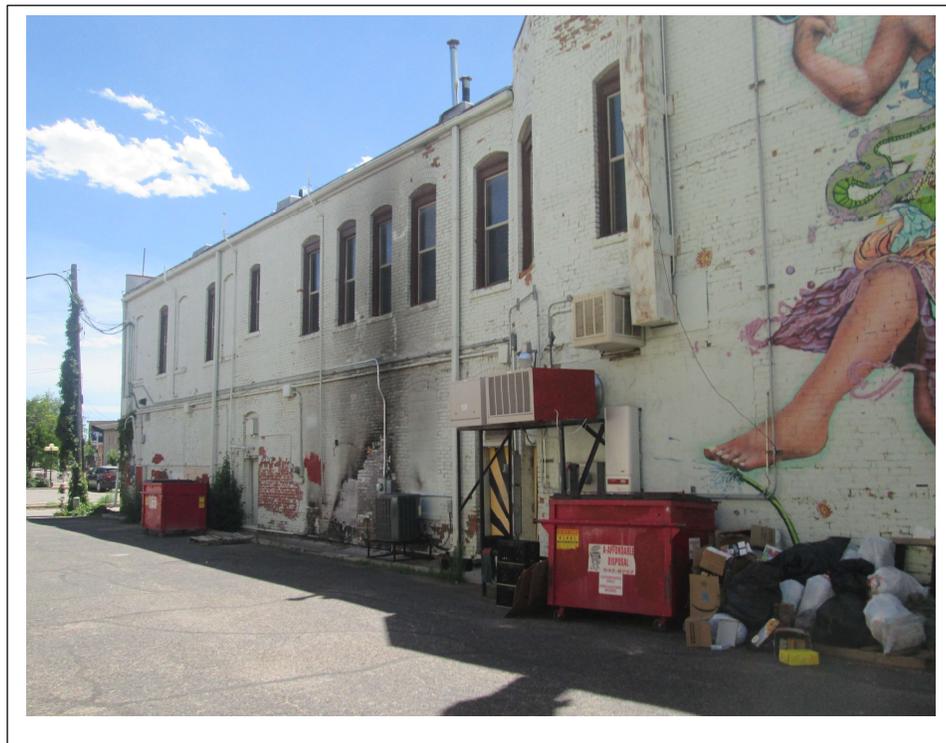
5PE8221 – 214 N. Main  
Street. Southern façade.  
Looking northeast. Photo ID:  
5PE8221f. June 2017.

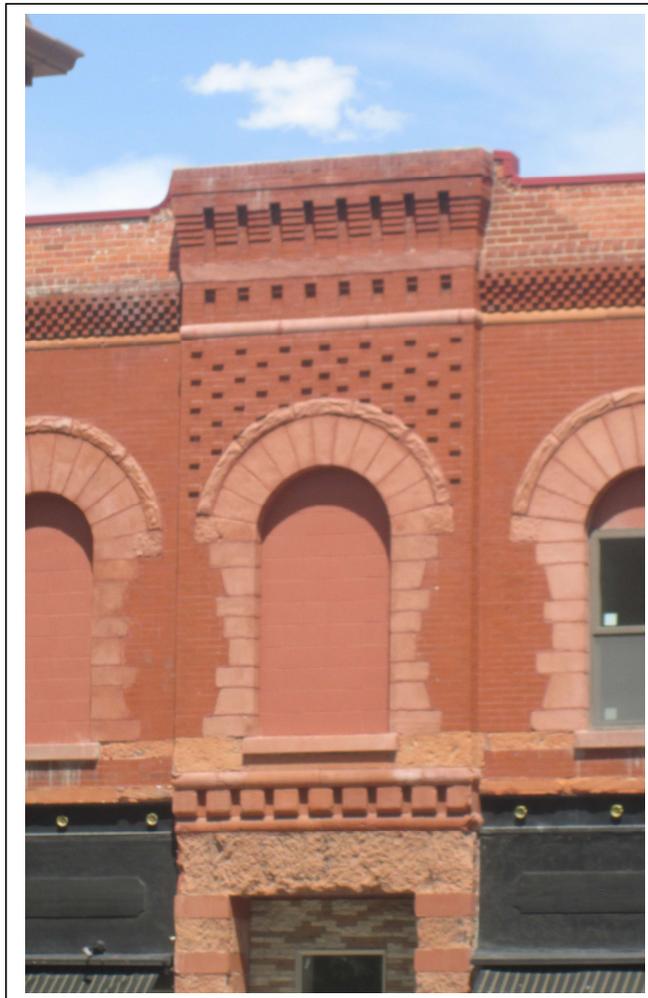
5PE8221 - 214 N. Main Street. Northern façade. Looking south. Photo ID: 5PE8221g. June 2017.

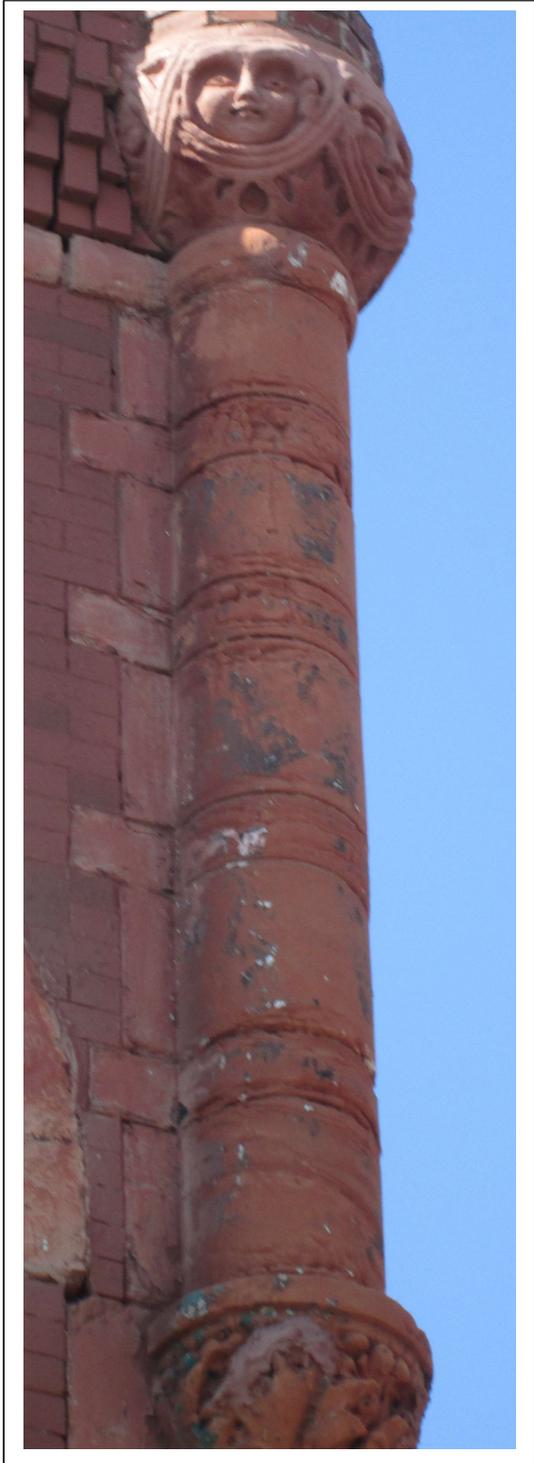
5PE8221 - 214 N. Main Street. Second story corner. Western/northern façades. Looking northeast. Photo ID: 5PE8221h. June 2017.

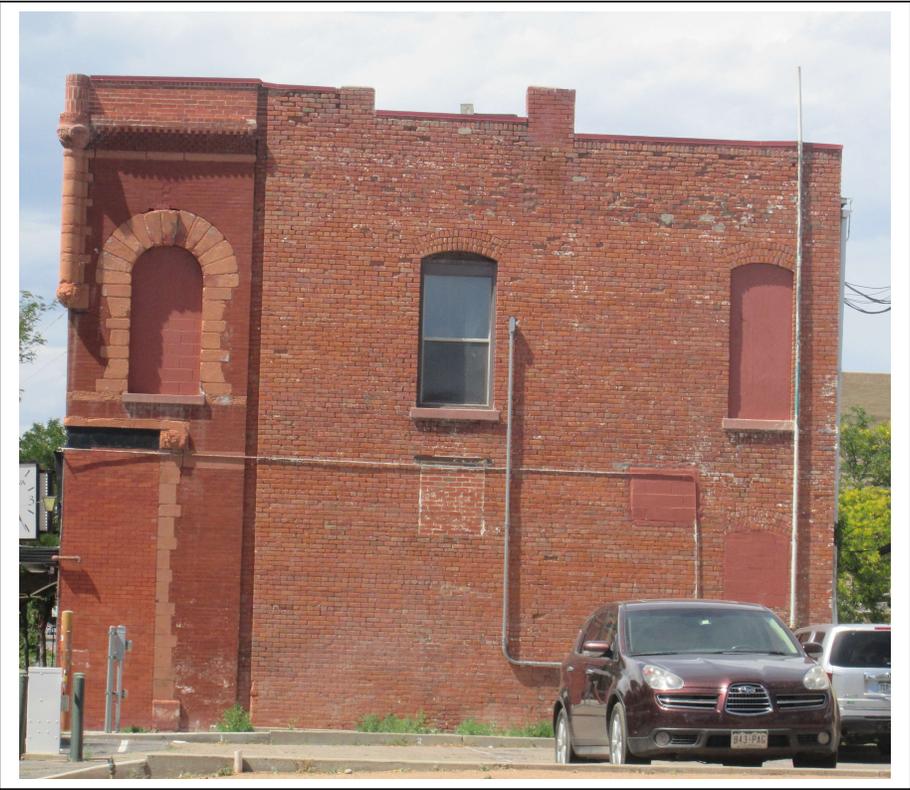
5PE8221 - 214 N. Main Street. Eastern façade. Looking west. Photo ID: 5PE8221j. June 2017.

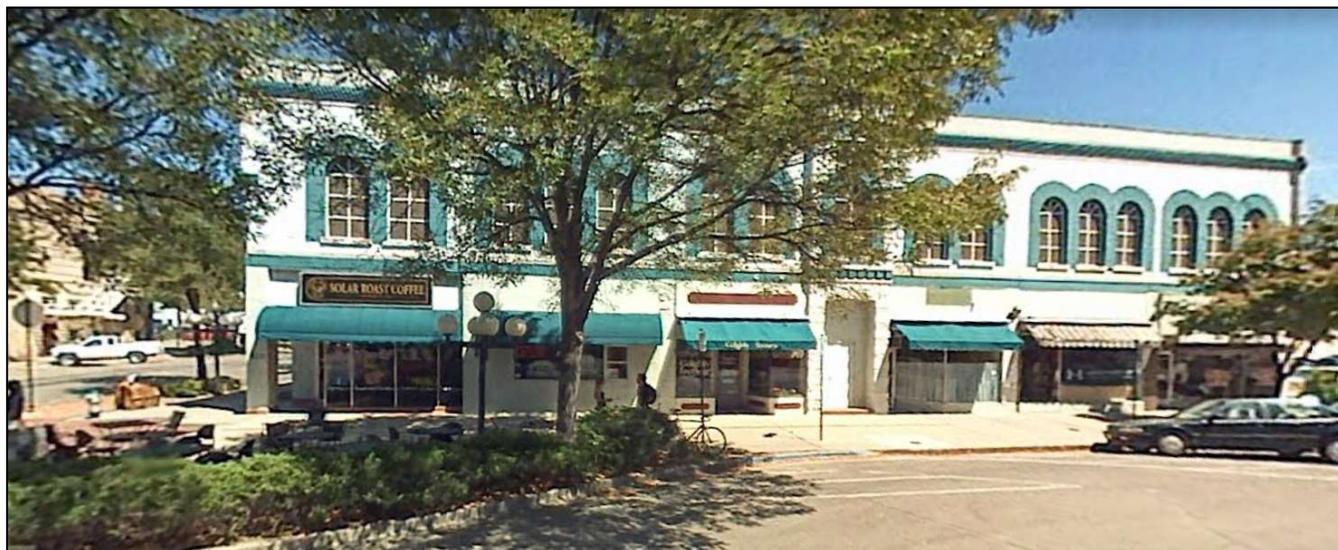
Google street view August 2007.

29. Construction history (include description and dates of major additions, alterations, or demolitions): The Pueblo County Assessor gives a date of construction for 5PE8221 as 1895. Photographs and Google street views indicate that there have been many alterations to the exterior between 2007 and 2017. 5PE8221 has retained half of its original exterior, despite the bricking over the second-story windows and the addition of awning and metal framed fixed single pane windows along the ground level during the mid-twentieth century. The current primary tenant installed an array of solar panels along the length of the roof in 2014. Other revisions include a new exterior treatment around an access door along the North Main Street side.
