COLORADO CULTURAL RESOURCE SURVEY

Architectural Inventory Form

1. Resource number: 5PE8232
2. Temporary resource number:
3. County: Pueblo
4. City: Pueblo
5. Historic building name: Peoples Denver Furniture
6. Current building name: Top Bid Auction
7. Building address: 311-313 N. Santa Fe Avenue, Pueblo, Colorado 81003-4124.
8. Owner name and address: HJE LLC/Thomas and Frieda Makovsky, 30 Bellita Drive, Pueblo, Colorado 81001-1403.

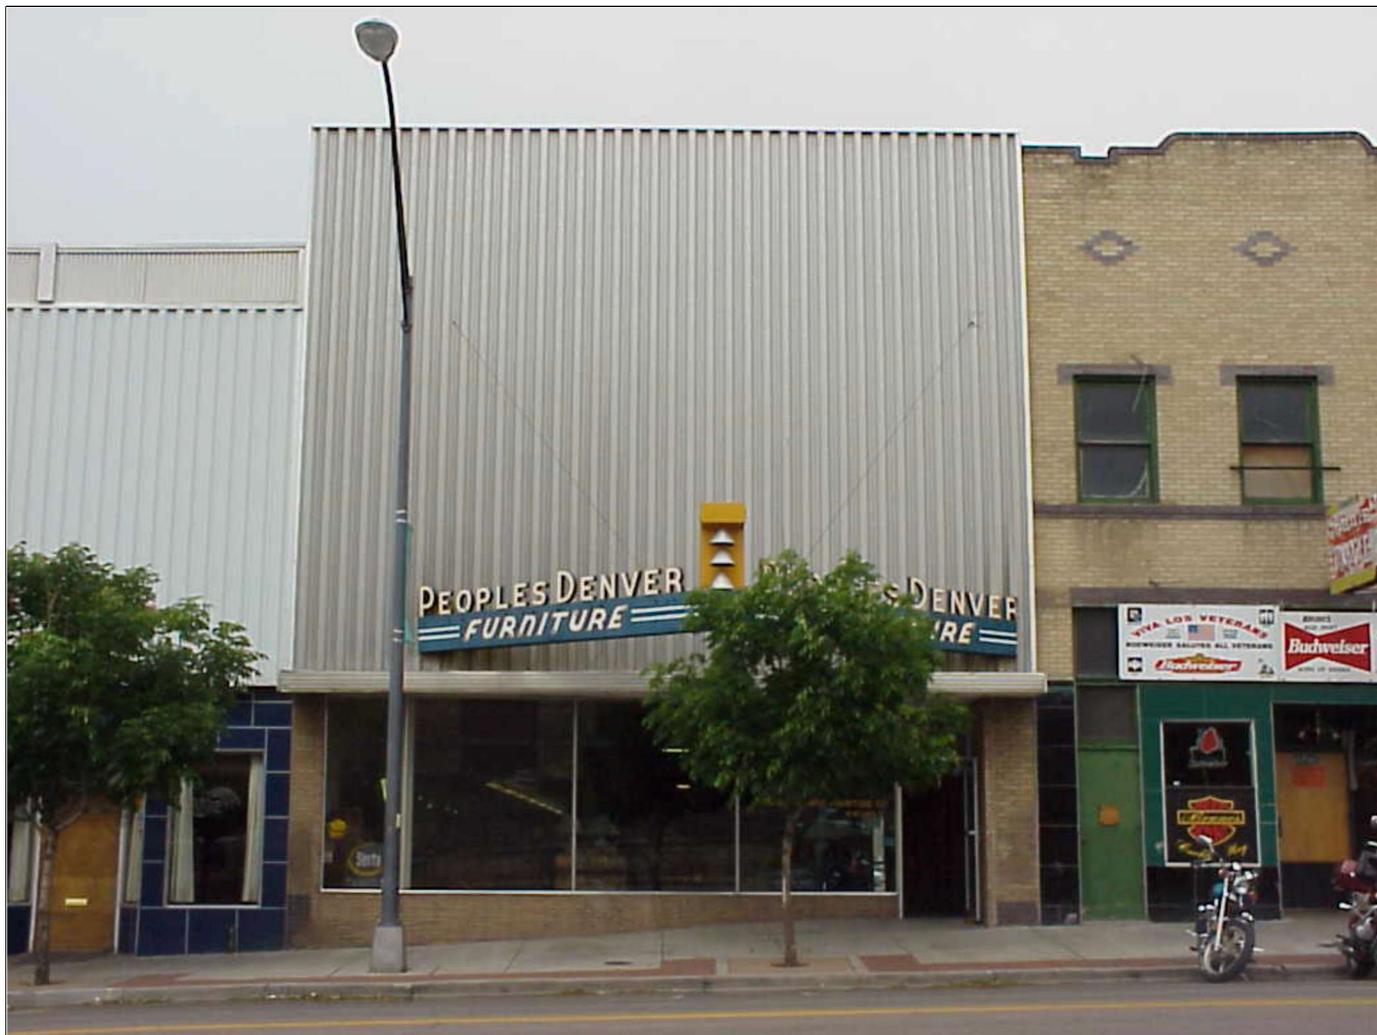
Pueblo County Assessor website. 536127007. Accessed August 2, 2017. (Note: This photo likely dates to the early 21st century.

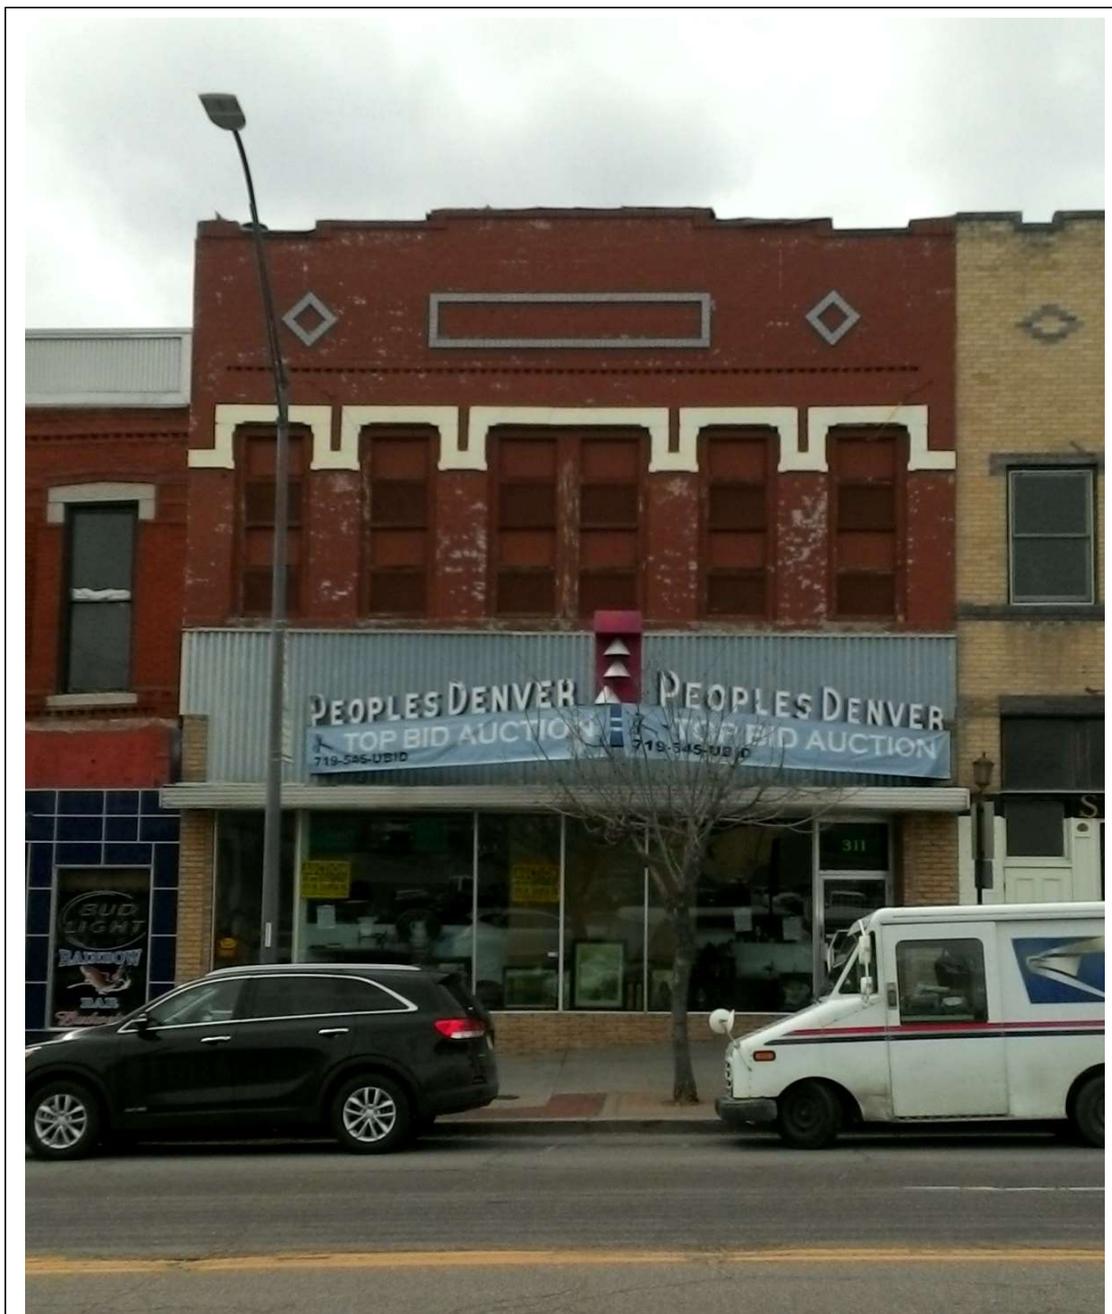
5PE8232 - 311-313 North Santa Fe Avenue. Looking west at eastern façade. Photo ID: 5PE8232a.
March 2016.

20. Special features: Parapet. Transom. Neon signage associated with a marquee above main entry. Decorative brick pattern along the second story.
21. General architectural description: Because the building shares party walls with the adjacent buildings, and this building extends above the rear additions of its neighbors, only the eastern and western façades are visible . The rear of both the northern and southern façades are partly visible. **Eastern Façade:** The eastern façade faces North Santa Fe Avenue. The storefront is angled with a brick wall standing approximately 1.5 feet high beneath the open, picture windows. The eastern façade's ground level is a series of open, picture windows framed by vertical metal mullions. The primary entry is located in the northeast corner. A transom window is above the entry. The primary entry are glass/metal hinged doors. A neon marquee reading PEOPLES DENVER is directly above the ground level, and extends the length of the eastern façade. A horizontal metal canopy runs the length of the façade and beneath the marquee. Approximately 31 feet of corrugated metal siding is affixed to the building's exterior. During the mid-twentieth century, pictures indicate a similar corrugated metal siding covered the second story exterior. In the past 15 years, the owner removed the siding to reveal the original window and brick treatments. Six narrow windows with brick run the length of the second story. Plywood covers the fenestrations. There is no available documentation to indicate what materials these windows once displayed. Dog tooth course. Painted brick frames the top of each window's arch. Two decorative brick diamonds flank a decorative brick rectangle located on the parapet near the roofline. **Western Façade:** The western façade faces an alley. A hinged metal door is located in the façade's approximate center. The door leads to a concrete stoop and five concrete steps leading to the ground level. A painted sign reading PEOPLES DENVER FEATURE is directly above the entry. A series of three windows is above the entry and near the roofline. Each of the windows is boarded over. A concrete chimney extends from the roof near the western boundary. A small, square opening is located near the northwest corner. Near the southwest corner are two recessed fenestrations. One window metal frame 1/1 window remains open, the other is boarded.

43. Assessment of historic physical integrity related to significance: 5PE8232 has lost and regained much of its historic physical integrity since the mid-twentieth century. The introduction, and later removal, of corrugated metal sheeting has altered the building's original brickwork along the eastern façade. A series of fixed single-pane storefront windows was added at some point during the last 60 years. Because of these alterations, 5PE8232's integrity is poor and the building has lost its original feeling and materials.

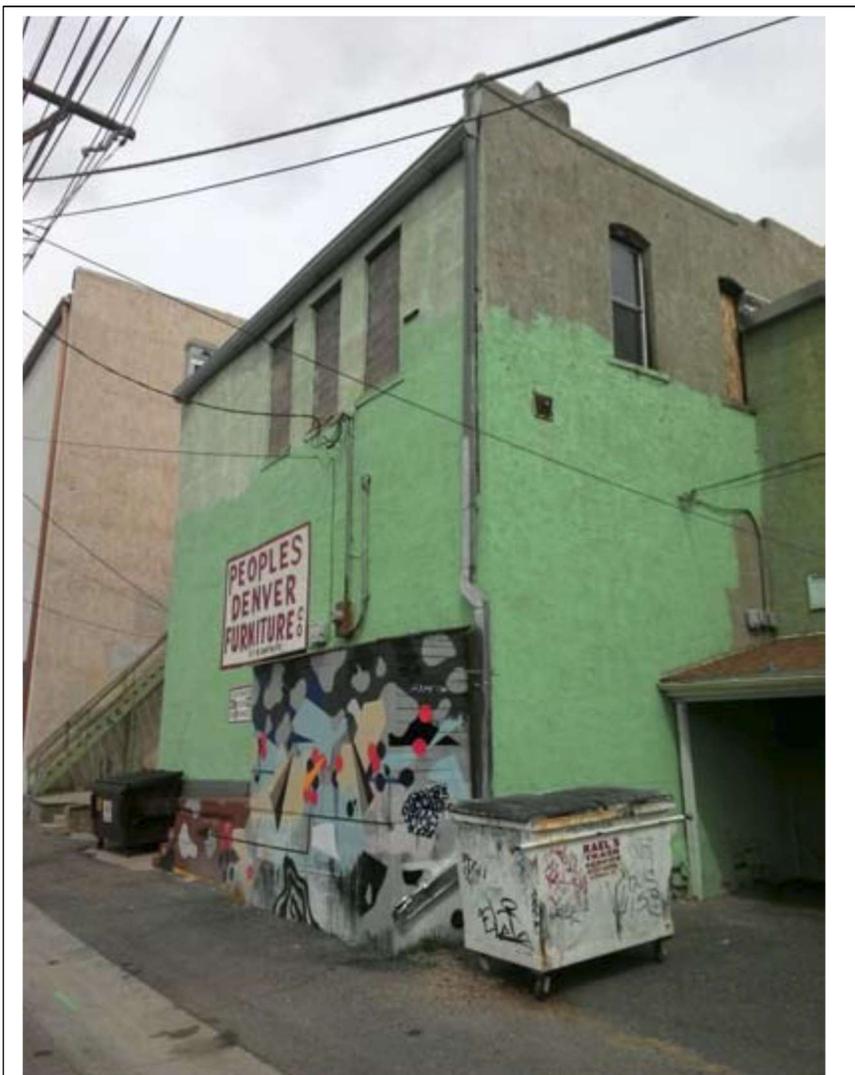
5PE8232 - 311-313 North Santa Fe Avenue. Looking northeast at western and southern façades. Photo ID: 5PE8232b. March 2016.

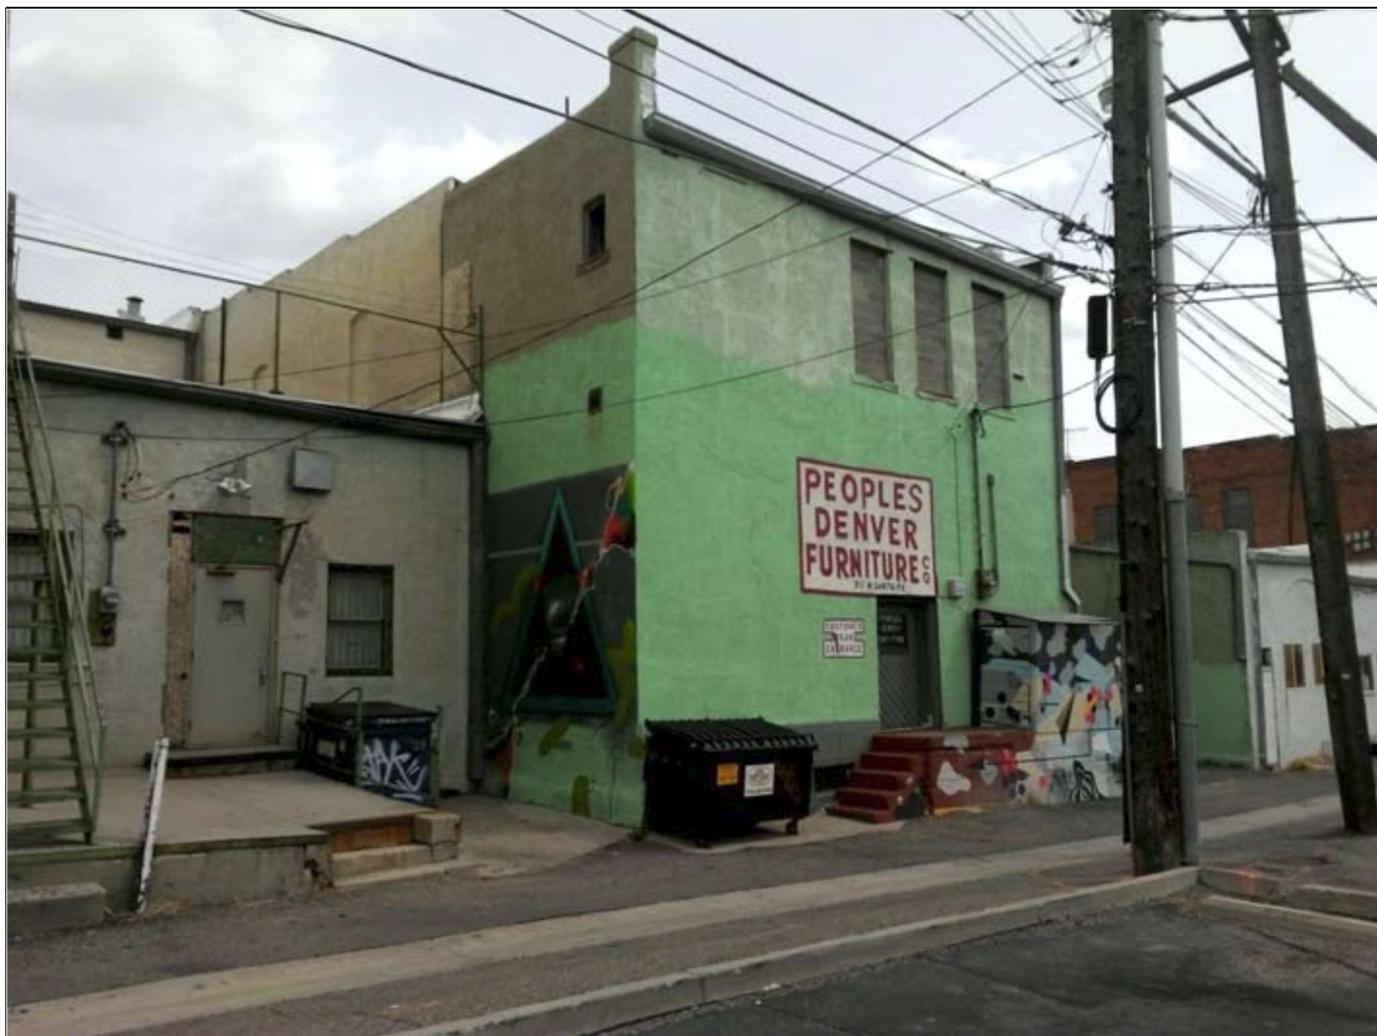
5PE8232 - 311-313 North Santa Fe Avenue. Looking southeast at northern and western façades. Photo ID: 5PE8232c. March 2016.

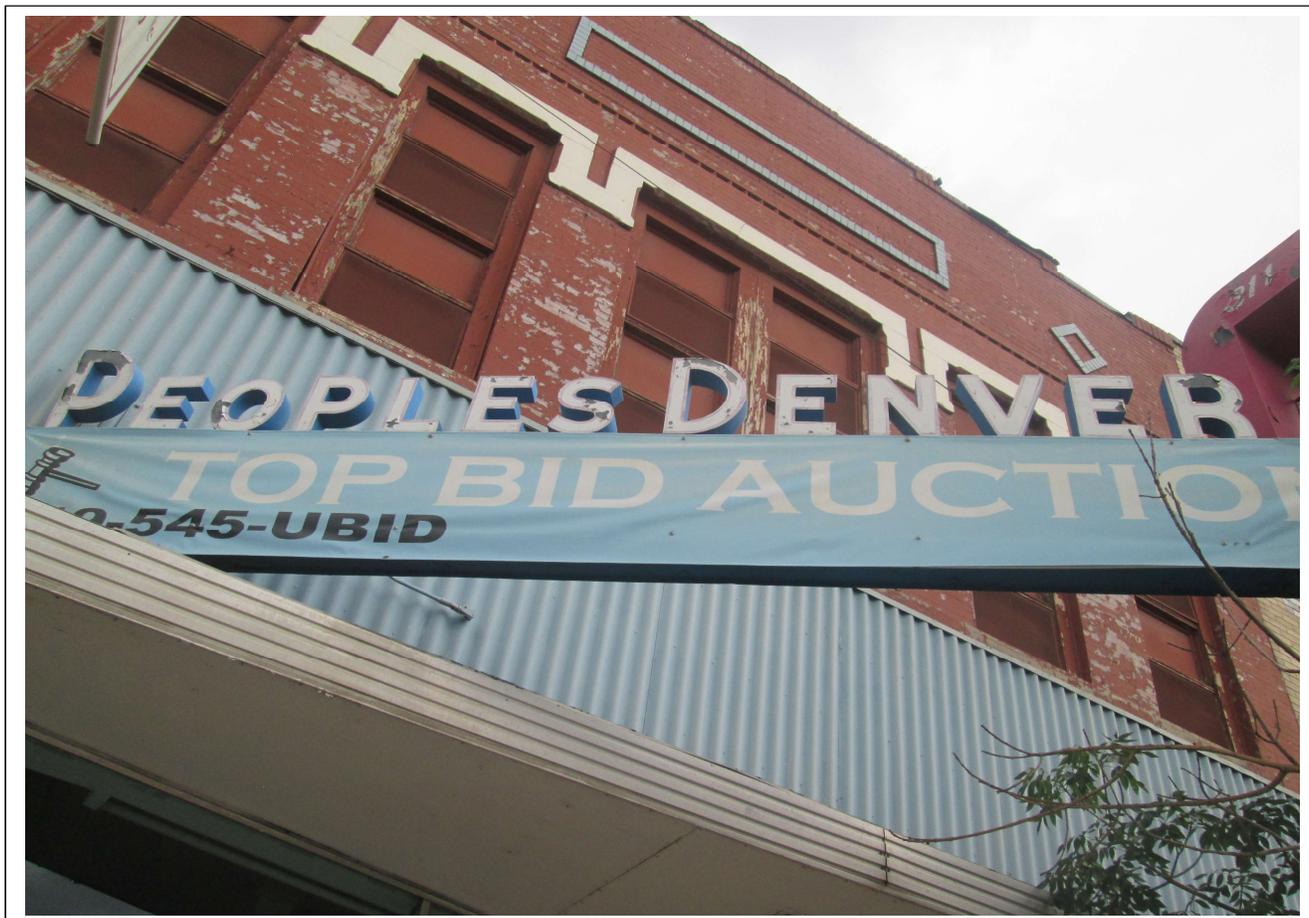
5PE8232 - 311-313 North Santa Fe Avenue. Looking northwest at eastern façade's marquee. Photo ID: 5PE8232d. June 2017.

mid-twentieth century. A neon marquee is above the main entry on the building's eastern façade. Its construction likely dates to the late 1940s to early 1950s. Other likely renovations include installation of the first floor storefront, marquee signage, projecting canopy and metal cladding. Photographs on the Pueblo County Assessor's website illustrate that as recently as the first decade of the twenty-first century; a corrugated metal façade covered the second floor on the eastern façade. At some point between then and 2017, the owner removed much of the façade to reveal original brick and window pattern along the second story. Unfortunately, plywood covers those second story windows. The same photos indicate the current corrugated siding is not the same that covered most of the façade in the twentieth century. There is no available documentation to confirm, but the original ground floor storefront was likely replaced during the mid-twentieth century by the current storefront assembly.
