COLORADO CULTURAL RESOURCE SURVEY

Architectural Inventory Form

1. Resource number: 5PE8254
2. Temporary resource number:
3. County: Pueblo
4. City: Pueblo
5. Historic building name: Henkel-Duke Mercantile Warehouse
6. Current building name: N/A
7. Building address: 222 West 3rd Street, Pueblo, Colorado 81003-3227
8. Owner name and address: Louie D. Carleo, 503 N. Main Street, Suite 5, Pueblo, Colorado 81003-3130

48. Report title: Steel City's Barometer: A Survey and Context of Downtown Pueblo's History and Architecture.

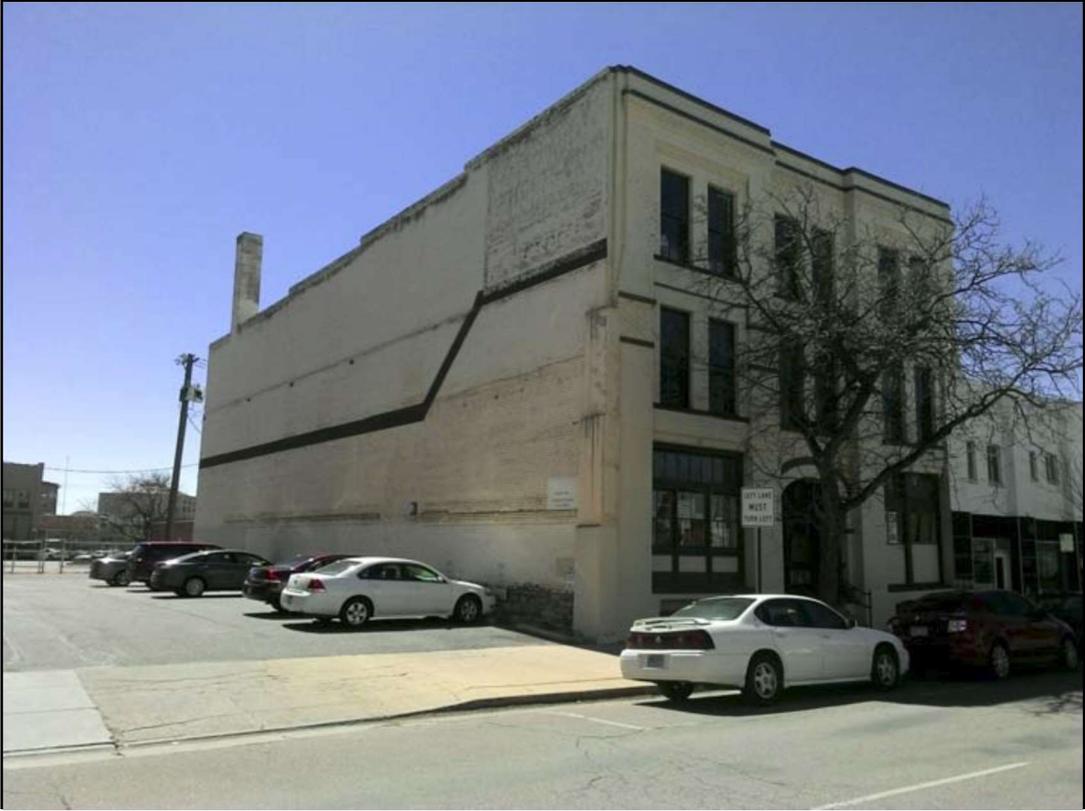
5PE8254. 222 W. 3rd Street. Northern and eastern façades. Facing southwest. Photo ID: 5PE8254a. March 2016.

21. General architectural description: **Northern Façade:** This façade exhibits common nineteenth century commercial architectural elements such as a recessed central entry, windows set in pairs, pilasters, belt courses, and a decorative brick parapet. It is unique in that most of the windows are two over two, and that the first floor is at the garden level. Few buildings in Pueblo's commercial districts have an elevated main entrance. Another common element of nineteenth century commercial buildings demonstrated with 5PE8254 is the use of structural materials to create a decorative exterior division of the building into vertical sections. Unlike most of the buildings in this survey, 5PE8254 was built to house a single business so the central entry is also the main entry. The pilasters that divide the northern façade into sections are also unique. They are brick set on square stone foundations which are the height of the visible first floor. Toward the top of the third floor the pilasters have an asterisk pattern in relief with a belt course above it and below it. The pilasters then taper inward toward the eastern and western sections on all three faces creating the look of a slightly stepped buttress. The first floor is partially below grade. There are two stationary rectangular windows that flank the five steps leading to the main entry. The windows on the eastern section have a flat lintel, and the two on the western section have an arched lintel. The second floor is also asymmetrical. The display window in the eastern section contains three windows each with four rectangular lights and a transom window. The overall effect is Craftsman. The central section contains the recessed main entry with a single Romanesque arch spanning the section. On the lower west side of the arch is a large burglar/fire alarm bell by "Viking." The door is also Craftsman in style, with a three over one widow for 2/3s its height. This door is flanked by one over one hung windows. The arch is divided into three stationary arched lights. The western section is divided into two display windows that have a two rectangular lights above which are a single stationary transom and below which is a wood panel. Both the eastern and western sections have a steel lintels with rosettes. On the third floor the eastern and western sections are symmetrical with each featuring a pair of two over two hung windows with wood frames and brick lintels. These lintels are a stacked running bond soldier bricks that fan out slightly. The two windows in the central section are also two over two but have an arched stacked running bond of soldiers. A belt course a single brick wide is picked out in paint above all of the windows. All of the windows on the fourth floor are two over two hung with wood frames. The sills are brick and also form a belt course. The lintels in the eastern and western sections seem to be a thin metal as the running bond that makes up the surrounding walls looks to touch the window frames. Four courses of brick are corbeled above the windows and between the pilasters that define the sections. The central section lintels are a stacked running bond of soldiers with a slight fan. The building is crowned with a brick corbel, a belt course, and a recessed parapet.

Eastern Façade: There are only three window openings on the third floor of this façade. They have brick lintels, were arched, and have been bricked in for a very long time. A ghost sign is barely visible in the upper right hand corner of the fourth floor. And a remnant stone pilaster/buttress from the now gone two-story neighboring building is still attached to the northeastern corner. Near the southwestern corner is a chimney. The parapet has five steps.

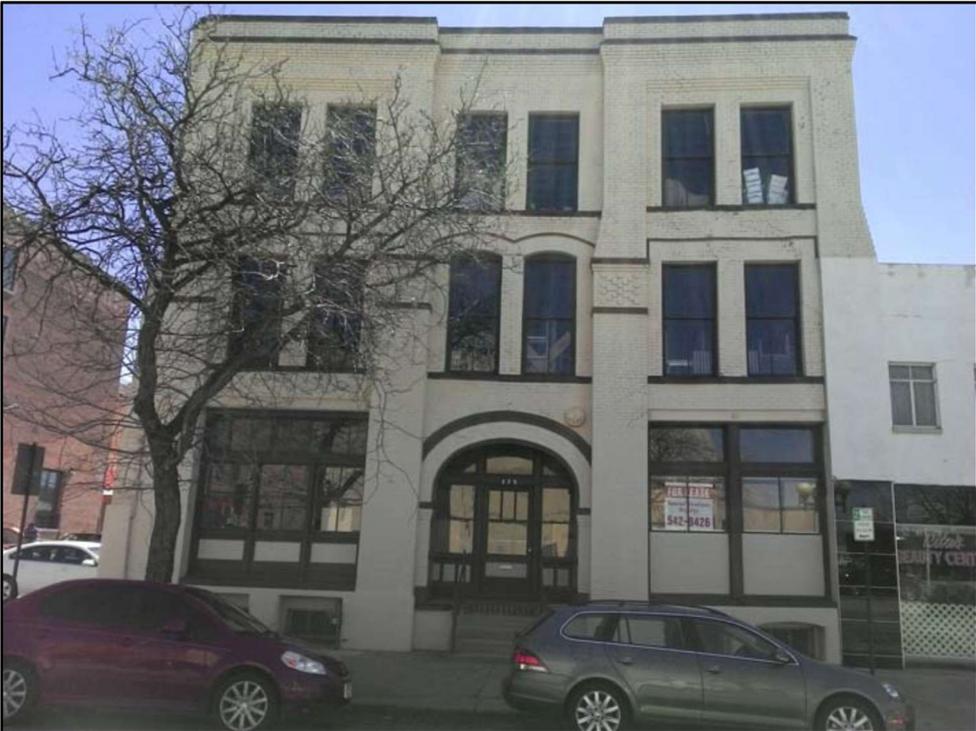
5PE8254. 222 W. 3rd Street. Northern façade. Facing South. Photo ID: 5PE8254b. March 2016.

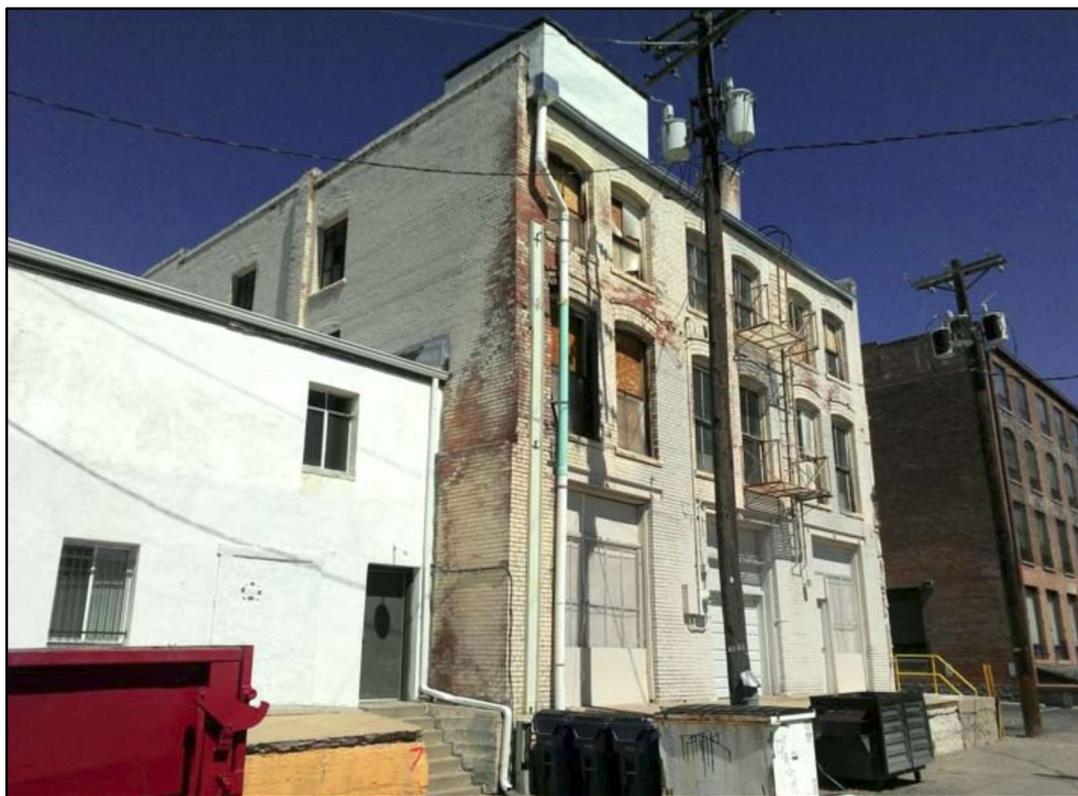
5PE8254. 222 W. 3rd Street. Southern and western façades. Facing northeast. Photo ID: 5PE8254c. March 2016.

Southern Façade: First floor is not visible. All three sections of the second floor have a large area that is set back and shows the buttresses that divide the building vertically. The western section has a multi-light window that occupies about one third of the space, and is off center vertically. The central section has a garage door, and the eastern section has a human door on the west and a multi-light window to the east. All of the windows

on third floor have a brick sill, arched brick lintel, and are two over two hung with wood frames. The western section windows are broken and covered from the inside. The east window of the central section is accessed by a metal fire escape. All of the windows on the fourth floor have brick sills, arched brick lintels, and are two over two hung with wood frames. The windows on the eastern section are broken and covered from inside. They are shorter than the windows on the third floor. The east window of the central section also has a metal deck and ladders for roof access and fire escape. On the roof above the eastern section is a small room. The southeastern corner has the roof's only downspout. A concrete loading dock is attached to this façade and measure 45 feet long and 9 feet wide. A set of concrete steps leads from the dock to the alley below.

Western Façade is not visible from the street, however looking north from the south windows are visible on the third and fourth floors. At least the one on the fourth floor appears to be multi-paned.

43. Assessment of historic physical integrity related to significance: 5PE8254 has retained almost all of its historic physical integrity. Little alteration or modification has occurred. There is some deferred maintenance with the broken and boarded windows on the southern façade, however, they are not yet permanently filled in. Three windows on the eastern façade have been bricked in but from visual inspection at ground level that modification may be historic. The northwest corner of the northern façade has been partially obscured by the neighboring building's mid-century modification.

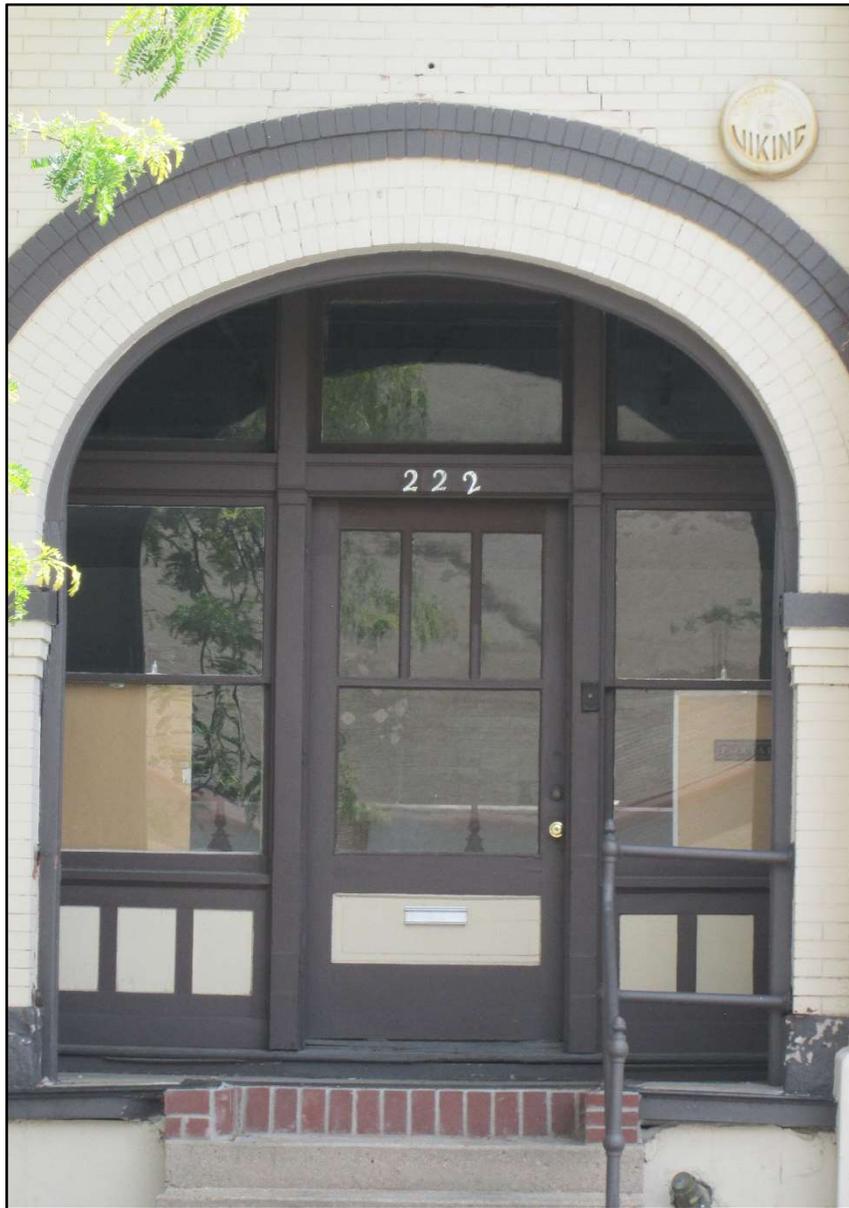
5PE8254. 222 W/ 3rd Street.
Main entry, northern façade.
Facing south. Photo ID:
5PE8254e. June 2017.
