COLORADO CULTURAL RESOURCE SURVEY

Architectural Inventory Form

1. Resource number: 5PE.2268
2. Temporary resource number: FN4
3. County: Pueblo
4. City: Pueblo
5. Historic building name: Colorado Laundry Garage
6. Current building name: Global Callcenter Solutions
7. Building address: 225 W. 2nd St
8. Owner name and address: K F H Realty LLC, 225 W. 2nd St., Pueblo, Colorado, 81003

48. Report title: Historic Downtown Property Survey, City of Pueblo, Pueblo County, Colorado

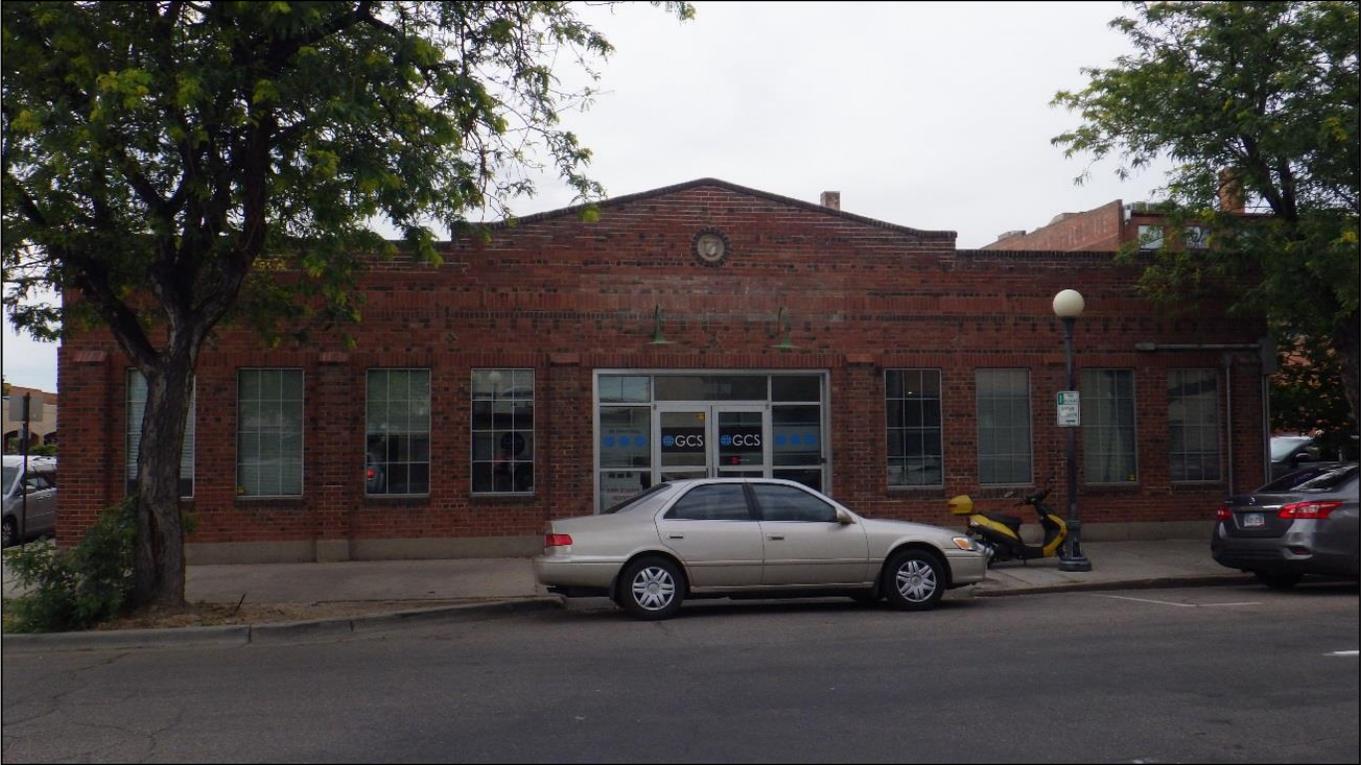
225 W. 2nd Street facing north showing south wall.

5PE.2268 is a one-part commercial building with a rectangular footprint constructed with brick masonry walls on a concrete slab foundation. The building is topped by a barrel vault constructed from steel bowstring trusses and covered in rolled asphalt roofing. A brick chimney is located near the building's northwestern corner. The primary street-facing south wall is crowned by a stepped false front with a triangular center capped by a course of rowlock bricks. A circular medallion containing a heraldic escutcheon ornaments the middle of the triangular step/merlon. Beneath this, the wall is divided into five bays by brick buttresses capped by brick set-offs. The two bays to the east and west are equally sized; however, the middle bay is slightly larger due to its original use as a vehicular entry. Today, this central bay is filled by an aluminum-framed window wall. This wall has three vertical panels further divided by horizontal members. The central panel contains aluminum-framed two-panel full glass double doors topped by a transom. The remaining four bays each contain two aluminum-framed fixed glass windows with 12 lights divided by a flat grid of muntins. Two industrial-style radial wave domed lights are placed above the central bay.

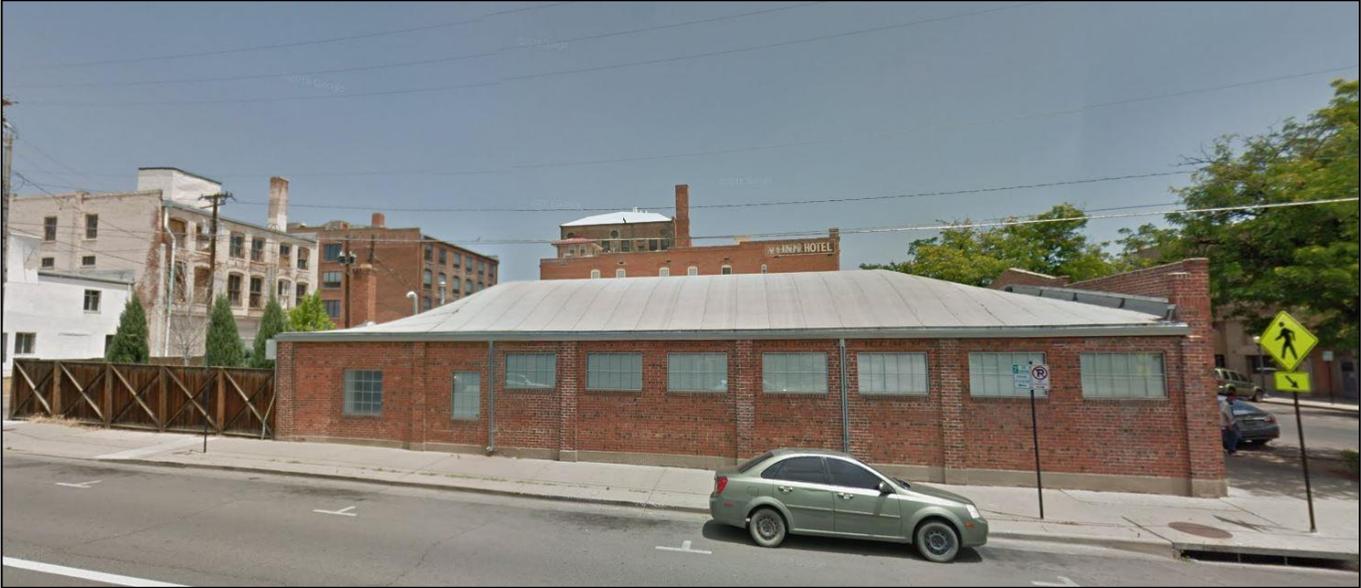
225 W. 2nd Street, facing east showing west wall. Courtesy of Google Maps.

Like the south wall, the building's west wall is divided into five bays by buttresses stretching from the wall's base to its roofline. The southern (right) three bays each contain two horizontally-orientated aluminum-framed fixed windows with 10 lights placed high in the wall. The fourth bay from the south contains one such window in its southern half, and a vertically-oriented 12-light window lower down in the wall in its northern half. The final bay contains a single square aluminum-framed fixed 16-light window placed close to its center. To the north (left) of this, a panel of lighter bricks indicate the former presence of a door.

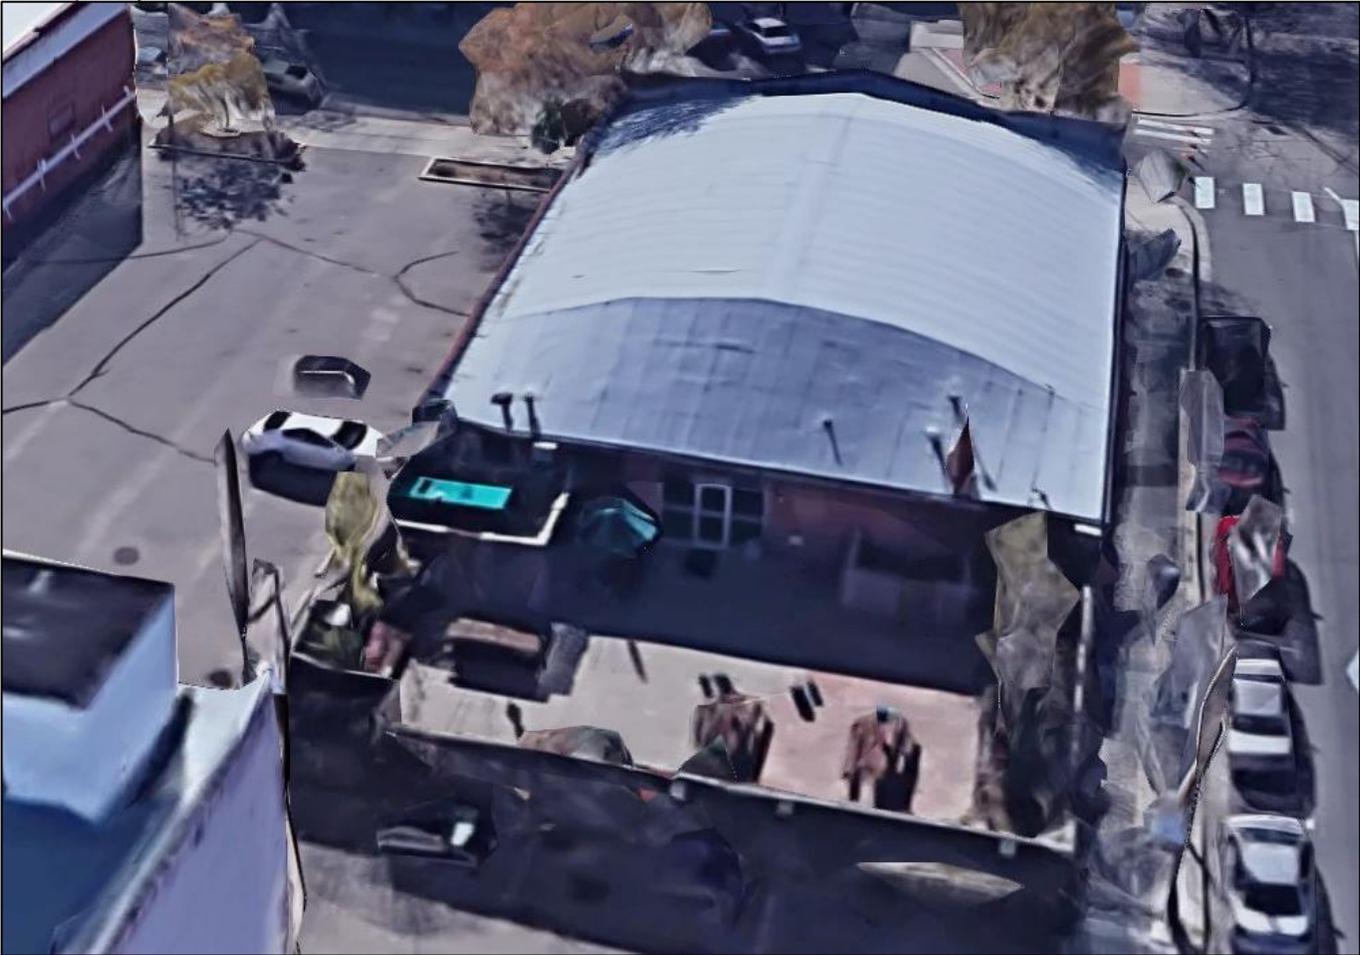
225 W. 2nd Street, facing southeast and showing rendered aerial of north wall and patio area. Courtesy of Google Maps.

The rear north wall of the building is enclosed by a high wooden fence encircling the remainder of the lot and obscuring the wall from view. Aerial imagery indicates this wall contains another wide aperture probably once used for vehicular entry and now enclosed in three glass panels including an aluminum-framed two-panel glass door. Various internal fences show the presence of utility equipment on the exterior of the building.

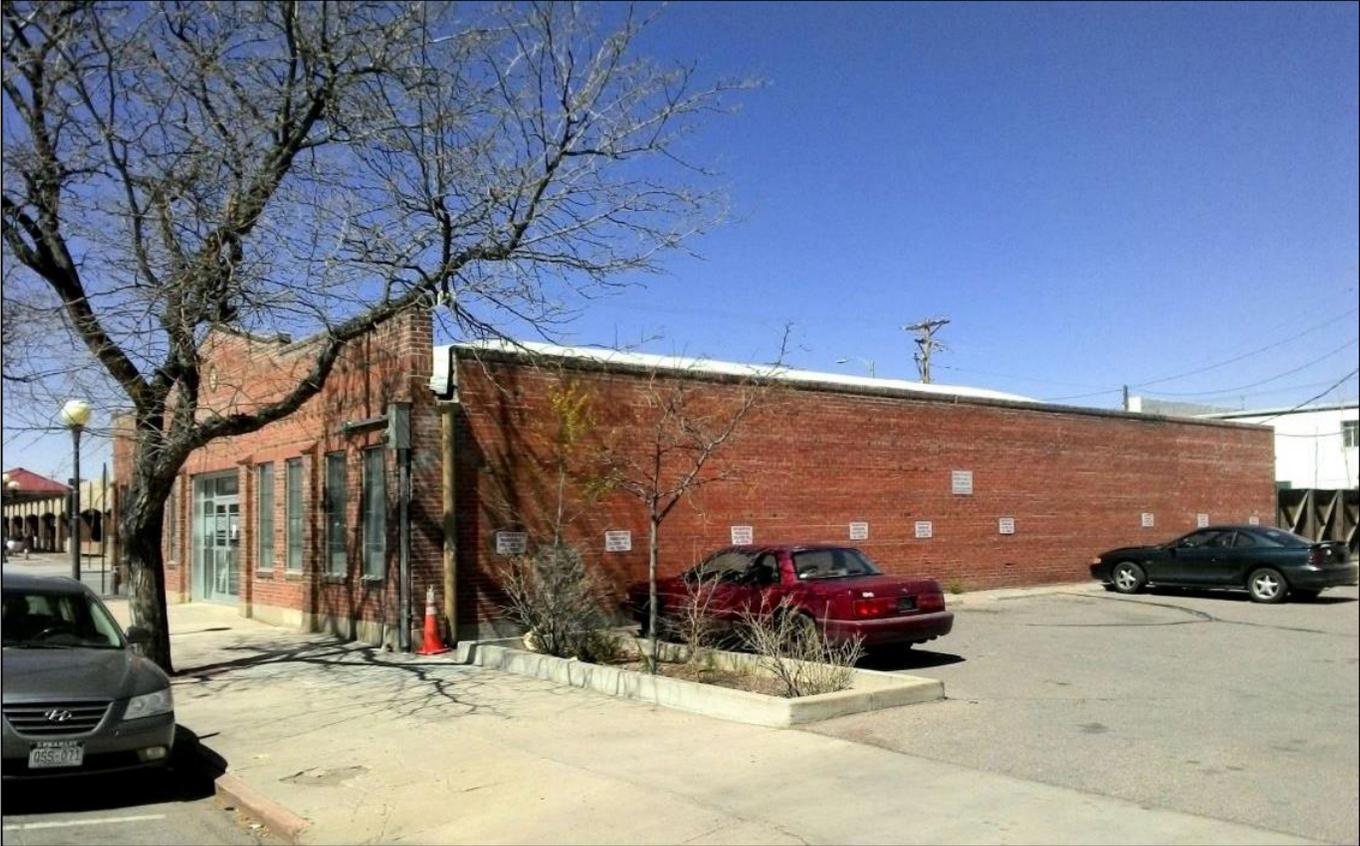
225 W. 2nd Street, facing northwest and showing north and east walls. Courtesy of the City of Pueblo.

The east wall of the building is devoid of apertures and buttressing and consists solely of a single large expanse of brick masonry topped by a parapet.

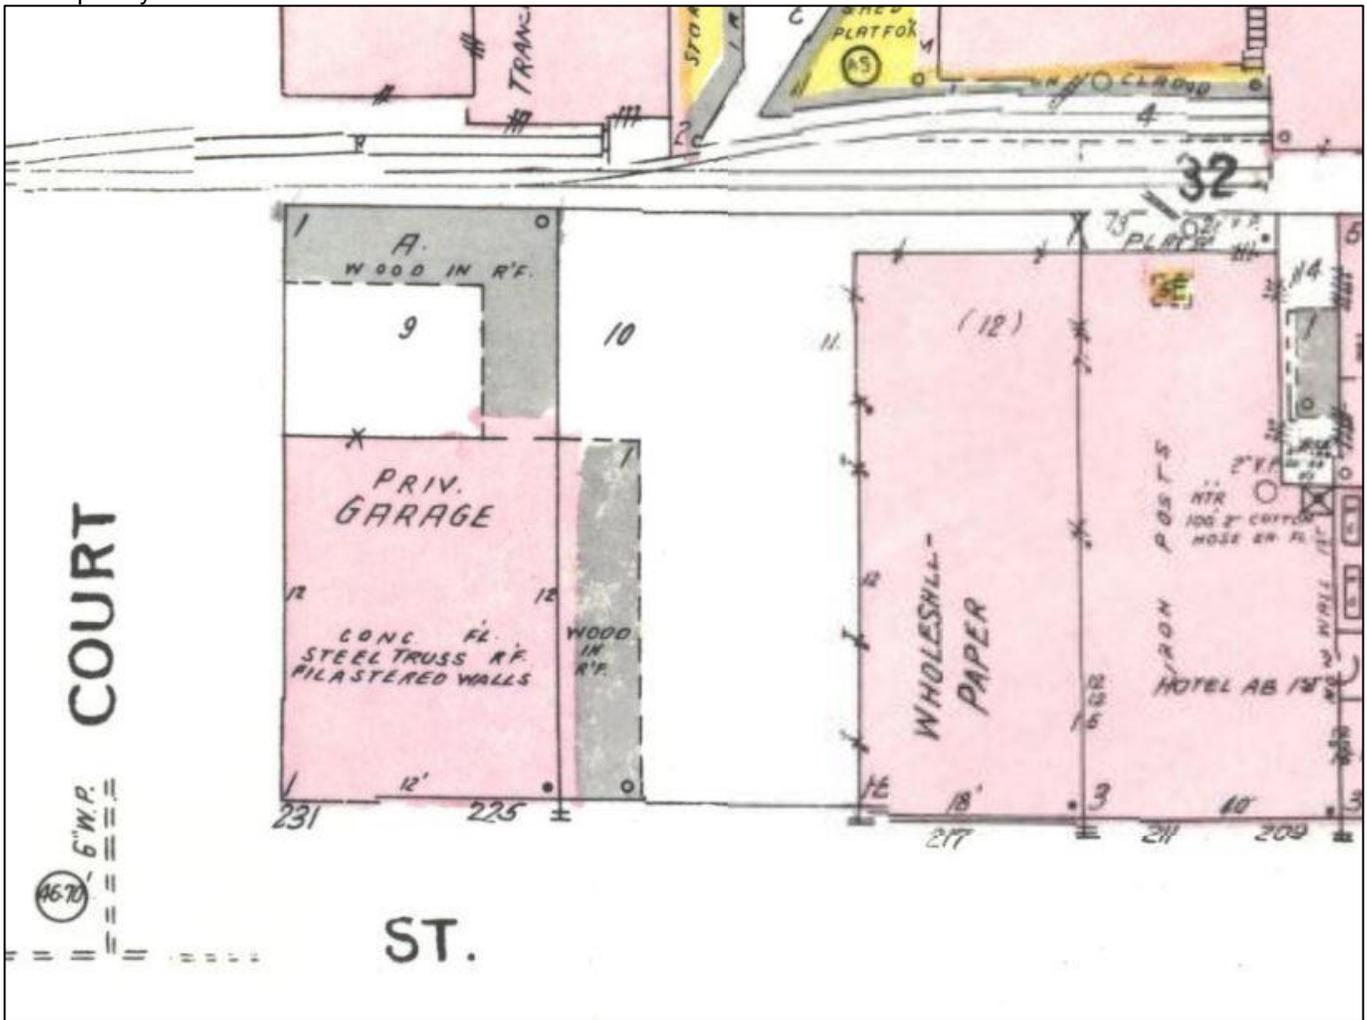
225 W. 2nd Street, footprint showing shed extension off north and east walls from the 1951 reprinting of the Sanborn Fire Insurance Maps. Courtesy of the Library of Congress.

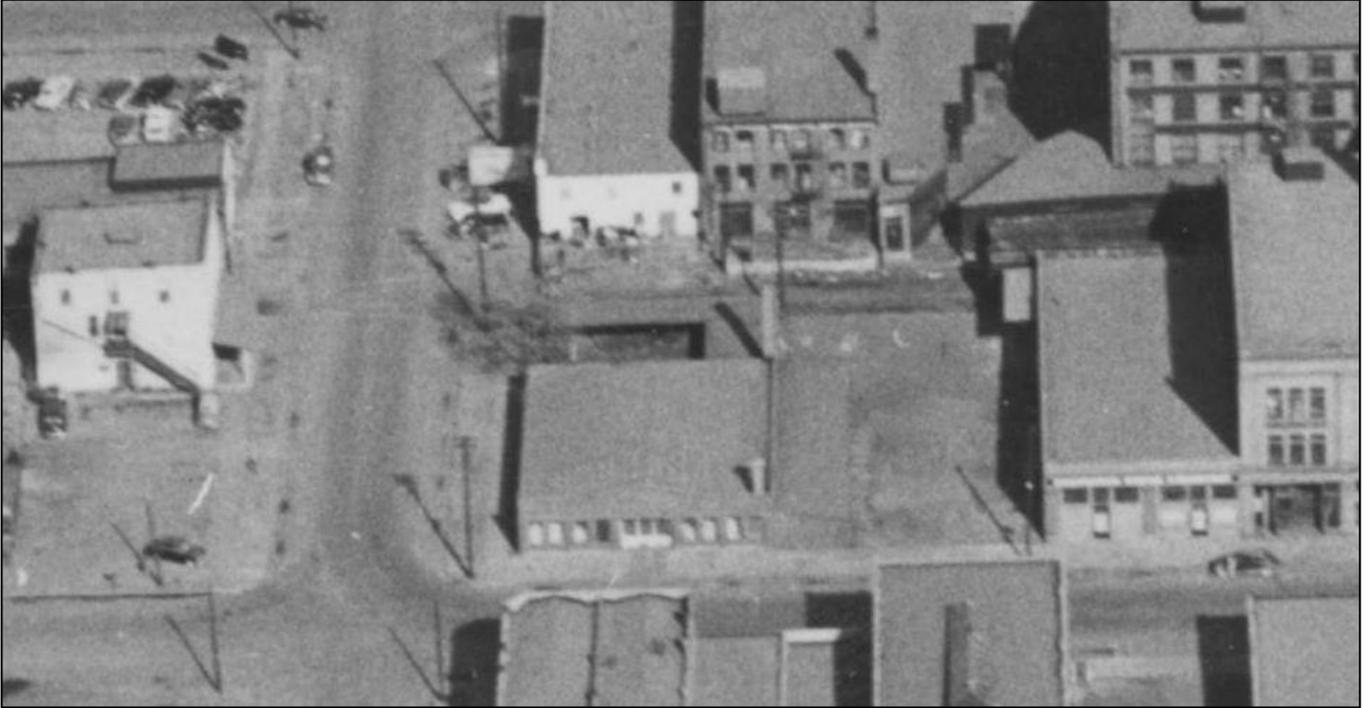
Detail of "Aerial view of downtown Pueblo." See 225 W. 2nd Street in center of image. Aerial image dated to April of 1957. Note the shed extensions as well as chimneys and white three-panel garage door. Courtesy of the City-County Library. Identifier No. PCCLD-Ph-P-01-09-005.

A field survey of the building indicated that it originally contained vehicular entrances in the north and south walls for its first use as a garage. A door was also likely located near the northwestern corner of the west wall due to the presence there of differently colored brickwork. Aerial imagery from the 1950s indicates that the building was also likely constructed with two additional chimneys at its northeastern corner and southeastern corner. The original garage doors were composed of three half-glass panels that likely utilized an accordion fold to allow ingress and egress. Aerial imagery further shows the presence of two large sheds attached to the building; an L-shaped shed creating a courtyard along the building's rear with an opening to Court Street and a long shed built onto the eastern wall. Further images show these sheds were designed to store additional vehicles. It is unclear whether they were original to the building or constructed to meet a later need.

These two sheds, two of the three chimneys, and the side door were all removed after 1958. At an unknown date after the 1995 sale of the building and before its 1998 survey, it was substantially remodeled and converted from a garage/warehouse space into a commercial office space. During this process, all of the building's windows were replaced by modern aluminum-framed units with flat muntins and commercial aluminum-framed doors were set into the apertures left by the removal of the garage doors. At an unknown date, the rear of the lot was enclosed by a high wooden fence and landscape was placed within to create a patio seating area.

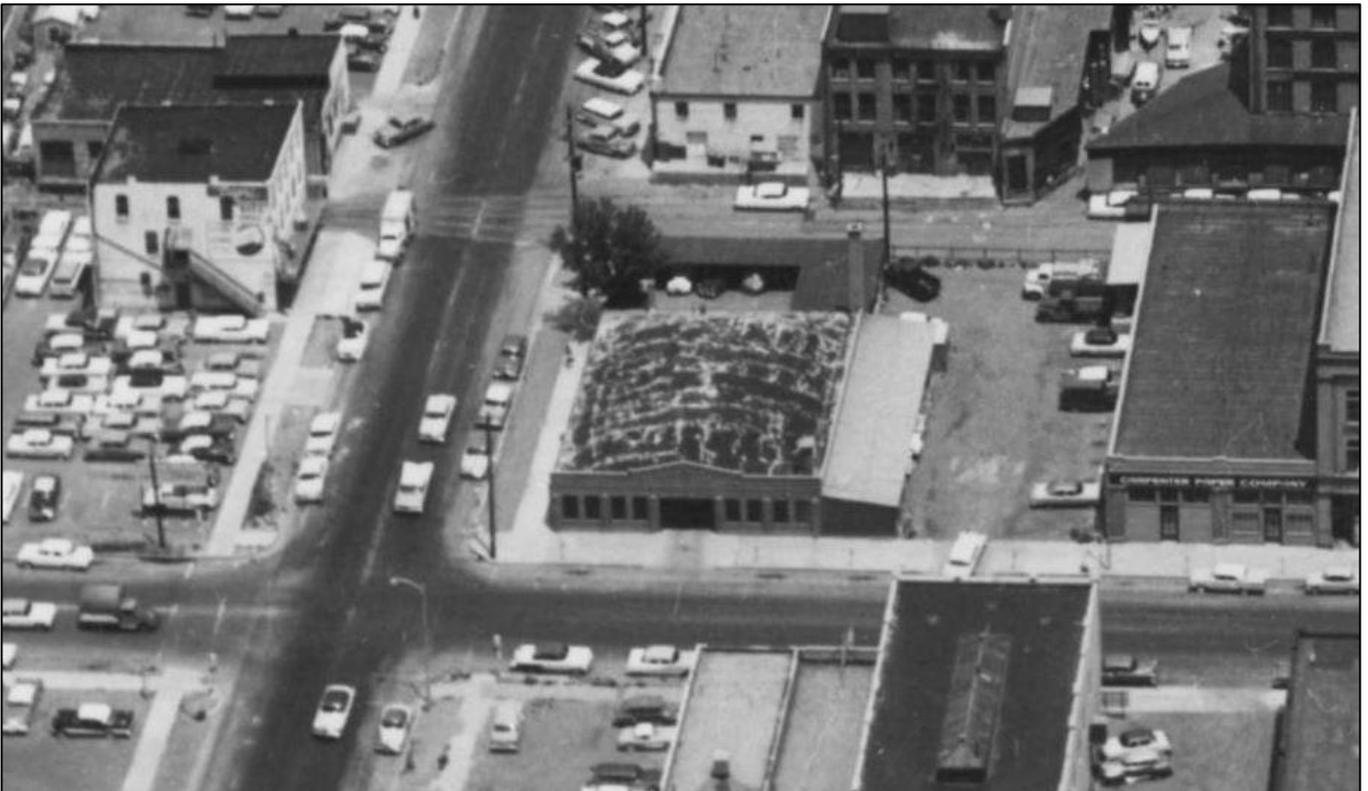
Detail of "Aerial View of downtown Pueblo." See 225 W. 2nd Street in center of image. Aerial image has no date. Note presence of cars in shed extensions. Courtesy of the City-County Library. Identifier No. PCCLD-Ph-P-01-10-005.
