COLORADO CULTURAL RESOURCE SURVEY

Architectural Inventory Form

1. Resource number: 5PE.8248
2. Temporary resource number: FN15
3. County: Pueblo
4. City: Pueblo
5. Historic building name: Firestone Service Stores, Inc.
6. Current building name: Firestone Tire Garage
7. Building address: 301 W. 8th St
8. Owner name and address: Bridgestone Retail Operations LLC., 333 E. Lake St., Bloomingdale, IL, 60108

48. Report title: Historic Downtown Property Survey, City of Pueblo, Pueblo County, Colorado

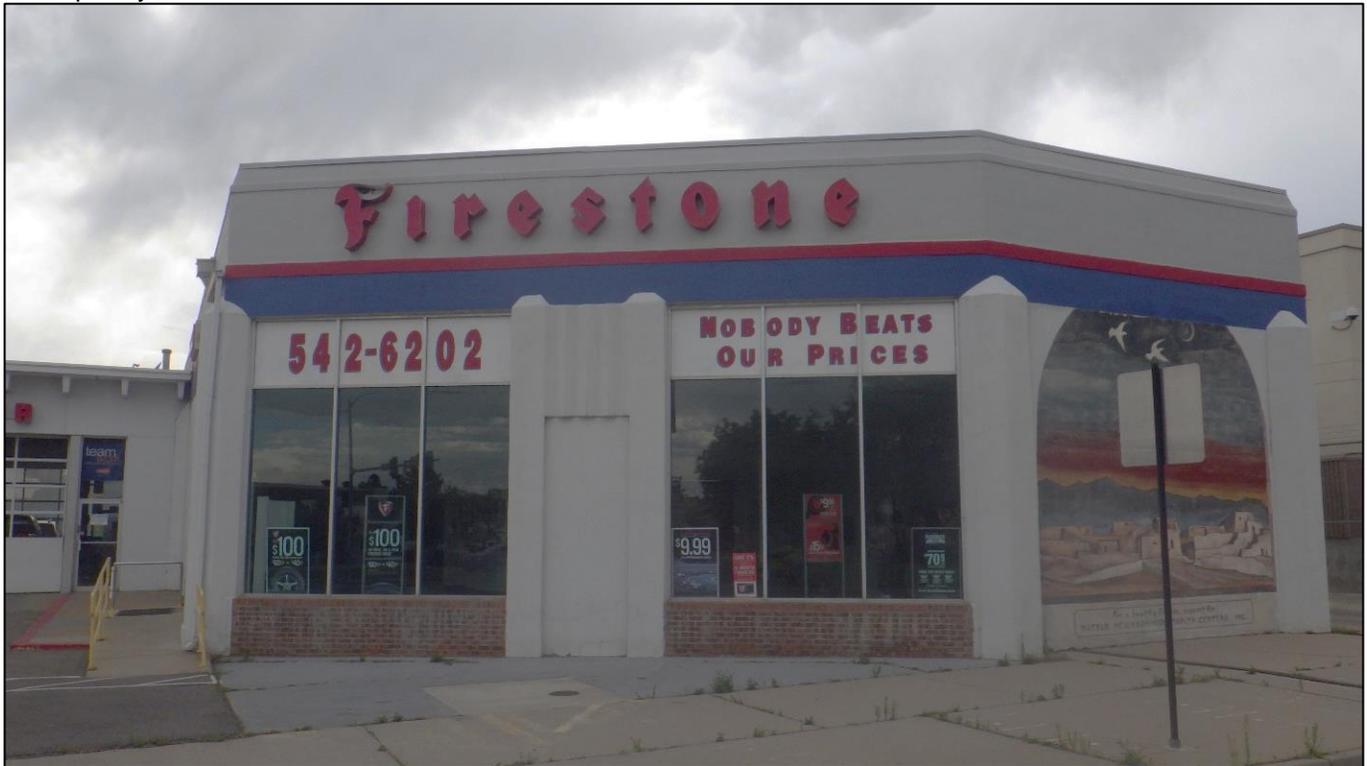
301 W. 8th St. facing west showing southeast truncated wall and east wall of original building block.

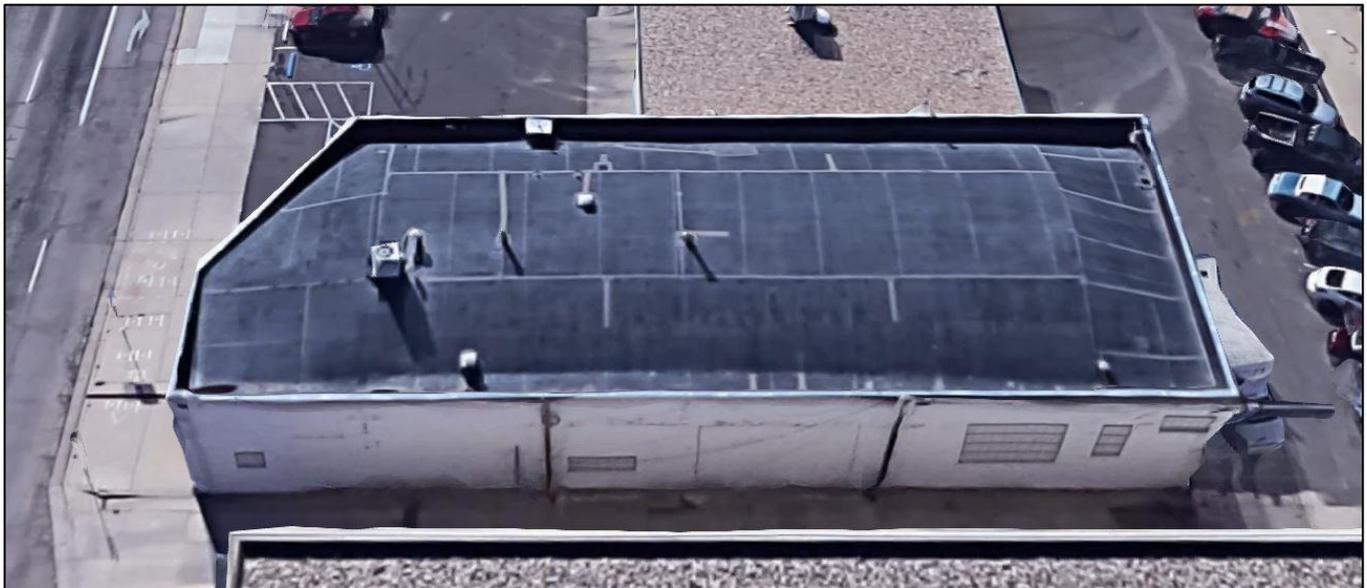
301 W. 8th St. facing south showing north wall. Courtesy of Google Maps.

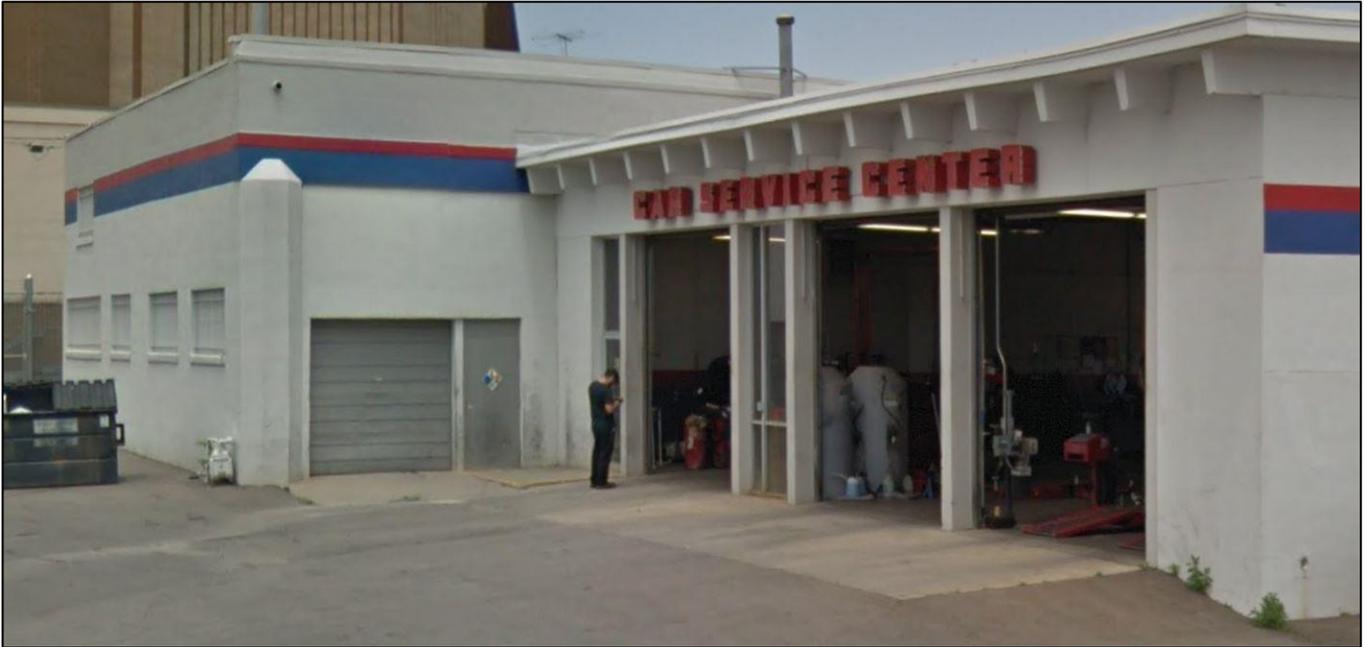
301 W. 8th St. facing northeast showing west wall of original building block, west portion of south wall of original building block, and west wall of modern addition. Courtesy of Google Maps.

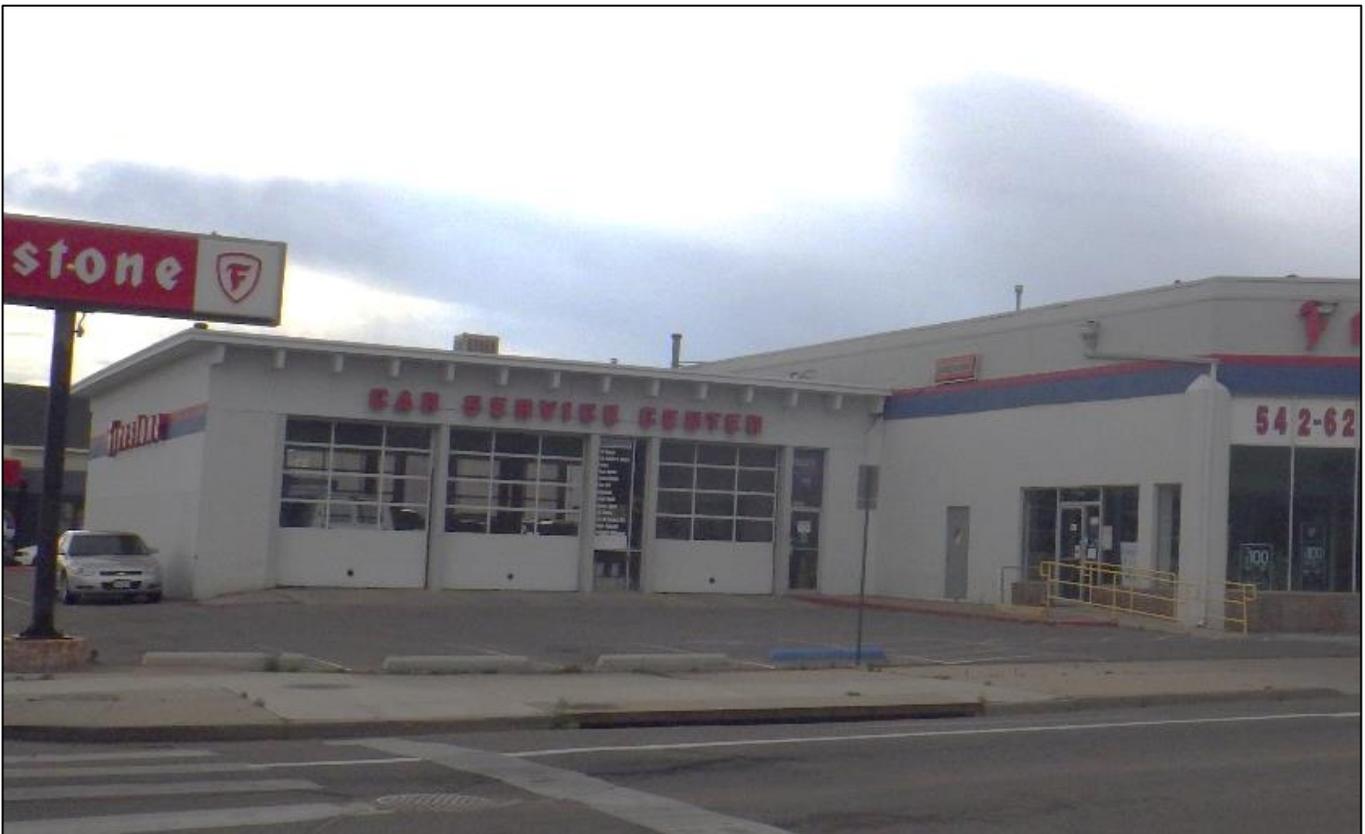
301 W. 8th St. facing northwest showing eastern portion of south wall of original building block and east wall of modern addition.

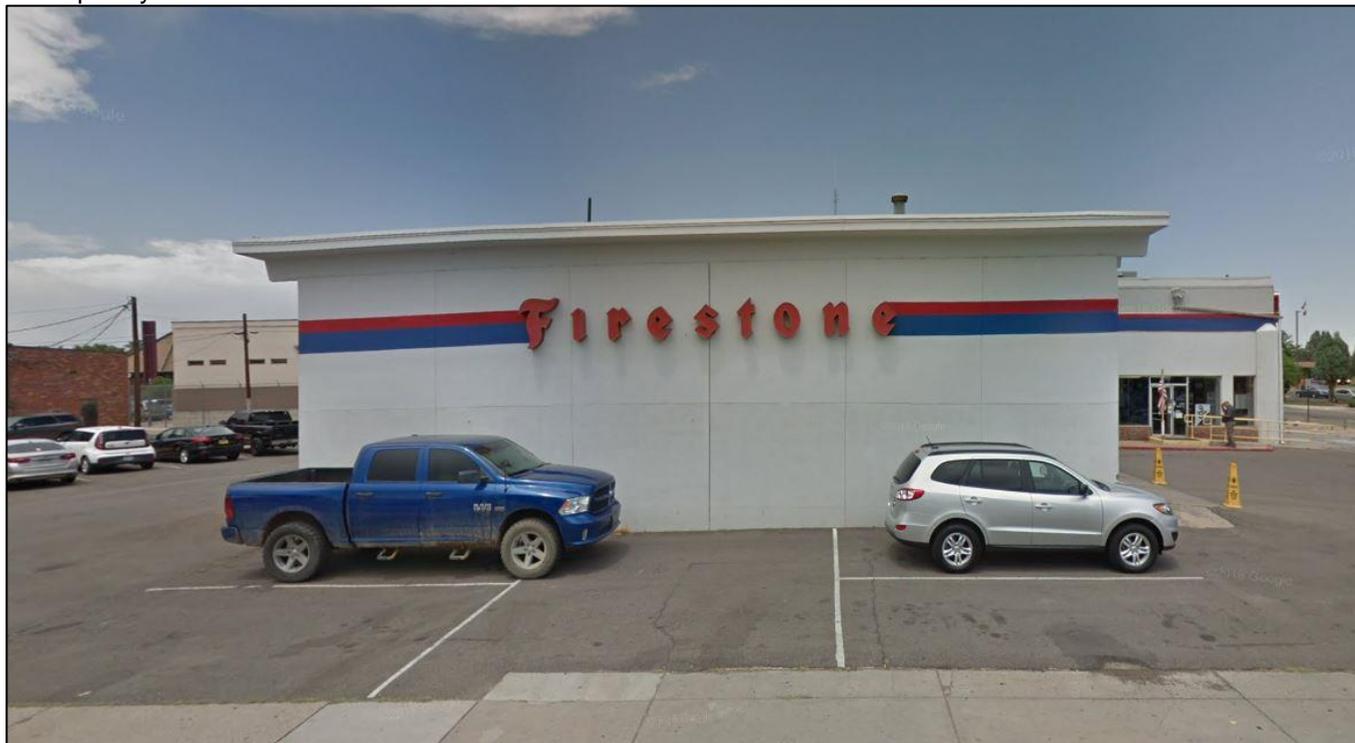
301 W. 8th St. facing north showing south wall of modern addition. Courtesy of Google Maps.

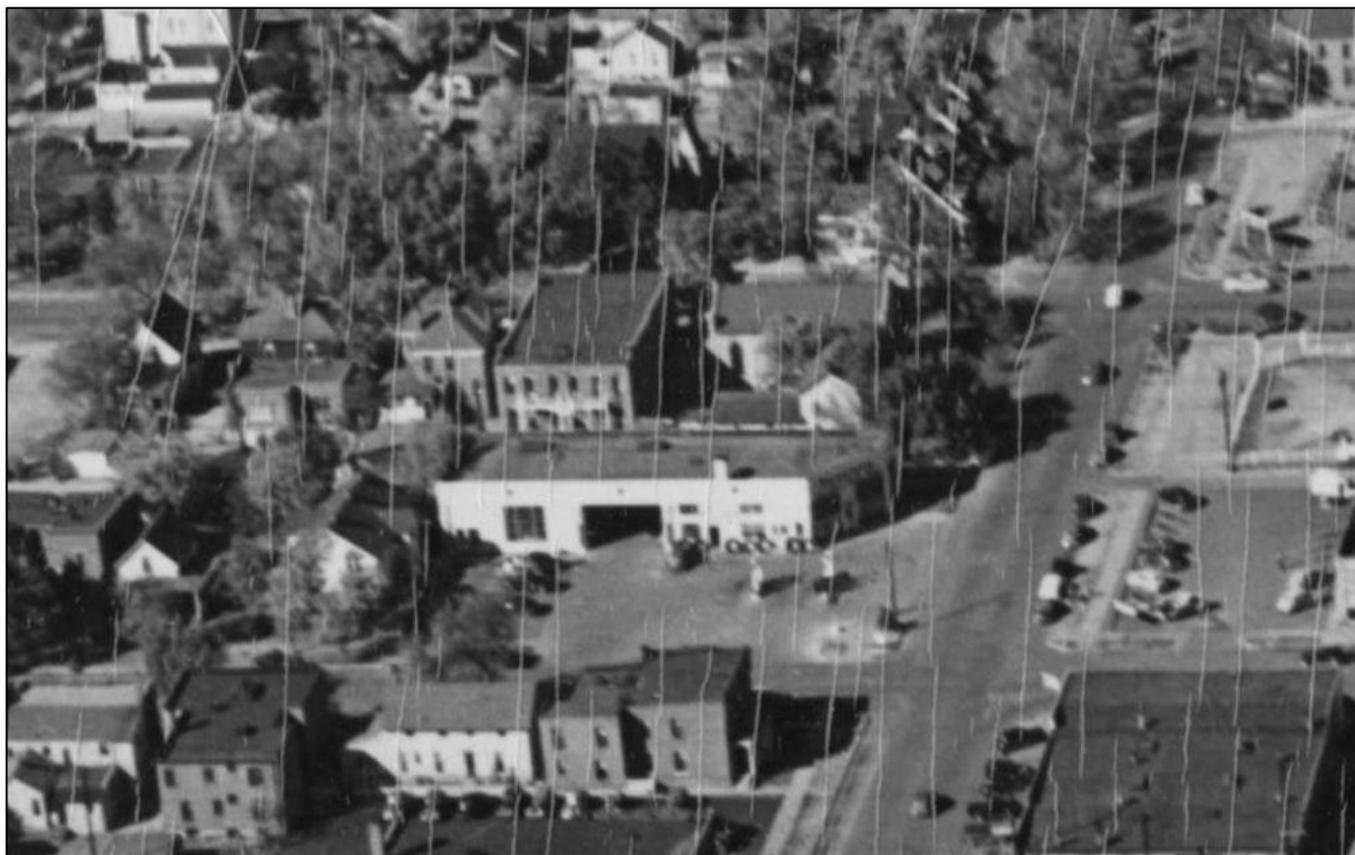
Detail of "Aerial View of Downtown Pueblo." See 5PE.8248 in center. This photograph is undated, but due to the lack of a southern addition to the building, is prior to 1951. Courtesy of the Pueblo City-County Library. Identifier No. PCCLD-Ph-P-01-11-003.

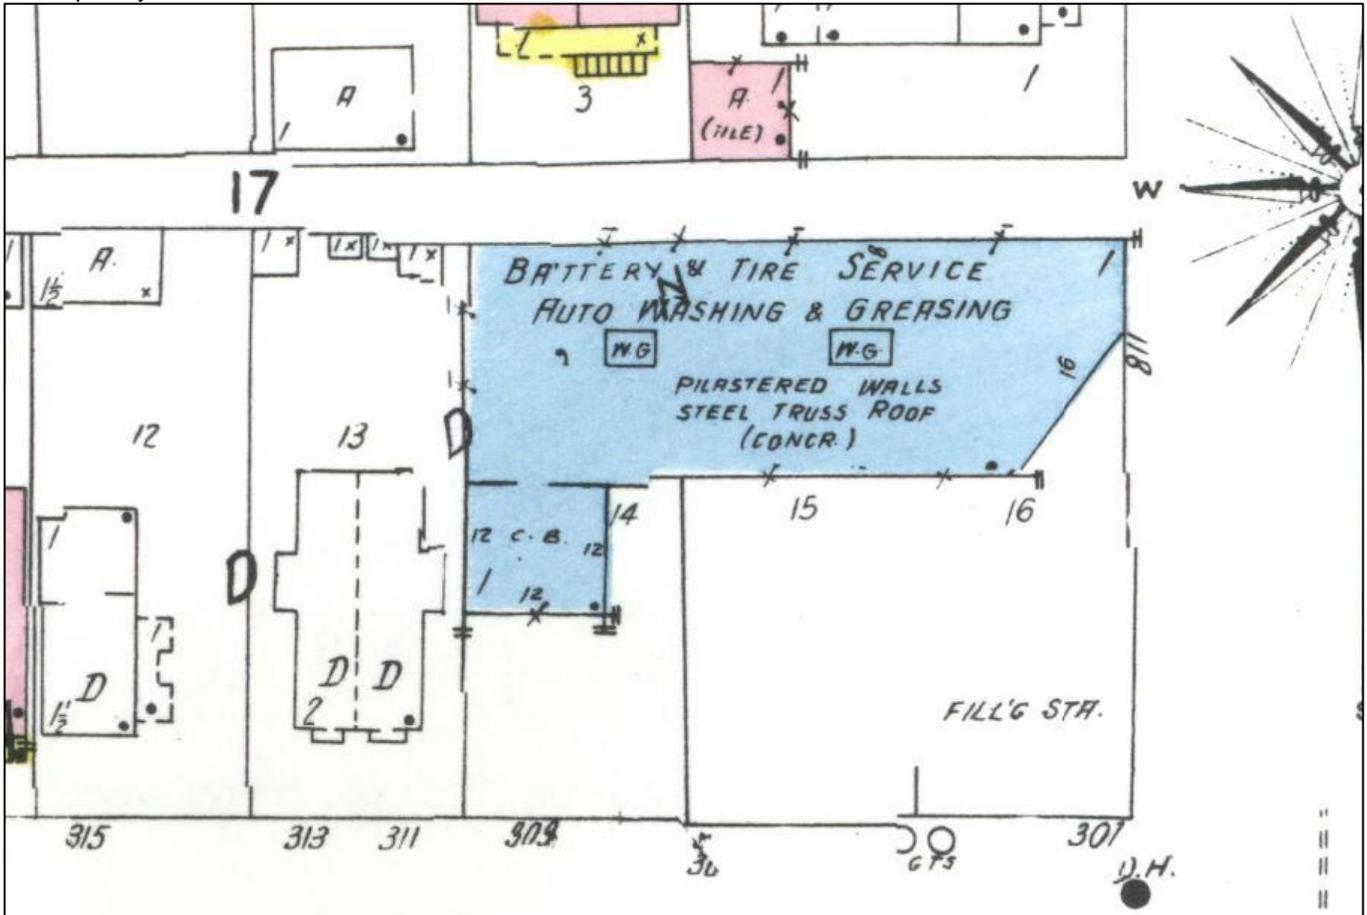
Detail of page 17 of the 1951 Sanborn Fire Insurance Map. Note the southern addition giving the building an L-shaped plan and not yet extending to the southern property line. Courtesy of the Library of Congress.

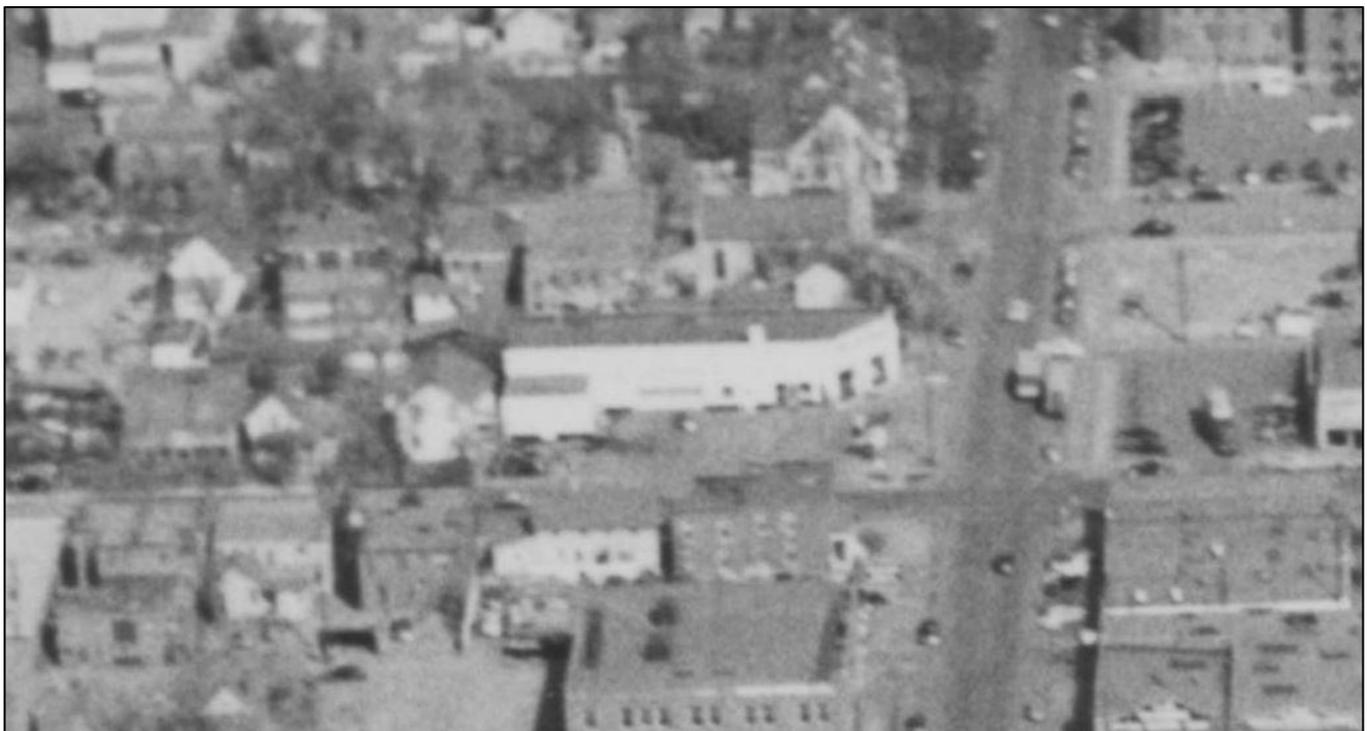
Detail of "Aerial View of Downtown Pueblo." See 5PE.8248 in center. April, 1957. Courtesy of the Pueblo City-County Library. Identifier No. PCCLD-Ph-P-01-09-005.

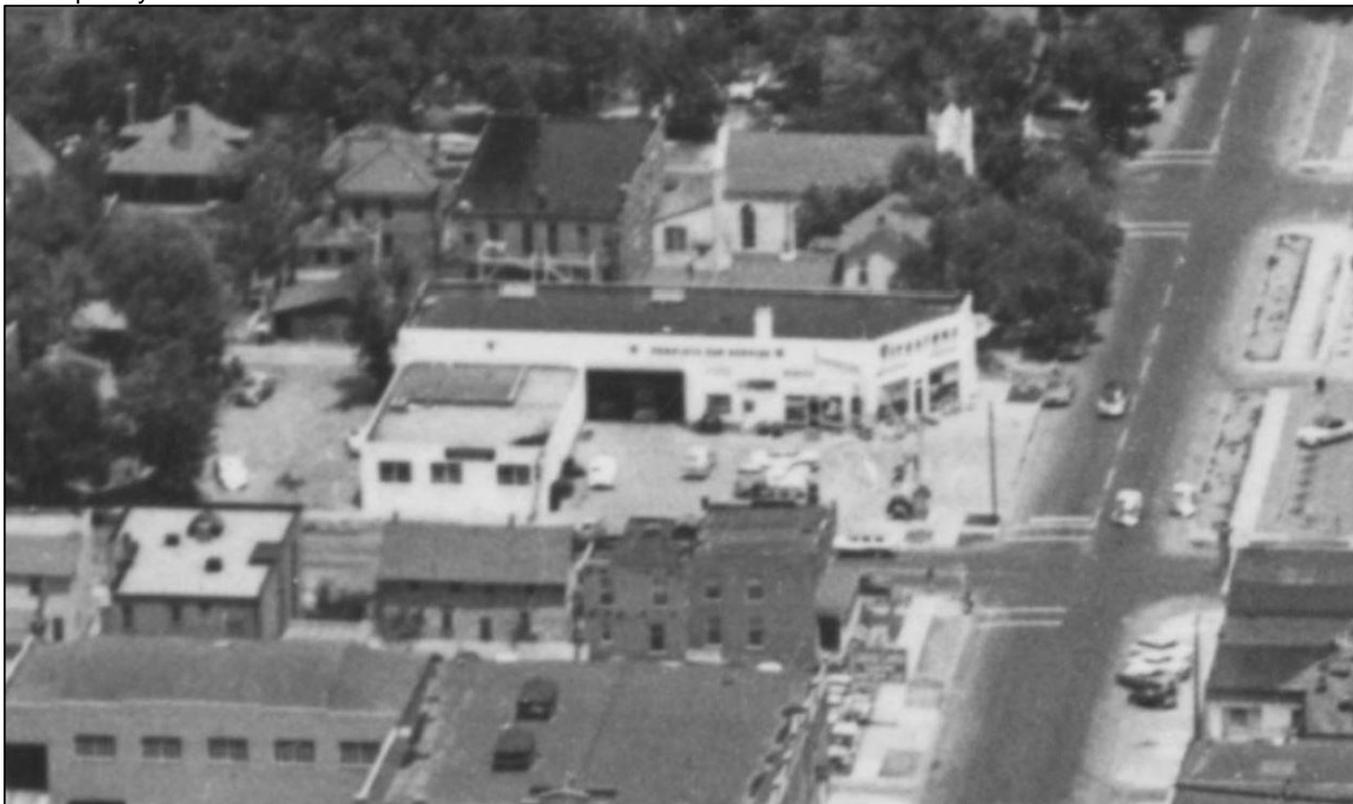
Detail of "Aerial View of Downtown Pueblo." See 5PE.8248 in center. After 1957. Note distended addition stretching all the way to the property line bordering W. 8th St. Courtesy of the Pueblo City-County Library. Identifier No. PCCLD-Ph-P-01-10-005.
