COLORADO CULTURAL RESOURCE SURVEY

**Architectural Inventory Form**

**I. IDENTIFICATION**

- 1. Resource number: **5PE.4977** Parcel number: **1501425001**
- 2. Temporary resource number: **1129Eilers**
- 3. County: **Pueblo**
- 4. City: **Pueblo**
- 5. Historic building name: **Zaitz House**
- 6. Current building name: **Lehew-Zaitz House**
- 7. Building address: **1129 Eilers Avenue**
- 8. Owner name: **Joann Lehew & Richard Zaitz**
- Owner organization:
- Owner address: **1129 Eilers Avenue  
Pueblo, CO 81006-1007**

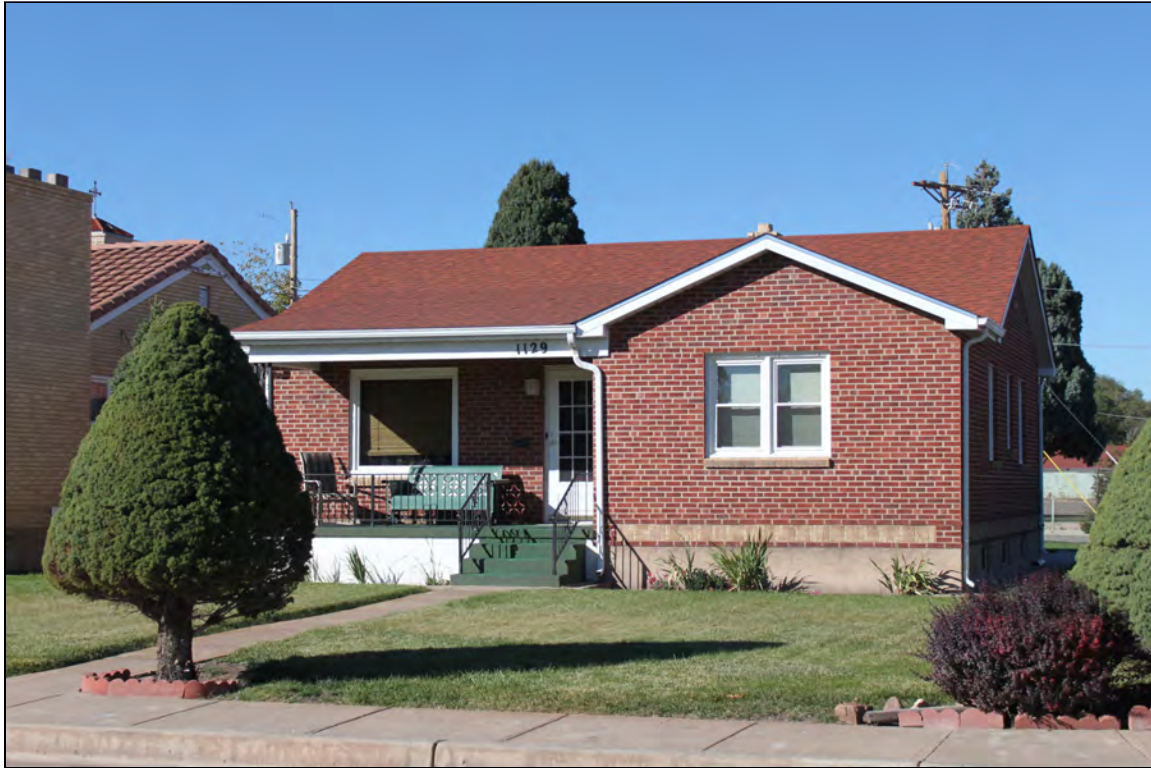
14. Building Plan (footprint, shape): **Square Plan**  
Other building plan descriptions:
15. Dimensions in feet: **994 square feet**
16. Number of stories: **One**
17. Primary external wall material(s): **Brick**  
Other wall materials:
18. Roof configuration: **Gabled Roof/Cross Gabled Roof**  
Other roof configuration:
19. Primary external roof material: **Asphalt Roof/Composition Roof**  
Other roof materials:
20. Special features: **Porch**  
**Chimney**
21. General architectural description:  
**Oriented to the east, this one-story Ranch home features a square plan and rests on a concrete foundation. The home is faced in red brick with a three-course decorative element in blonde brick running in centered bands above the concrete foundation. All of the trim is wood, painted white. The cross-gabled roof has slightly overhanging eaves and is covered in asphalt composition shingles.**

**The primary entry is centered on the façade within the recessed front porch near the intersection of the side- and front-gabled portions of the house. The concrete porch is reached via three concrete steps centered on the façade. Both the porch surface and steps are painted dark green with its concrete foundation painted white. The porch features black wrought iron railings and a corner support. The inside front door appears to be stained wood with an oval fixed pane window centered in the upper portion of the door. The white (wooden or metal) storm door has a twelve-light opening at the top and a paneled kickplate near the bottom. There is a porch light south of the front door. A square picture window**

appears further to the south on the façade. This opening is centered on the façade between the primary entry and the southeast corner of the house. There are two white metal drainpipes, one at the southeast corner of the house and the other on the southeast corner of the front-gabled bay at the northeast corner of the facade. This part of the home features a pair of centered double-hung windows with a brick sill. The house number "1129" appears on the fascia board above the front steps.

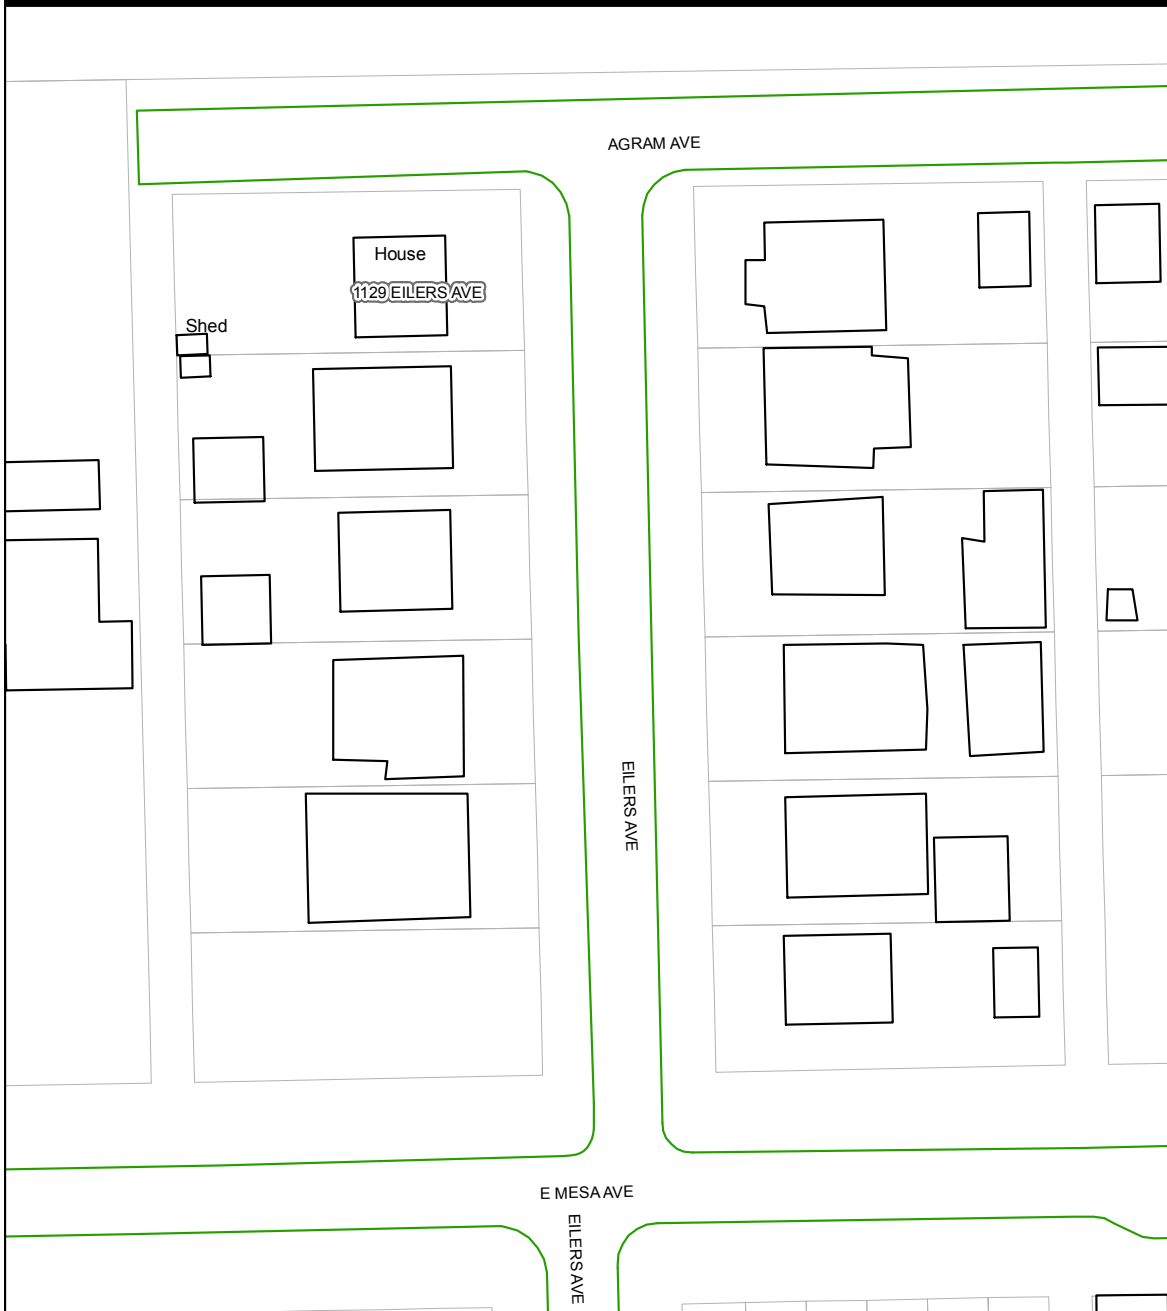
## SKETCH MAP

# 1129 Eiler's Ave
