COLORADO CULTURAL RESOURCE SURVEY

Architectural Inventory Form

I. IDENTIFICATION

Eilers Neighborhood Story and Community-Built Survey

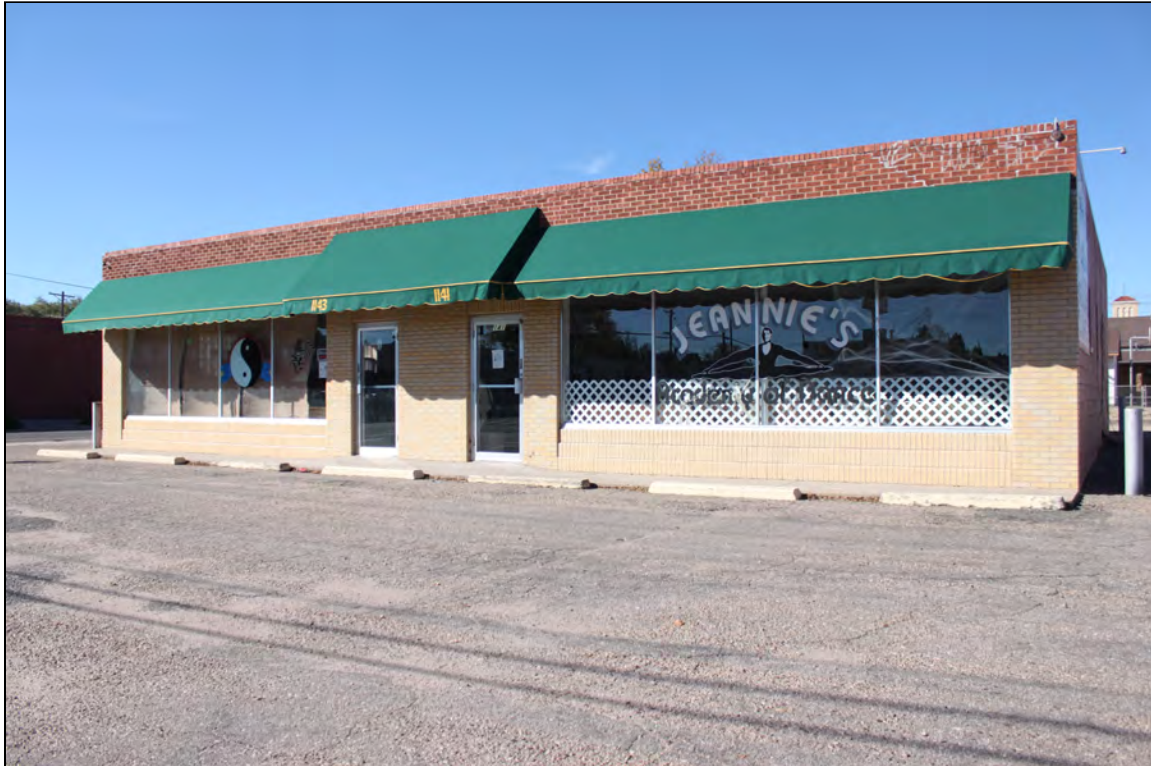
14. Building Plan (footprint, shape): **Rectangular Plan**
Other building plan descriptions:
15. Dimensions in feet: **3000 square feet**
16. Number of stories: **One**
17. Primary external wall material(s): **Brick**
Concrete/Concrete Block
Other wall materials:
18. Roof configuration: **Flat Roof**
Other roof configuration:
19. Primary external roof material: **Synthetic Roof**
Other roof materials:
20. Special features: **Window/Glass Block**
21. General architectural description:
Oriented to the east, this one-story Commercial building features a rectangular plan. The concrete-block building has brick facing on the façade and south elevation. All of the window sills are blonde brick. The flat roof likely is covered in synthetic material.

This building has space for two businesses. Each space features a large, rectangular, four-lite display window running from the exterior corner toward the center of the building. The primary entry for each store appears adjacent to the large window. Each door is fixed-pane glass with metal (perhaps aluminum) surround and hardware. A forest green, fabric awning runs the entire length of the façade; the address numbers "1141" and "1143" appear above the business entries. The façade below this awning is faced in blonde brick. A red brick parapet appears above the awning.
