COLORADO CULTURAL RESOURCE SURVEY

Architectural Inventory Form

- 1. Resource number: **5PE.5596**
- 2. Temporary resource number: **011**
- 3. County: **Pueblo**
- 4. City: **Pueblo**
- 5. Historic building name: **613 West Eleventh Street**
- 6. Current building name: **613 West Eleventh Street**
- 7. Building address: **613 W 11th Street**
- 8. Owner name: **Housing Authority of Pueblo**
- Owner organization:
- Owner address: **1414 N Santa Fe Ave**  
**Pueblo, CO 81003**

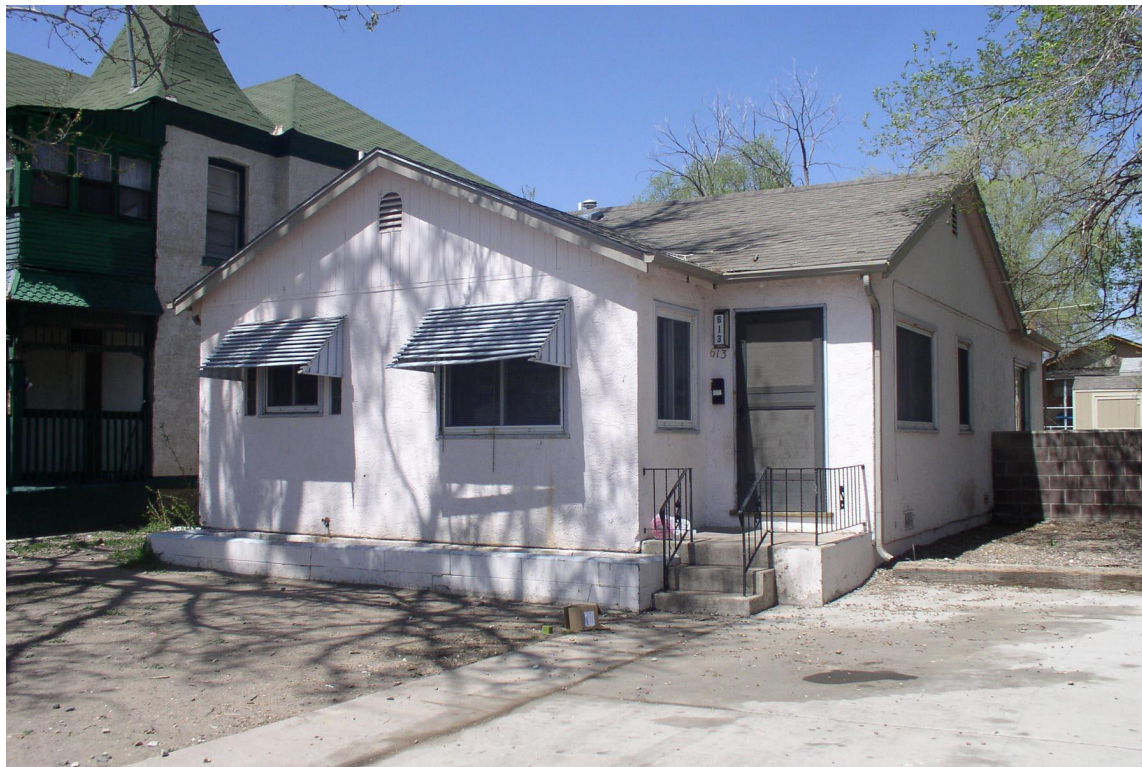
**Oriented to the south, this house rests on a pink-painted, concrete foundation. Pink-painted stucco clads the exterior walls. Vertical wood siding, also painted pink, covers the gables. Windows are generally 1-beside-1-light, sliding-sash, with white, vinyl frames and white, aluminum-frame storm windows. The westernmost window on the front (south) façade has glass-block sidelights. Metal, louvered awnings shelter to windows on the front (south) elevation. Surrounded by a black, wrought-iron railing, a 3-step, concrete stoop approaches the front door, which is located on the east end of the asymmetrical façade. It is a 6-panel, white, steel door, opening behind a brown, aluminum-frame storm door. Another doorway pierces the west elevation. A 2-step concrete stoop approaches the door from the north. It is a 6-panel, white, steel door, opening behind a brown, aluminum-frame storm door. A round-roof awning, on wood brackets, shelters the door. A plate-glass sliding door is located on the north end of the east elevation. Gray-green asphalt shingles cover the cross-gabled roof, and the rafter ends are exposed but, in most cases, capped with a fascia board. Arched, louvered attic vents pierce the gables.**

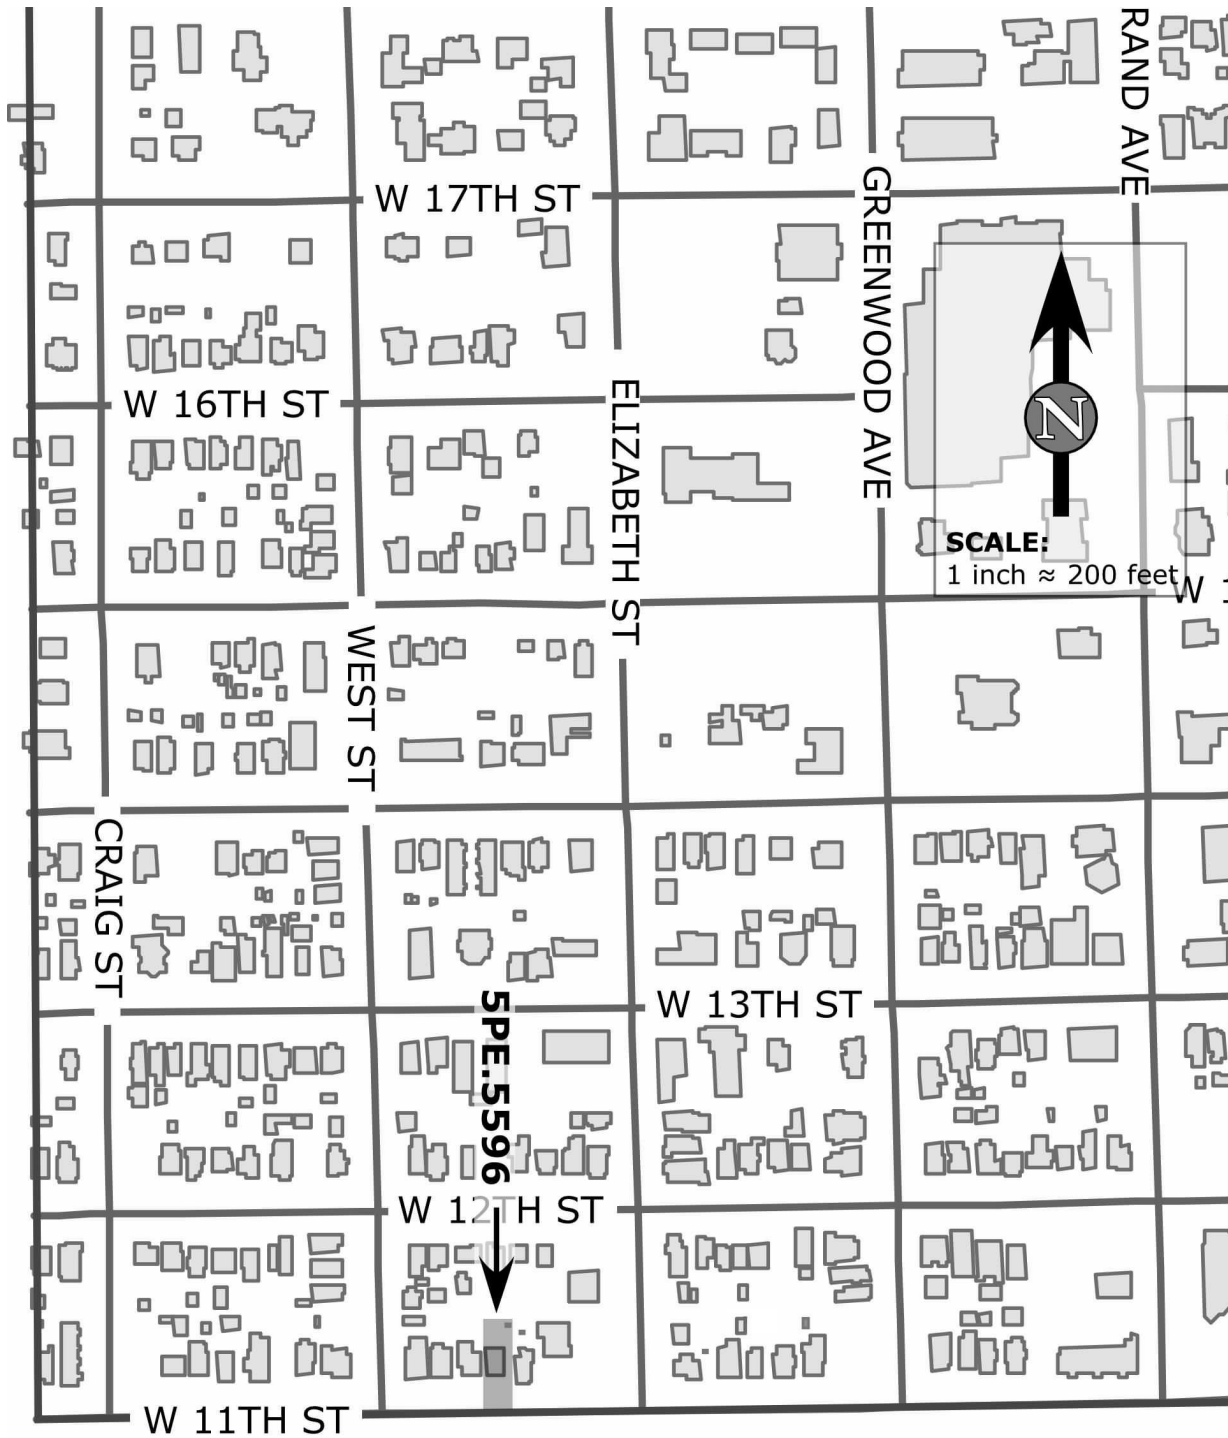
#### SITE SKETCH MAP

This property is located on terrain sloping downward from north to south, with an elevation of around 4,700 feet above mean sea level. The neighborhood features modest, one- and two-story houses. A grass strip, generally planted with large cottonwood or elm trees, separates the sidewalk from the street. This property is located on the north side of West 11th Street, an east-west-oriented thoroughfare. It is situated between 611 West 11th Street, to the east, and 615 West 11th Street, to the west. A planted grass yard surrounds the house. A chain-link fence encloses the backyard, while a concrete-block wall extends eastward from the northeast corner of the house. A planter of the same construction lines the front (south) of the house.

- 1 : Type: **Shed**  
 Describe: **A modular shed is located northeast of the house. Oriented to the south, the structure rests on a concrete slab. Tan-painted particleboard sheets, with white-painted, 1-by-3-inch cornerboards, clad the exterior walls. A particleboard door, opening on metal strap hinges, dominates the front (south) elevation. Brown asphalt shingles cover the side gabled roof.**
