COLORADO CULTURAL RESOURCE SURVEY

Architectural Inventory Form

- 1. Resource number: **5PE.5599**
- 2. Temporary resource number: **017**
- 3. County: **Pueblo**
- 4. City: **Pueblo**
- 5. Historic building name: **Weber, Frank A., House**
- 6. Current building name: **715 West Eleventh Street**
- 7. Building address: **715 W 11th Street**
- 8. Owner name: **Rowland Realty, Inc.**
- Owner organization:
- Owner address: **1501 Zuni Rd**
Pueblo, CO 81001

47. Photograph numbers): **CD-ROM Photo Disc: North Side Photos
File Name(s): 11thstw715**
- Negatives filed at: **Special Collections
Robert Hoag Rawlings Public Library
100 East Abriendo Avenue
Pueblo, CO 81004-4290**
48. Report title: **Pueblo North Side Neighborhood Survey**
49. Date(s): **04/28/05**
50. Recorder(s): **Adam Thomas**
51. Organization: **Historitecture, L.L.C.**
52. Address: **PO Box 419
Estes Park, CO 80517-0419**
53. Phone number(s): **(970) 586-1165**

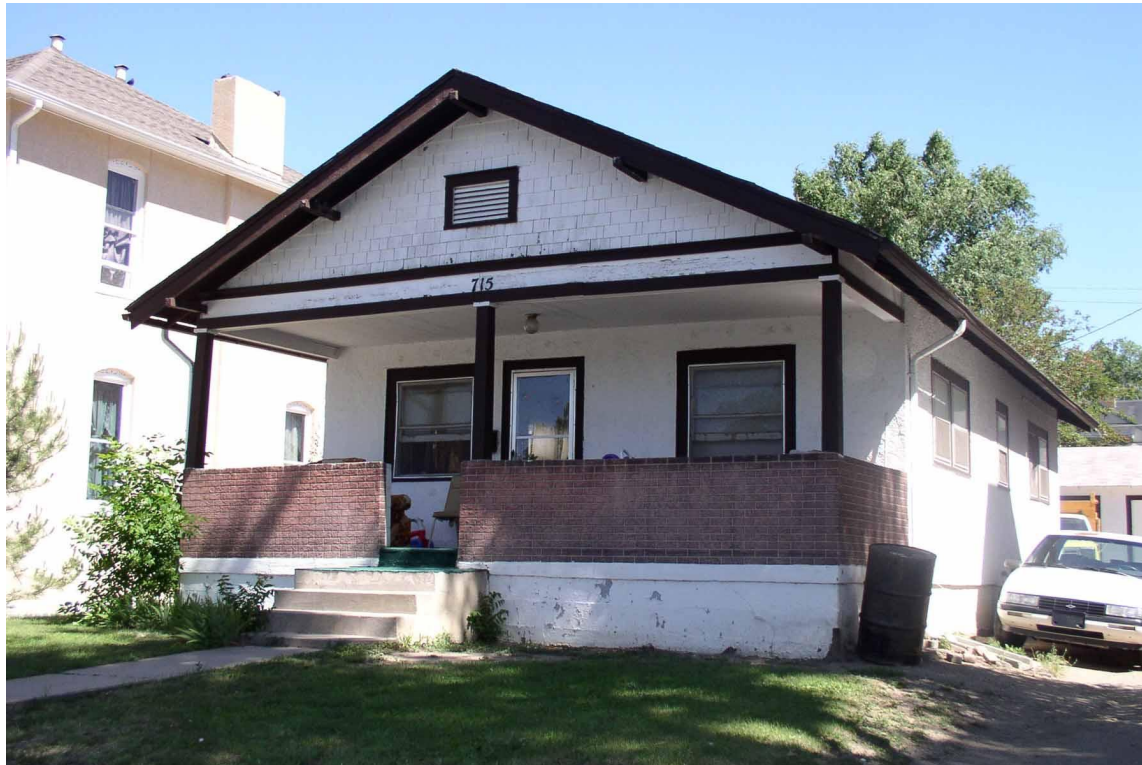
19. Primary external roof material: **Asphalt Roof/Composition Roof**
Other roof materials:
20. Special features: **Chimney**
Porch
21. General architectural description:
Oriented to the south, this house rests on a white-painted concrete foundation. Basement windows have been boarded shut. White-painted stucco clads the exterior walls. Wood shingles, also painted white, cover the gables. Windows are 1-over-1-light, double-hung sash, with white-painted wood frames, aluminum-frame storm windows, and brown-painted wood surrounds. An enclosed porch or mud room, attached to the west side of the rear (north) elevation, has 4-light hopper, awning, or casement windows, with brown-painted wood frames and surrounds. A full-width, integral porch dominates the front (south) façade. It features a concrete floor, beadboard ceiling, and simple, brown-painted, square wood posts, which rest on a pink-brick kneewall. The porch is approached via a 4-step concrete stoop offset west of center. The principal (south) entrance is also offset west of center in the otherwise symmetrical facade. It hosts a wood slab door, opening behind an aluminum-frame storm door. A 2-step concrete stoop approaches the rear (north) doorway, which opens in the center of the rear enclosed porch or mud room. The doorway hosts a wood slab door, opening behind an aluminum-frame storm door. Gray red asphalt shingles cover the front-gabled roof, and the rafter and shaped perlin ends are exposed. A short, red-brick chimney emerges near the north end of the house, just west of the roof ridge.

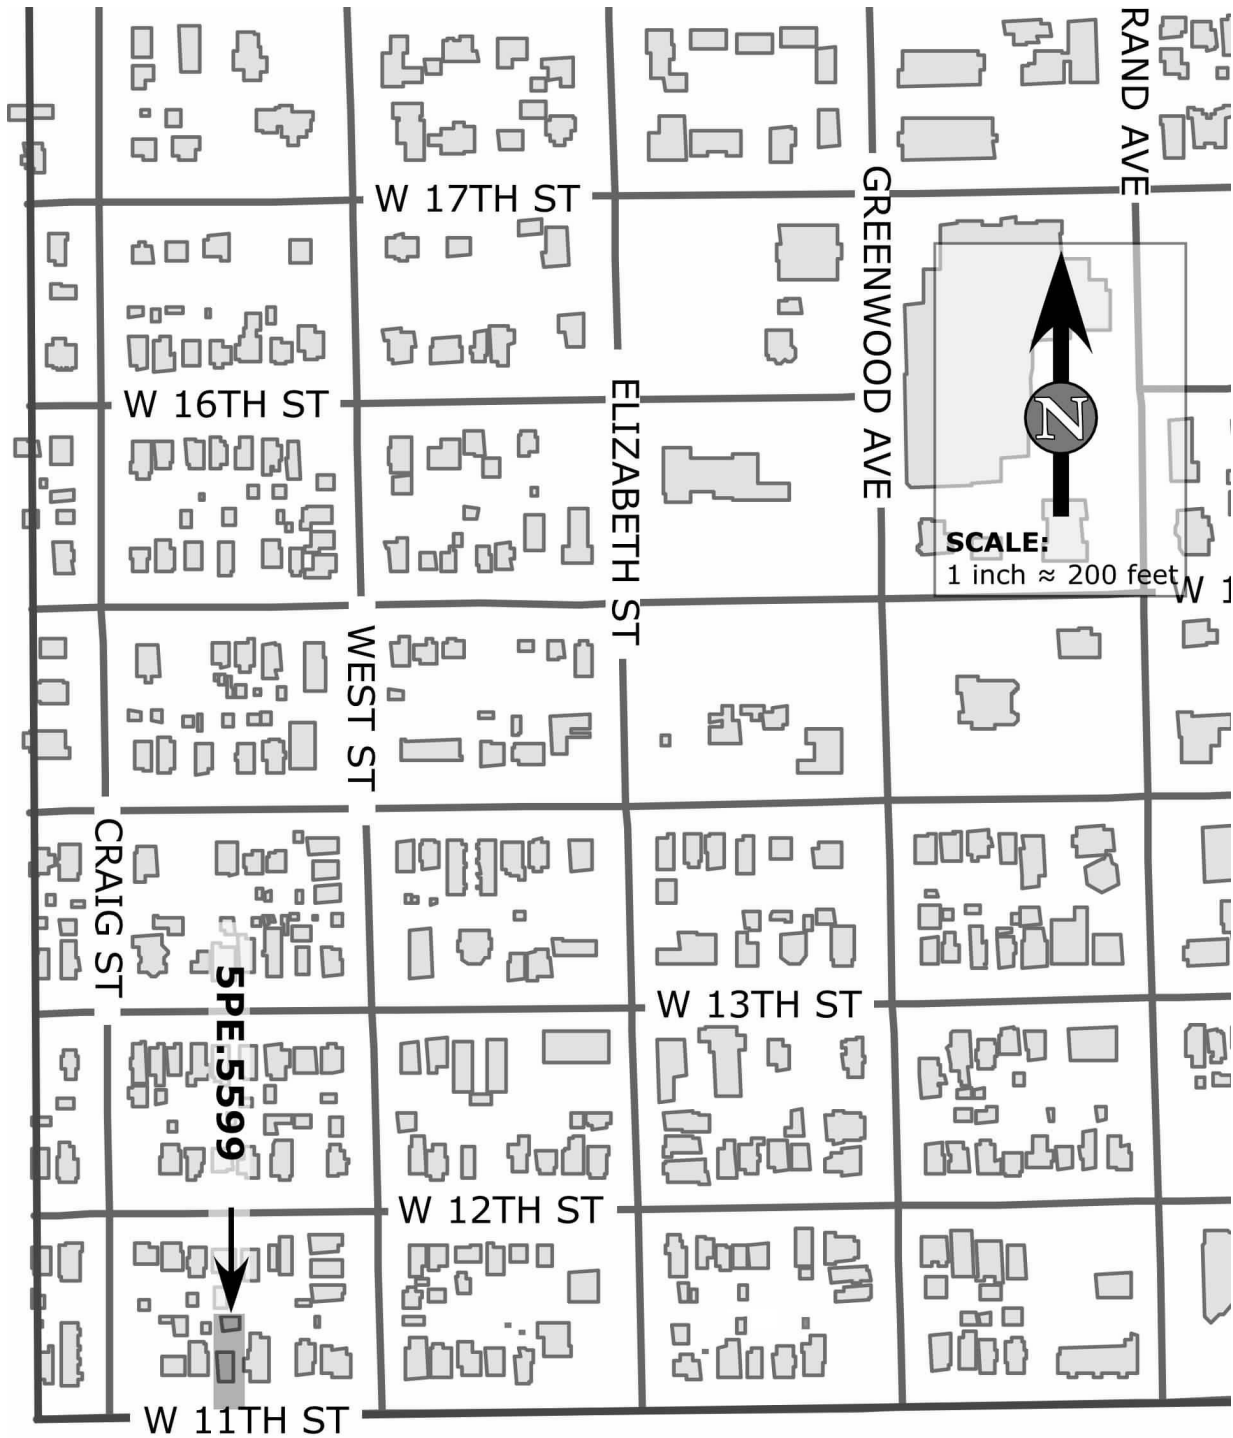
SITE SKETCH MAP

This property is located on terrain sloping downward from north to south, with an elevation of around 4,700 feet above mean sea level. The neighborhood features modest, one- and two-story houses. A grass strip separates the sidewalk from the street. Pink sandstone comprises the sidewalk. This property is located on the north side of West 11th Street, an east-west-oriented thoroughfare. It is situated between 713 West 11th Street, to the east, and 719 West 11th Street, to the west. A planted grass yard surrounds the house. A chain-link fence surrounds the backyard. A gravel parking area is located behind (north) of the house, connecting West 11th Street to an east-west-oriented alley and providing access to a garage north of the house.
