COLORADO CULTURAL RESOURCE SURVEY

Architectural Inventory Form

- 1. Resource number: **5PE.513.27** Parcel number(s):
- 2. Temporary resource number: **032** **525425007**
- 3. County: **Pueblo**
- 4. City: **Pueblo**
- 5. Historic building name: **Nichols, Wilbur Fisk, Duplex**
- 6. Current building name: **428-420 West 12th Street Apartments**
- 7. Building address: **428-430 W 12th Street**
- 8. Owner name: **Neighborhood Services, Inc.**
- Owner organization:
- Owner address: **3937 Ivywood Ln**
Pueblo, CO 81005

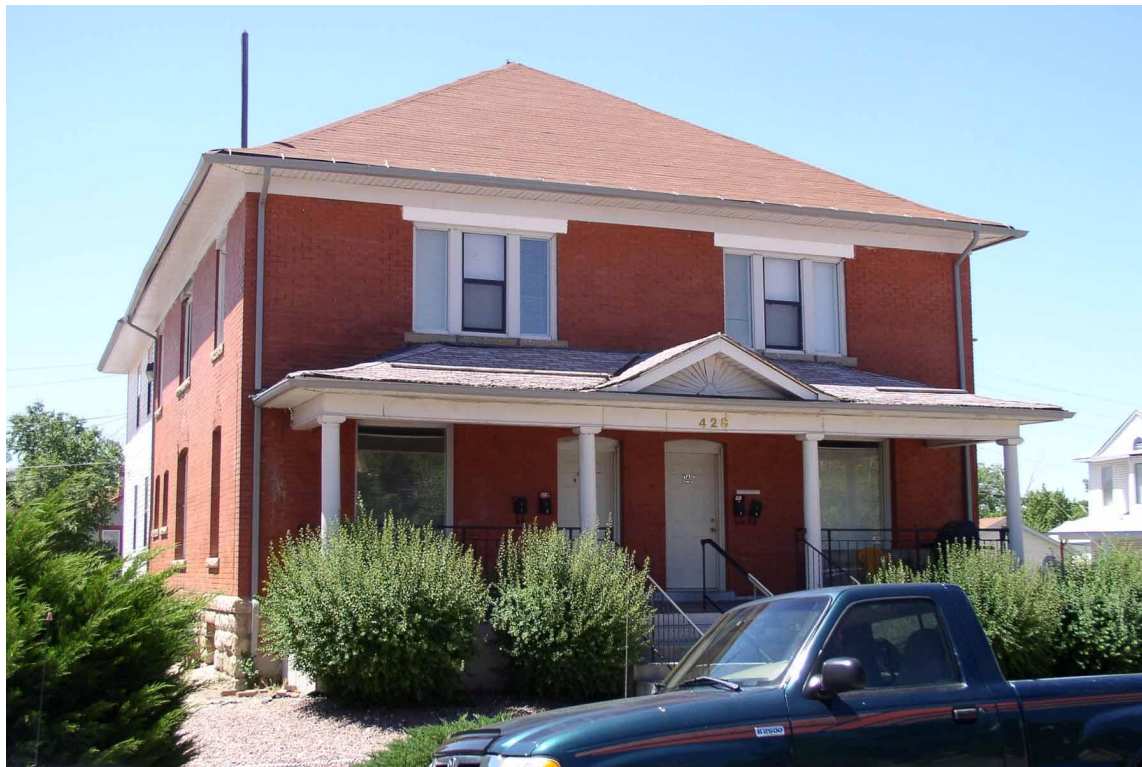
19. Primary external roof material: **Asphalt Roof**
Other roof materials:
20. Special features: **Porch**
Window/Segmental Arch
21. General architectural description:
Oriented to the north, this apartment building rests on a buff-colored, rock-faced sandstone foundation arranged as coursed ashlar beneath the front (north) façade and random ashlar beneath other elevations. A large addition across the rear elevation has a concrete foundation. Basement windows are 1-light, fixed frame. A red-brick veneer, with thin, pink mortar, clads the exterior walls of the original (north) half of the building. Cladding the newer (south) half of the building is white, vinyl siding. Most windows are 1-over-1-light, double-hung sash, with brown or white aluminum frames. Those windows opening within brick portions of the building have sandstone sills and segmental arches, except for the larger window openings, with have sandstone lintels. The sidelights of all tripartite windows now have single-light, fixed-frame windows. Picture windows are also located on either end of the principal (north) elevation's first story. The rear elevation hosts only small, square, fixed-frame windows. A hipped-roof porch spans the entire façade. Its supports have been wrapped in sheets of white vinyl, as has the frieze of the central pediment. Beneath this pediment, 6 concrete steps approach the porch. A black, wrought-iron railing flanks the steps and surrounds the porch. Opening in the center of the symmetrical facade are a pair of identical doorways. Both host 6-panel metal doors, beneath segmental arches. Another identical door provides access to a basement stairwell on the west end of the rear (south) elevation. This door opens behind a white, aluminum-frame storm door. Brown asphalt shingles cover the hipped roof, and white vinyl boxes the eaves.

Constructed in 1910, this building exhibits a moderate level of physical integrity relative to the seven aspects of integrity as defined by the National Park Service and the Colorado Historical Society: location, setting, design, materials, workmanship, feeling, and association. The most notable alteration has been the addition of a two-story structure across the rear elevation, essentially doubling the size of this building. However, the addition is isolated to the rear elevation and is clearly differentiated from the historic portion of the building. Windows and doors have also been replaced.

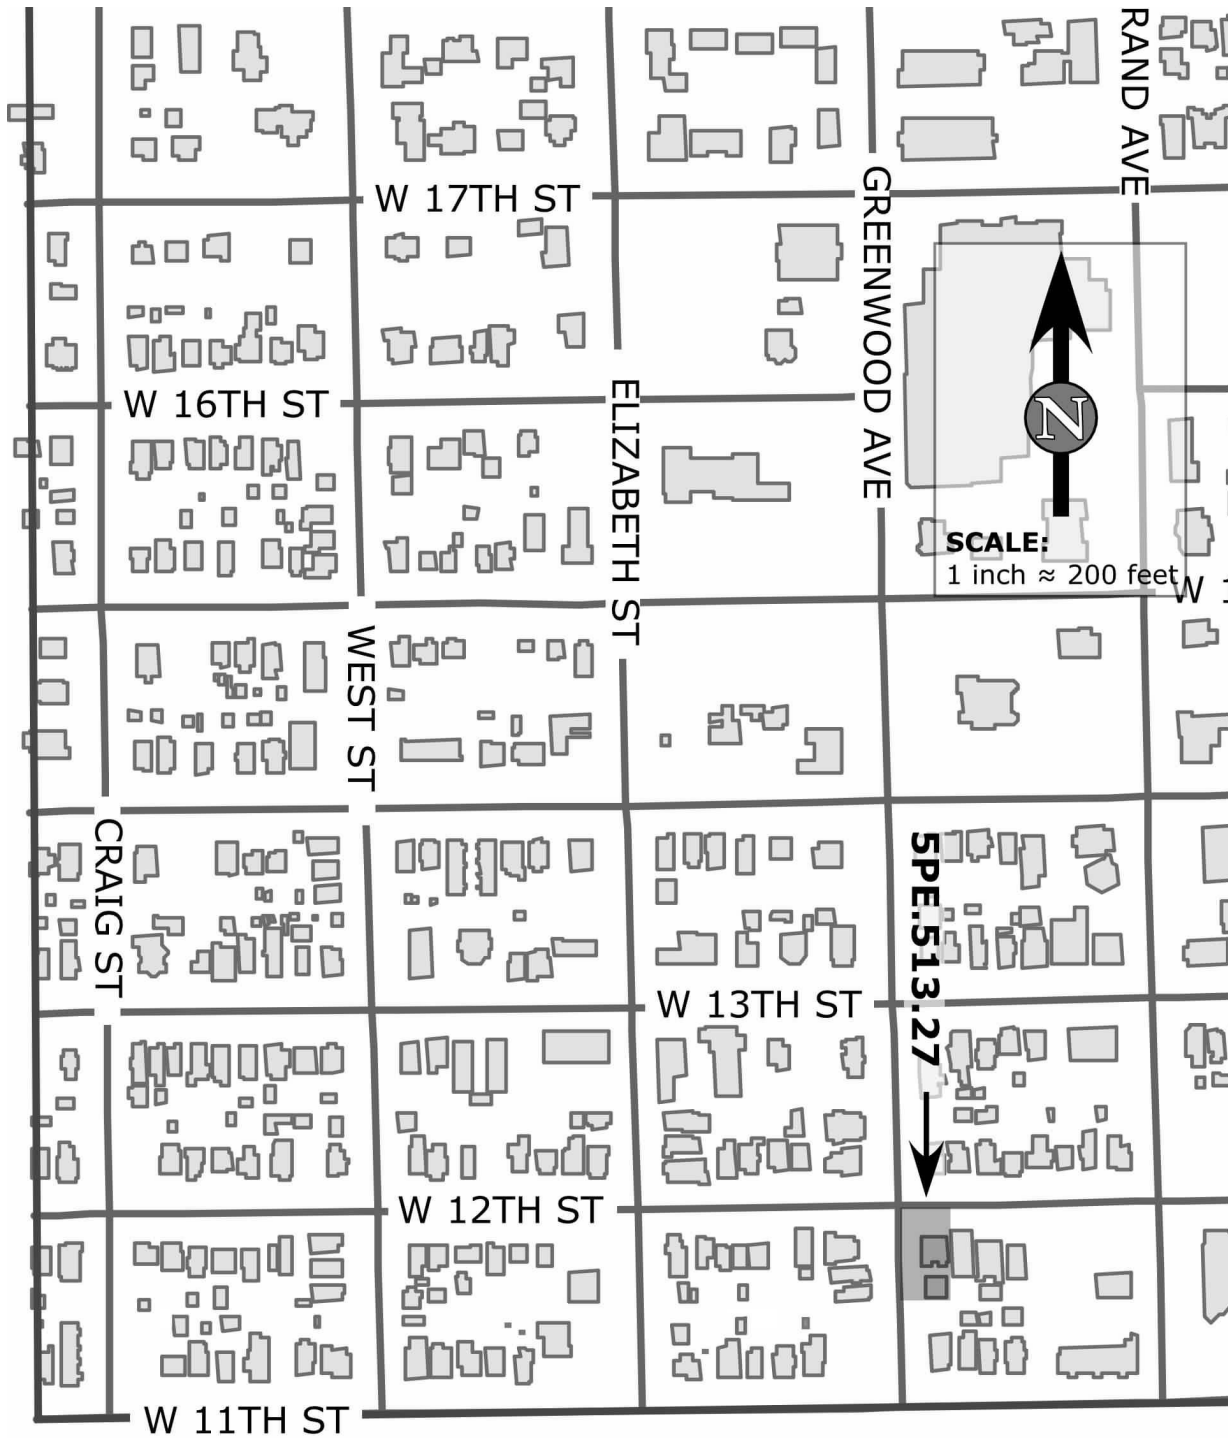
SITE SKETCH MAP

This property is located on terrain sloping downward from north to south, with an elevation of around 4,700 feet above mean sea level. The neighborhood features modest, one- and two-story houses. This property is situated on the southeast corner of West 12th and North Greenwood streets. A gravel-covered strip separates the sidewalk from the street. Gravel, interspersed with shrubs and flowering bushes, also covers the entire yard. A concrete parking lot is located behind (north of) this apartment building.
