COLORADO CULTURAL RESOURCE SURVEY

Architectural Inventory Form

- 1. Resource number: **5PE.5618**
- 2. Temporary resource number: **045**
- 3. County: **Pueblo**
- 4. City: **Pueblo**
- 5. Historic building name: **616 West Twelfth Street**
- 6. Current building name: **616 West Twelfth Street**
- 7. Building address: **616 W 12th Street**
- 8. Owner name: **Karen A. Harrington**
- Owner organization:
- Owner address: **311 Bennett Dr**  
**Pueblo, CO 81004**

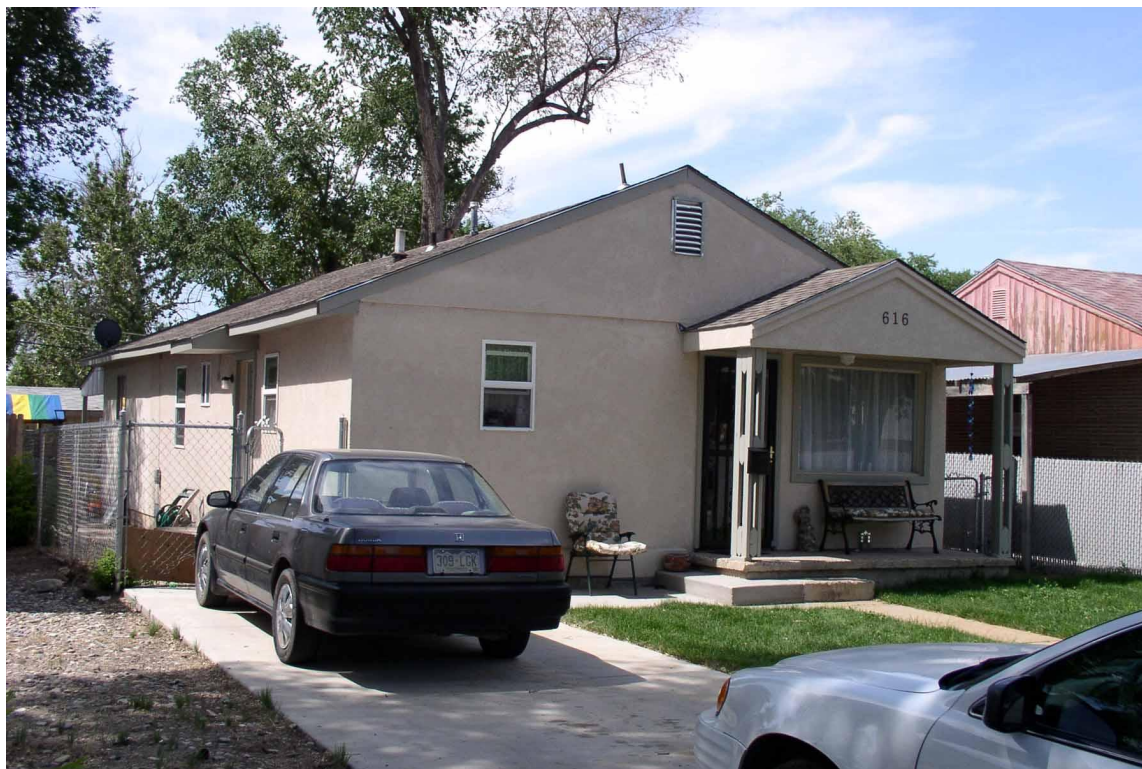
**Oriented to the north, this house rests on a concrete foundation, largely covered in cream-tinted stucco. The same stucco clads the exterior walls. Windows are generally 1-over-1-light, double-hung sash, with white vinyl frames and thin, aluminum surrounds. The center and south end of the east elevation hosts 1-beside-1-light, sliding-sash windows of the same style. These windows also appear on either end of the rear (south) elevation. The south end of the west elevation has a similar window. A small, front-gabled porch protrudes from the west end of the front (south) façade. It has a concrete floor and sage-green-painted, wood supports. Opening beneath the porch on the west end of the façade is a single-light picture window. East of it, but still beneath the porch roof, opens the principal doorway. It hosts a sage-green-painted, 6-panel metal door, opening behind a black, security-type storm door. Another doorway opens near the north end of the east elevation. It hosts a sage-green-painted, 6-panel metal door, opening beneath a small, shed-roofed hood. A shed-roof porch spans the entire rear (south) elevation. It has a concrete floor and simple, white-painted, square, wood supports. No doorway opens beneath this porch. A two-step concrete stoop approaches the doorway. Brown asphalt shingles cover the front-gabled main and porch roofs. Sage-green-painted wood frames box the shallowly overhanging eaves. An aluminum, louvered attic vent pierces the front- (north-) facing gable.**

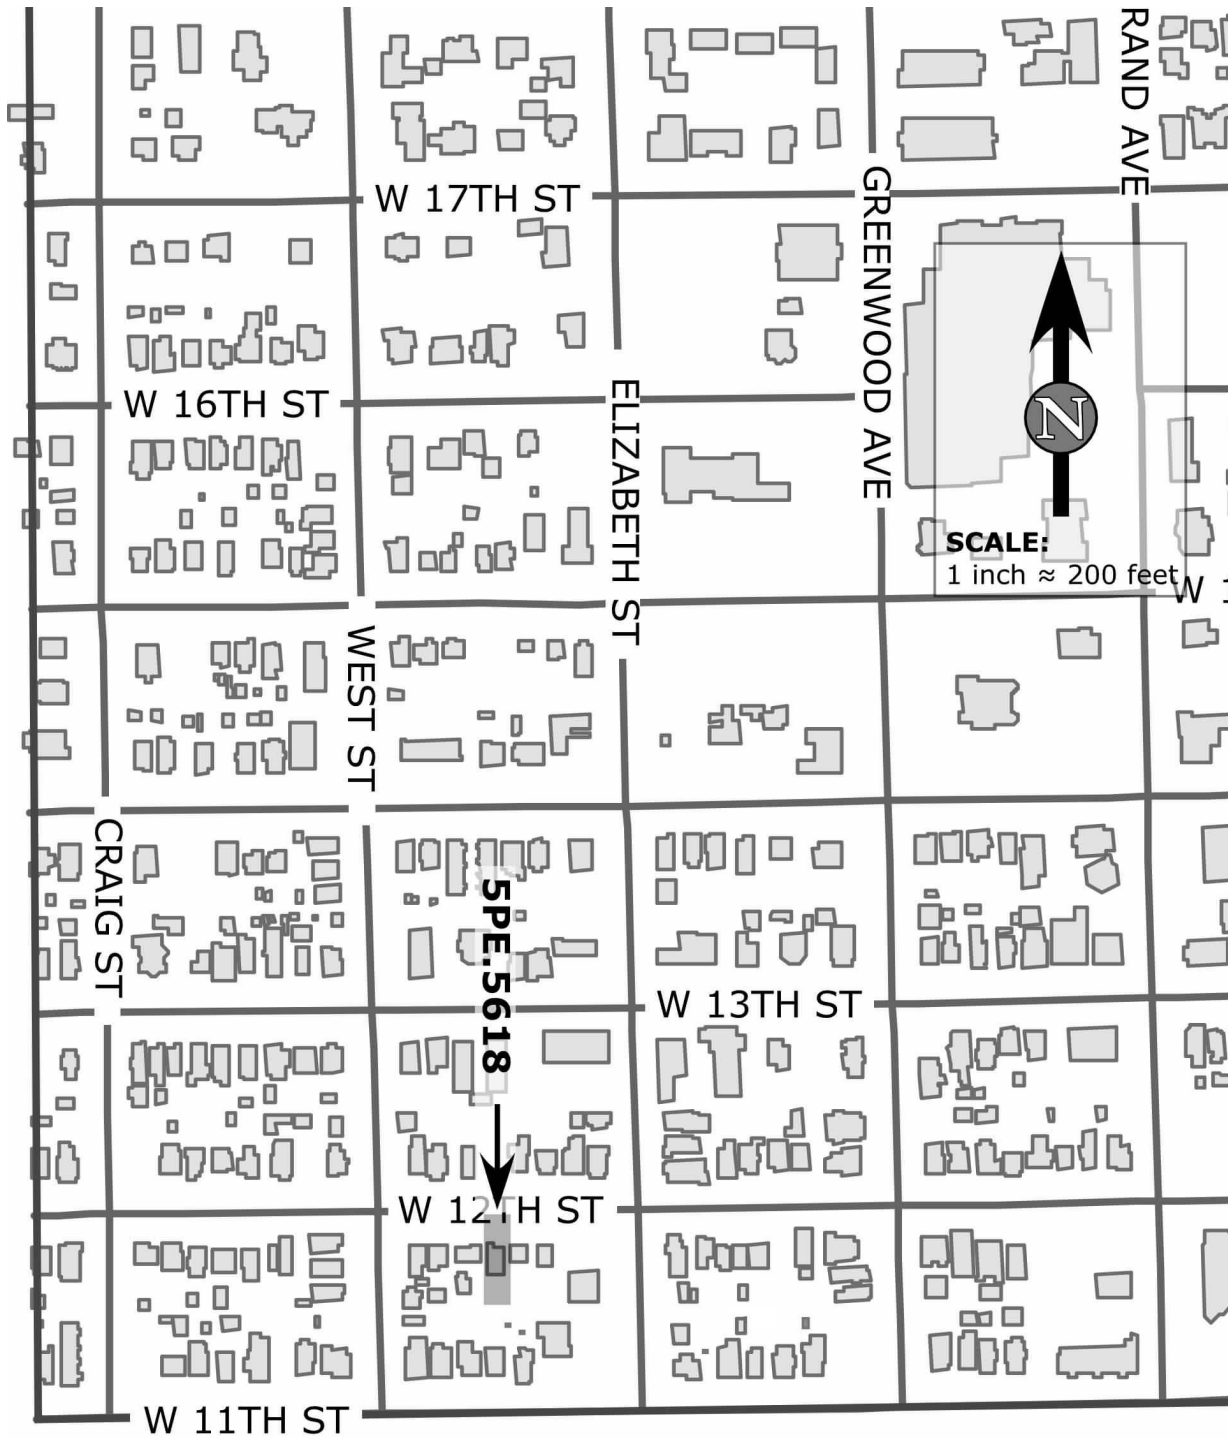
#### SITE SKETCH MAP

**This property is located on terrain sloping downward from north to south, with an elevation of around 4,700 feet above mean sea level. The neighborhood features modest, one- and two-story houses. This property is located on the south side of West 12th Street, an east-west-oriented thoroughfare. It is situated between 612 West 12th Street, to the east, and 618 West 12th Street to the west. A concrete driveway along the east edge of the property connects the street to a parking area off the northeast corner of house. A grass strip separates the sidewalk from the street. Surrounding the house is a planted-grass yard, with mature landscaping. A high, wood privacy fence runs along the south edge of the property while a chain-link fence surrounds the rest of the property.**

Describe: **A shed is located on the southeast corner of the lot. Oriented to the west, the building lacks a formal foundation. Tan-painted sheets of plywood clad the exterior walls. The same material forms the door, which is located south of center in the front (west) elevation. Brown asphalt shingles cover the front-gabled roof, and the rafter ends are exposed but capped by a fascia board.**
