COLORADO CULTURAL RESOURCE SURVEY

Architectural Inventory Form

- 1. Resource number: **5PE.4222** Parcel number(s):
- 2. Temporary resource number: **056** **525311010**
- 3. County: **Pueblo**
- 4. City: **Pueblo**
- 5. Historic building name: **Rude, Joshua R. and Megan R., House**
- 6. Current building name: **Rude, Joshua R. and Megan R., House**
- 7. Building address: **717 W 12th Street**
- 8. Owner name: **Joshua R. and Megan R. Rude**
- Owner organization:
- Owner address: **717 W 12th St**  
**Pueblo, CO 81003**

47. Photograph numbers): **CD-ROM Photo Disc: North Side Photos**  
**File Name(s): 12thstw717**
- Negatives filed at: **Special Collections**  
**Robert Hoag Rawlings Public Library**  
**100 East Abriendo Avenue**  
**Pueblo, CO 81004-4290**
48. Report title: **Pueblo North Side Neighborhood Survey**
49. Date(s): **06/20/05**
50. Recorder(s): **Adam Thomas**
51. Organization: **Historitecture, L.L.C.**
52. Address: **PO Box 419**  
**Estes Park, CO 80517-0419**
53. Phone number(s): **(970) 586-1165**

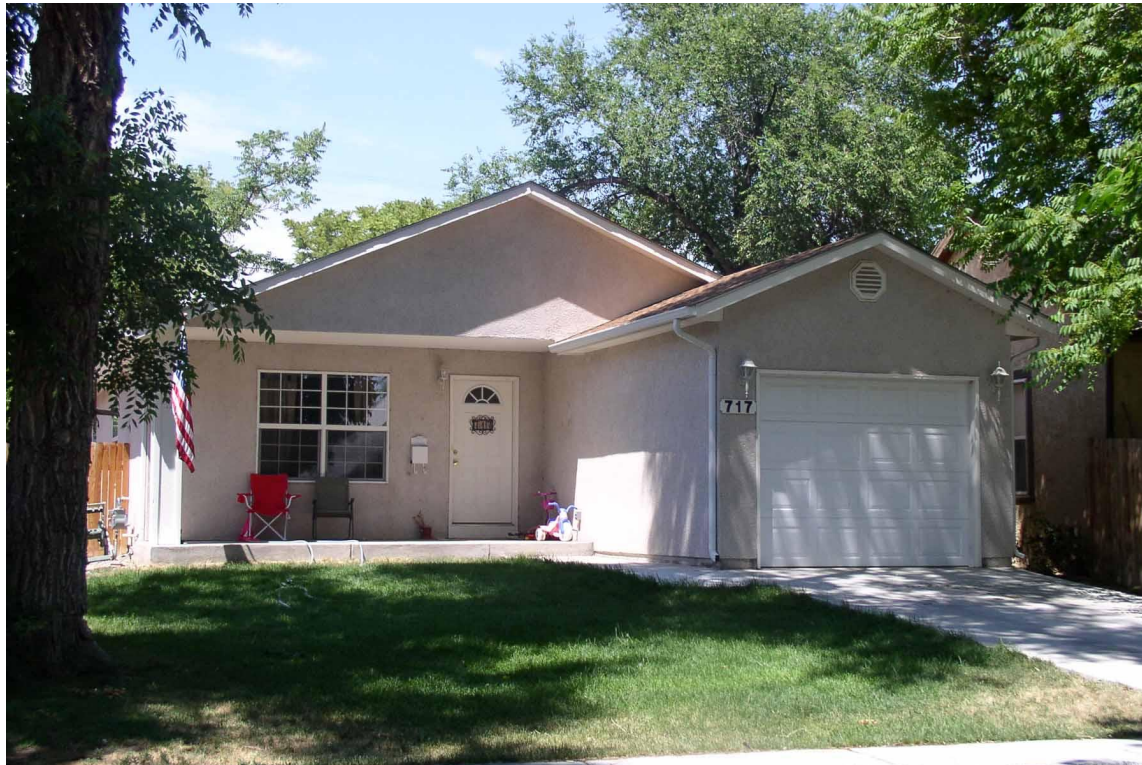
**Porch**
21. General architectural description:  
**Oriented to the south, this house rests on a concrete foundation. Cream stuccos clads the exterior walls. Windows are generally 1-over-1-light, double-hung sash, with white vinyl frames. Paired, 9-over-9-light, double-hung sash windows open in the front (south) façade. An integral porch fills the west half of the asymmetrical façade. It has a single support at its southwest corner. The principal doorway, which opens just west of center, is a white, 4-panel, metal door, with fanlight. A doorway opening in the rear (north) elevation hosts an identical door. An attached garage protrudes from the east half of the façade. A concrete driveway connects it to West 12th Street. The garage door is a white, 16-panel, steel, overhead-retractable door. Brown asphalt shingles cover the front-gabled roof, and white-painted wood soffit and fascia box the eaves.**

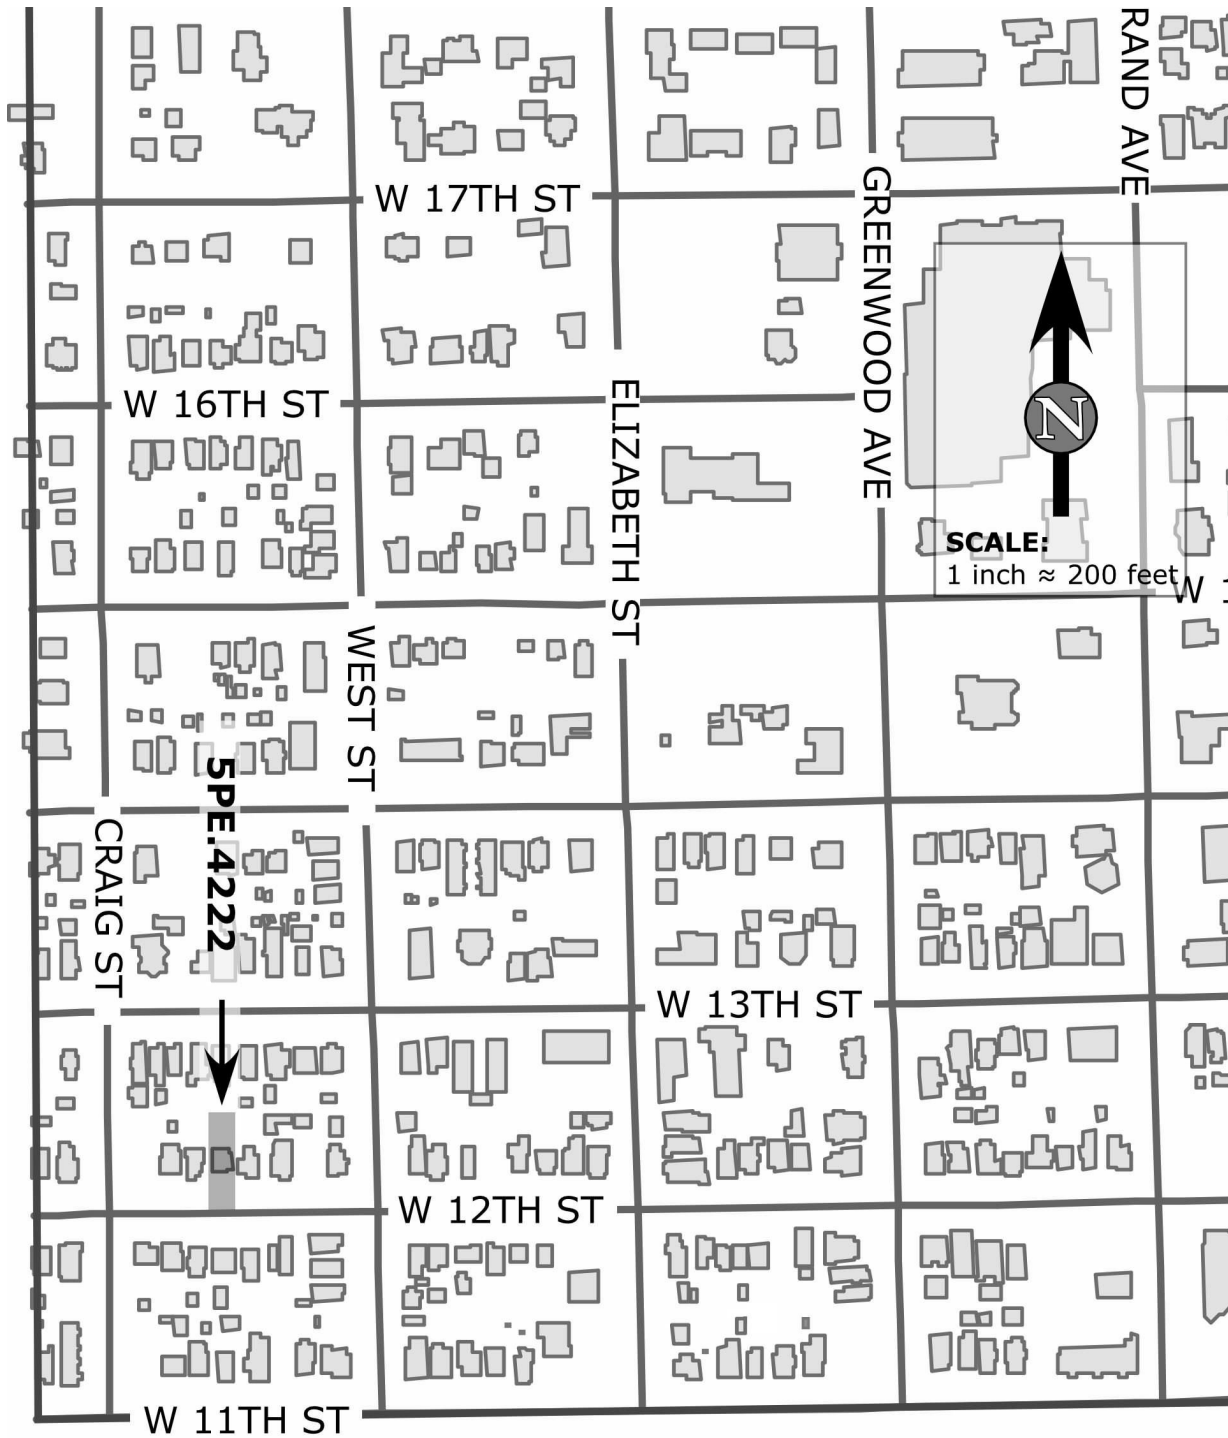
#### SITE SKETCH MAP

This property is located on terrain sloping downward from north to south, with an elevation of around 4,700 feet above mean sea level. The neighborhood features modest, one- and two-story houses. This property is located on the north side of West 12th Street, an east-west-oriented thoroughfare. It is situated between 715 W 12th Street, to the east, and 721 West 12th Street, to the west. A grass strip separates the sidewalk from the street. Surrounding the house is a planted-grass yard, with mature landscaping. A wood privacy fence encloses the backyard.
