COLORADO CULTURAL RESOURCE SURVEY

Architectural Inventory Form

- 1. Resource number: **5PE.5634** Parcel number(s):
- 2. Temporary resource number: **525418015**
- 3. County: **Pueblo**
- 4. City: **Pueblo**
- 5. Historic building name: **Fanning, John J., House**
- 6. Current building name: **408 West 13th Street**
- 7. Building address: **408 W 13th Street**
- 8. Owner name: **Security Service Federal Credit Union**
- Owner organization:
- Owner address: **16211 La Cantera Parkway**
San Antonio, TX 78256

48. Report title: **Pueblo North Side Neighborhood Survey**

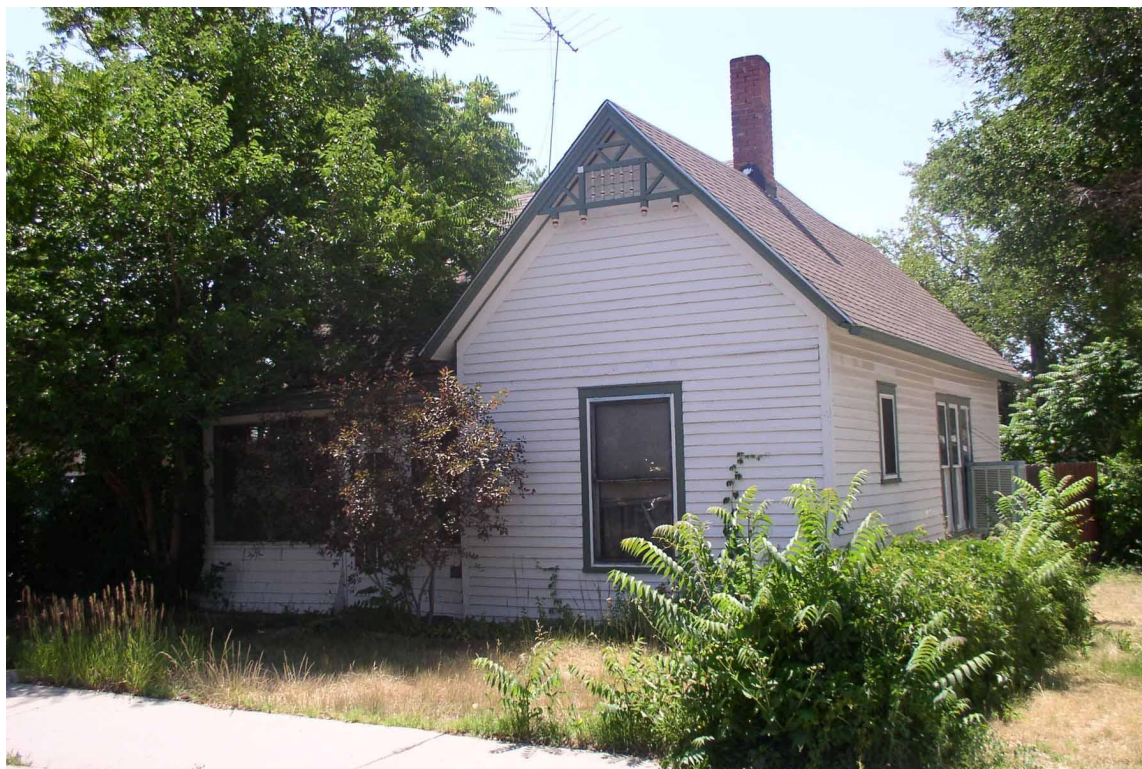
19. Primary external roof material: **Asphalt Roof/Composition Roof**
Other roof materials:
20. Special features: **Fence**
Chimney
Porch
21. General architectural description:
Oriented to the north, this house appears to rest on a concrete sill, most likely installed after construction. White-painted, horizontal wood siding, with narrow cornerboards, clads the exterior walls. Windows are generally 1-over-1-light, double-hung sash, with white-painted wood frames and green-painted wood surrounds. Four-light windows enclose a porch on the southwest corner of the house. A window opening in the south-facing gable has been boarded shut. A shed-roof porch fills the inside (northeast-facing) corner. White-painted, square-cut wood shingles cover the kneewall. Spanning between the kneewalls and the porch's ceiling are wire-mesh screen. A white, aluminum-frame storm door opens near the west end of the porch. Another doorway opens in the south elevation of a shed-roofed structure protruding south of center on the east elevation. Brown-gray asphalt shingles cover the main cross-gabled and porch roofs. White-painted wood soffit and green-painted wood fascia box the eaves. Decorative stickwork, with turned spindles and finials, fills the north-facing gable. A tall, red-brick chimney emerges near the junction of the roof ridges.

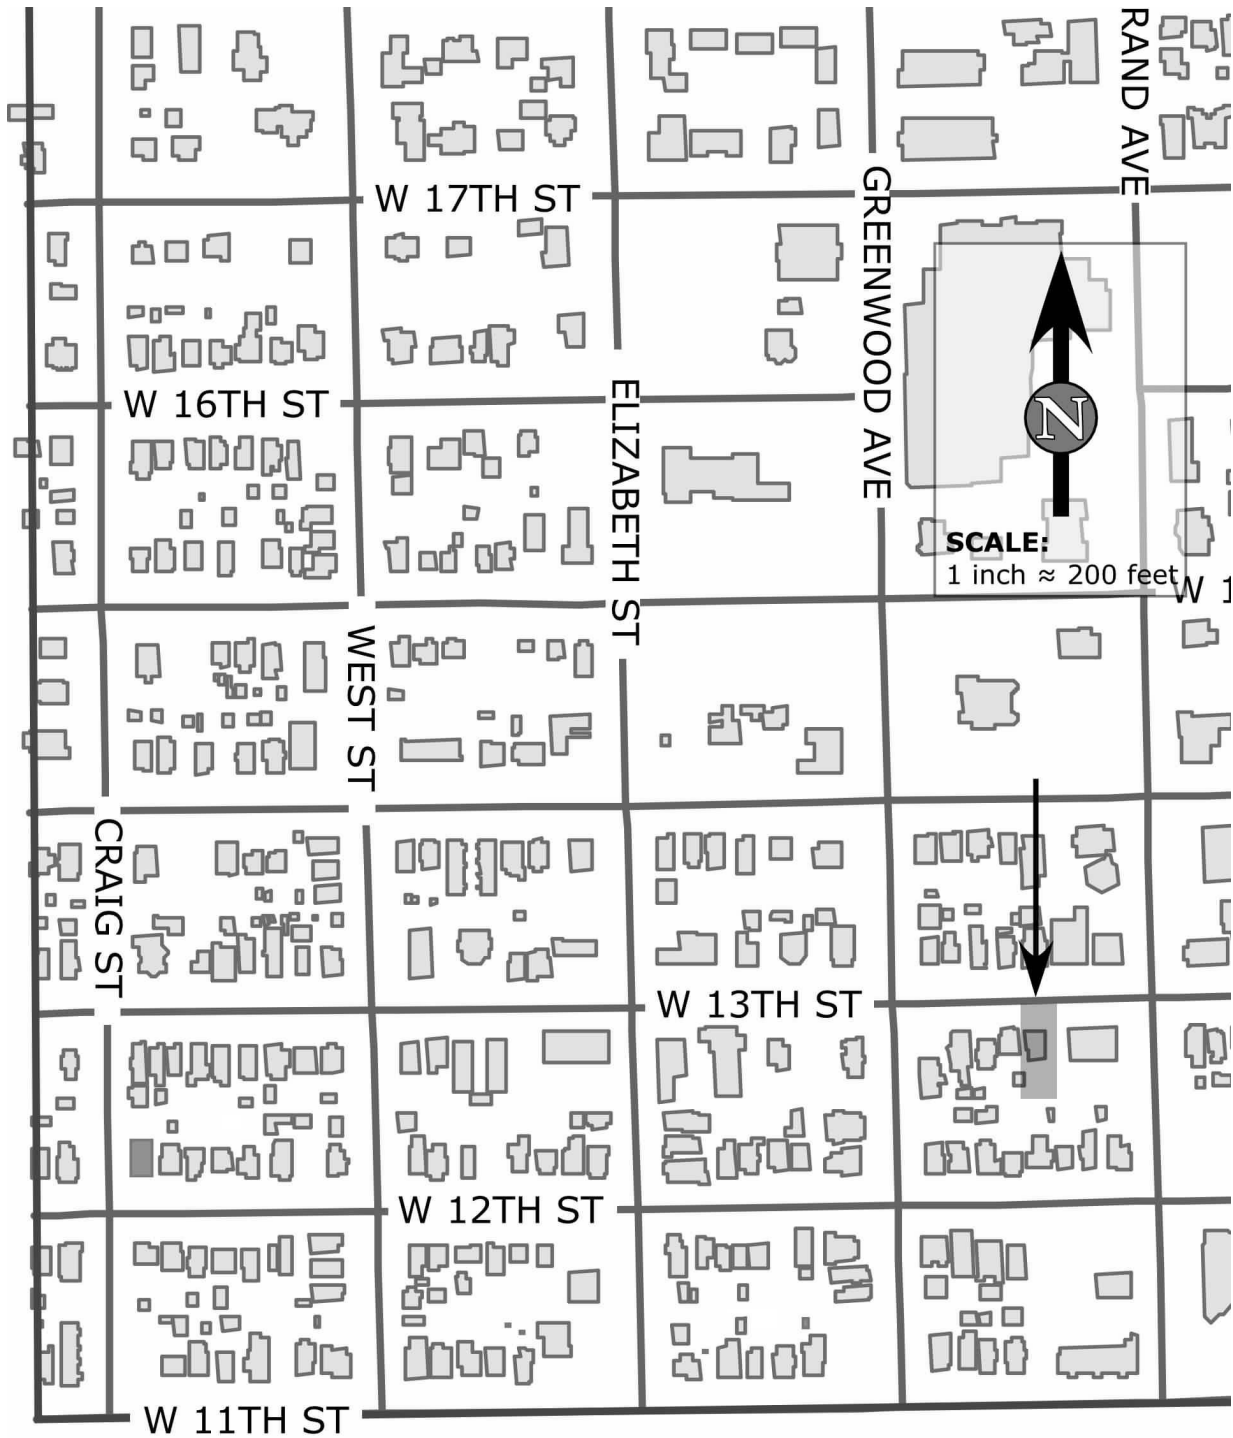
SITE SKETCH MAP

This property is located on terrain sloping downward from north to south, with an elevation of around 4,700 feet above mean sea level. The neighborhood features modest, one- and two-story houses. Most of the houses here have an unusually shallow setback from West 13th Street, the busy, principal east-west thoroughfare through this area. This property is situated on the south side of West 13th Street, between 1221 North Grand Avenue to the east and 410 West 13th Street to the west. A planted-grass yard, with mature landscaping, surrounds the building. Encircling the property is a wood privacy fence. Along the southern edge of the property, along an east-west-oriented alley, is a gravel parking area.

Describe: **A standard kit-built shed is located on the southwest corner of the lot. Oriented to the south, the structure lacks a formal foundation. The walls consist of white-painted sheet metal. Paired, sliding doors of the same description dominate the front (south) elevation. The front-gabled roof also consists of sheet metal.**
