COLORADO CULTURAL RESOURCE SURVEY

Architectural Inventory Form

- 1. Resource number: **5PE.5635** Parcel number(s):
- 2. Temporary resource number: **525411010**
- 3. County: **Pueblo**
- 4. City: **Pueblo**
- 5. Historic building name: **Meigs, Dwight C., House**
- 6. Current building name: **Kilpatrick, Yvonne Kaa, House**
- 7. Building address: **409 W 13th Street**
- 8. Owner name: **Yvonne Kaa Kilpatrick**
- Owner organization:
- Owner address: **409 W 13th St**
Pueblo, CO 81003

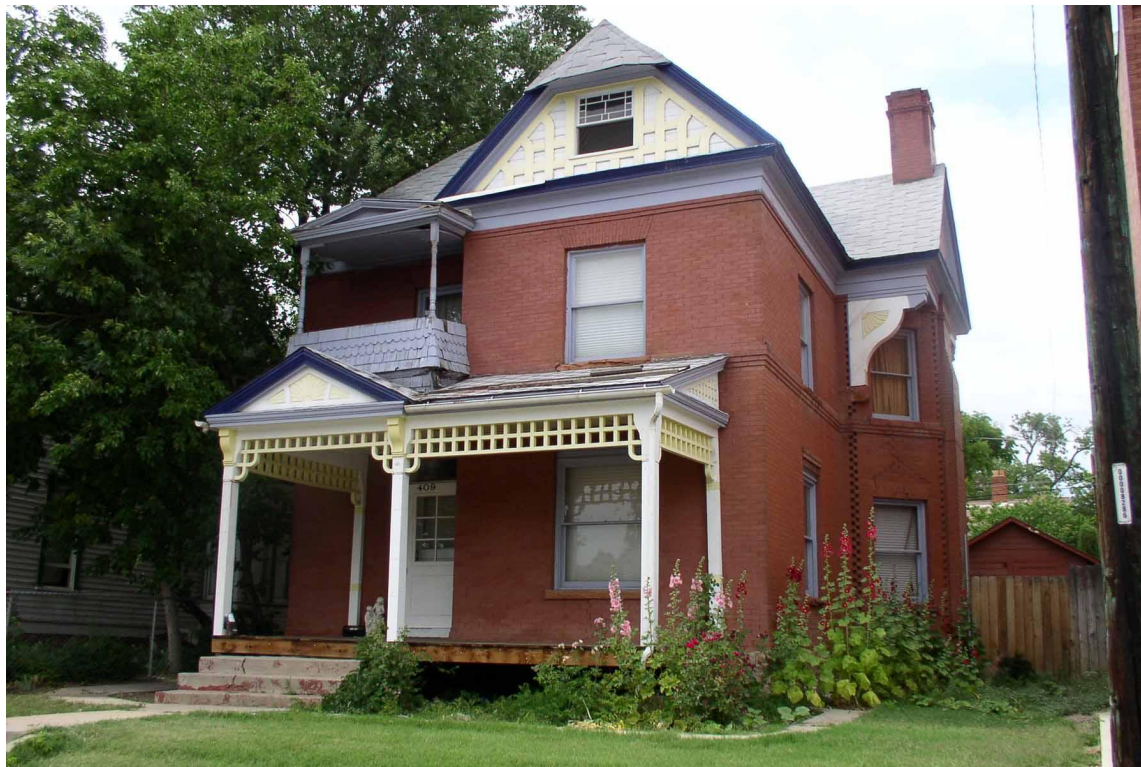
21. General architectural description:
Oriented to the south, this house rests on a buff-colored, rock-faced sandstone foundation arranged as coursed ashlar. A red, pressed-brick veneer, with thin, red mortar, clads the exterior walls. False half-timbering, over horizontal wood siding, covers the south-facing gable. A large, 2-story canted bay protrudes beneath its own gabled roof from near the center of the east elevation. An engaged hearth and chimney consume the easternmost portion of the bay. Covering the gable over the bay are lavender-painted, variegated wood shingles. Enormous brackets, framing a sunburst pattern, rest on hung sandstone ledges and support the gable over the canted portions of the bay. Windows are generally 1-over-1-light, double-hung sash, with lavender-painted wood frames. They generally open between rough-faced, pink sandstone sills and flat arches. Windows in either face of the southeast-facing corner have corbelled cornices above them. A shed-roofed porch spans much of the front (south) façade. It features simple, white-painted, square supports with yellow-painted latticework friezes between them. A pediment protrudes above the porch roof on its western side. A yellow-painted sunburst pattern covers the face of the

pediment. At its bottom corners are heavy, yellow-painted scrolled brackets. Approaching the porch, beneath the pediment, are 3 concrete steps. The principal doorway opens on the west side of the asymmetrical facade. It is a paneled, 1-light, glass-in-wood-frame door, painted white. It opens behind a white-painted, wood-frame storm door. A stained-glass transom is above the door. Another doorway opens above this one, in the second story. It provides access to a small, covered balcony above the porch. This balcony features a smaller pediment on turned, lavender-painted supports. It has a kneewall covered in variegated, purple-painted wood shingles. An integral porch within the northwest corner has been enclosed with white, horizontal, wooden composition siding. A 3-panel, 4-light, glass-in-wood-frame door opens on the porch's north elevation. An identical door opens on the east end of the rear (north) elevation. Gray, interlocking asphalt shingles cover the main, gable-on-hip roof and all other porch roofs. Lavender-painted wood soffit and purple-painted wood fascia, with projecting cornice, box the eaves.
