COLORADO CULTURAL RESOURCE SURVEY

Architectural Inventory Form

- 1. Resource number: **5PE.5638** Parcel number(s):
- 2. Temporary resource number: **525418004**
- 3. County: **Pueblo**
- 4. City: **Pueblo**
- 5. Historic building name: **Bergerman, Solomon, House**
- 6. Current building name: **Serna, Yolanda Alise Espinoza, House**
- 7. Building address: **412 W 13th Street**
- 8. Owner name: **Yolanda Alise Espinoza Serna**
- Owner organization:
- Owner address: **412 W 13th St**  
**Pueblo, CO 81003**

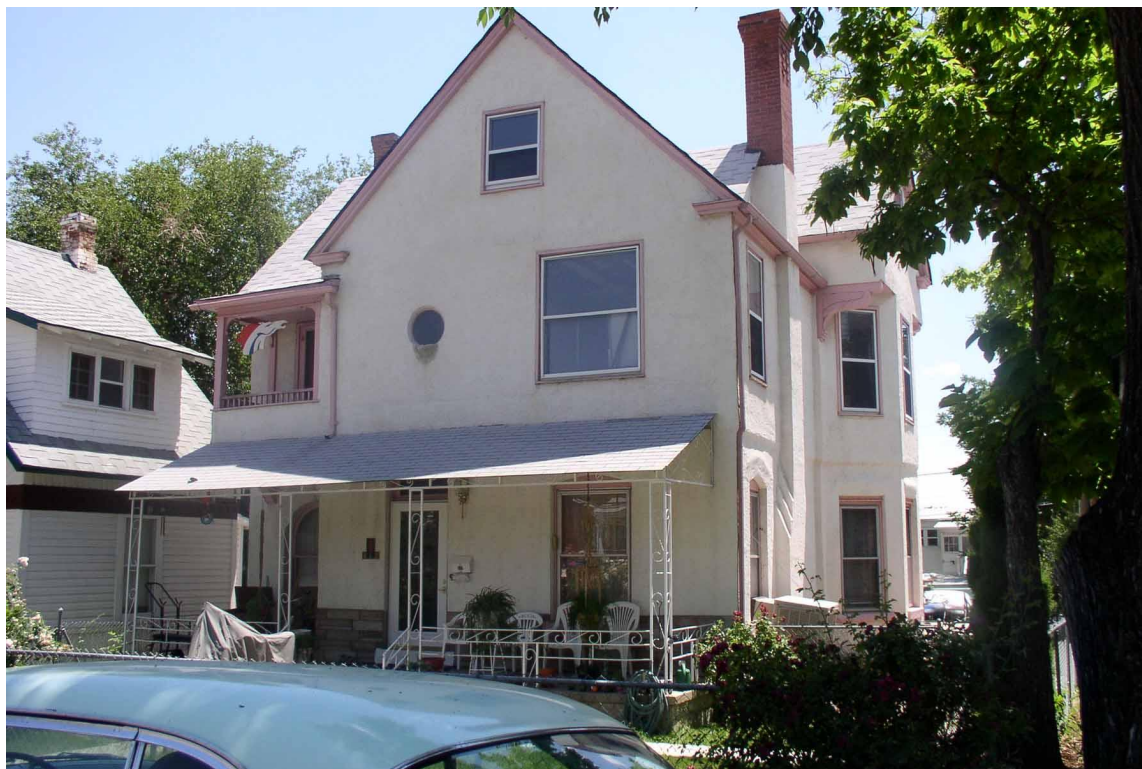
21. General architectural description:  
**Oriented to the north, this house rests on a sandstone foundation, largely concealed behind concrete. Cream-painted stucco clads the exterior walls. A faux stone veneer covers the bottom 3 feet of the front (north) facade. Windows are 1-over-1-light, double-hung sash. Most have white aluminum frames and storm windows. All have narrow, pink-painted wood frames. Many have pink-painted, rough-faced sandstone sills and a few open beneath segmental arches. The window piercing the east end of the façade's first story has a round-arch transom. This particular window has pink-painted wood frames. A single-light, round window opens directly above the principal doorway, in the second story. Some kind of cantilevered pedestal or basin projects from the wall below the window. A 2-story, 3-sided, canted bay protrudes from near the center of the west elevation. It is protected beneath its own gable. Large, scrolled brackets support the gable of the canted corners of the bay. A shed-roofed porch spans the entire façade. It has a concrete floor, and white, wrought-iron railings and supports. Approaching the center of the porch are 2 concrete steps. The principal doorway opens east of center in the façade. It hosts a paneled, 1-light, glass-in-wood-frame door, opening behind a white, aluminum-frame storm door. A single-light transom is above the door. A small balcony, protected beneath a shed roof, fills the inside (northeast-facing) corner. Supporting the structure along its east side is**

a massive, scrolled bracket. The balcony features pink-painted, square, wood supports and balustrade. A doorway opens onto the balcony. It hosts a paneled, 1-light, glass-in-wood-frame door, with a transom above it. Another doorway opens in the south end of the west elevation, providing access to an uncovered porch or patio. A short and narrow doorway opens in the south-facing gable. It hosts a two-light, white-painted door, behind an aluminum-frame storm door. A sidelight is east of the doorway, which provides access to a small, steel balcony. Gray, interlocking asphalt shingles cover the cross-gabled roof. Pink-painted wood fascia and soffit box the shallowly overhanging eaves and the gables have eave returns. A corbelled, red-brick chimney protrudes above the east-facing gable, while another is above the south-facing gable. A more elaborate chimney protrudes near the northwest corner of the house.
