COLORADO CULTURAL RESOURCE SURVEY

Architectural Inventory Form

- 1. Resource number: **5PE.5642** Parcel number(s):
- 2. Temporary resource number: **525411007**
- 3. County: **Pueblo**
- 4. City: **Pueblo**
- 5. Historic building name: **Townsend, Samuel W., House**
- 6. Current building name: **Parkview Family Counseling Center**
- 7. Building address: **417 W 13th Street**
- 8. Owner name: **Parkwood, LLC**
- Owner organization:
- Owner address: **417 W 13th St**
- Pueblo, CO 81003**

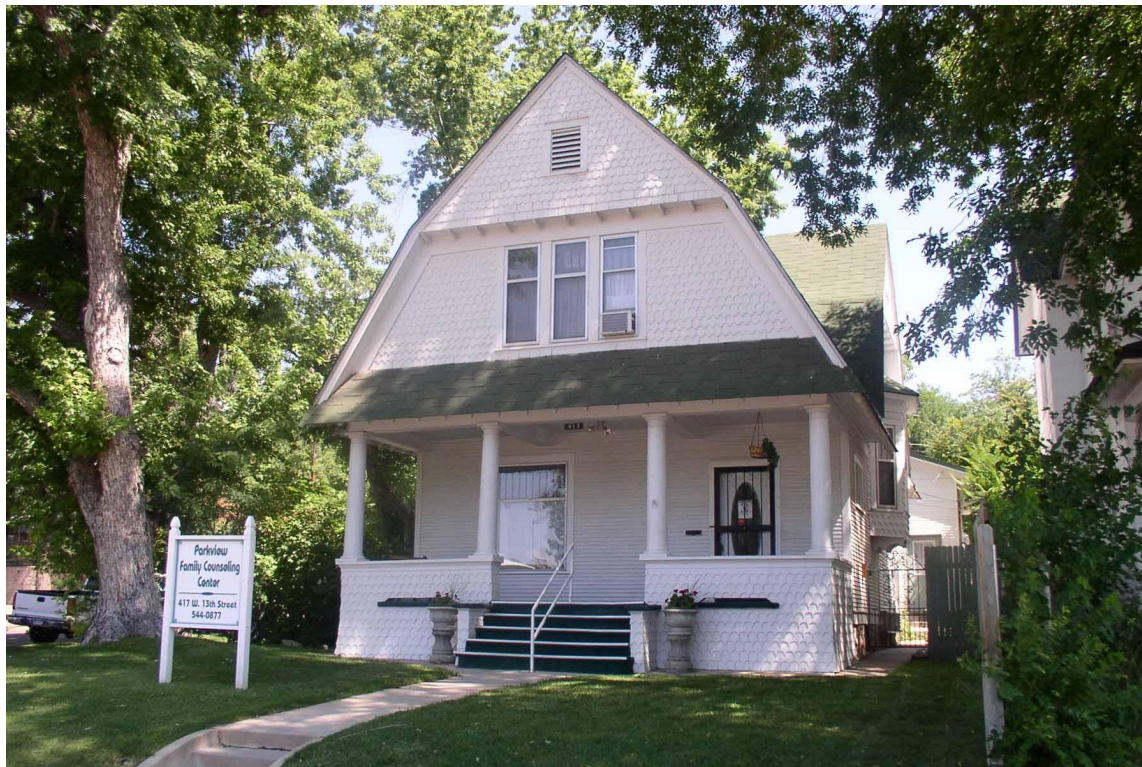
21. General architectural description:  
**Oriented to the south, this house rests on a buff-colored, rock-faced sandstone foundation arranged as coursed ashlar, with raised mortar. Narrow, white-painted, horizontal wood siding, with 1-by-4-inch cornerboards, clads the exterior walls. Variegated wood shingles, also painted white, cover porch kneewalls, bay and bow windows, and the face of the gambrels. Windows are generally double-hung sash, with green-painted wood frames, aluminum-frame storm windows, and white-painted wood surrounds. They have narrower upper sashes featuring cottage-style glazing. A 3-sided, canted bow window protrudes near the center of the east elevation's first story. It rests on heavy, scrolled brackets. A similar bay window protrudes from the west elevation's first floor, south of center. East of this window is a rectangular bow window. Double-hung sash windows always appear in sets of 3 in the second story. A hopper or awning window pierces the south end of the east elevation's first floor. Hopper, awning or casement windows open in either end of the rear (north) elevation's second story. An integral porch spans the entire front (south) façade. It features a shingle-covered kneewall and white-painted Doric columns, constructed of wood. These columns support corresponding beams, which create a coffered effect across the porch's ceiling. Approaching the porch at its center are 4 concrete steps, covered in dark green carpet. A white-painted, metal railing runs down the center of the steps. The principal doorway opens in the east side of the otherwise symmetrical façade. It hosts a single-light, glass-in-**

wood-frame door, with an oval-shaped light, opening behind a black, security storm door. A doorway opens in the center of the rear (north) elevation. A concrete step approaches the doorway. It provides access to a concrete patio connecting this house to the office behind (north of) it. A green, canvas awning protects the walkway. Green, interlocking asphalt shingles cover the cross-gambrelled main roof and the pent roof between the first and second stories. White-painted wood fascia and soffit box the eaves. However, shaped rafter ends appear beneath the pent roof. Shaped brackets appear beneath the jetties at the top of the gambrels. A red-brick chimney emerges at the junction of the roof ridges.

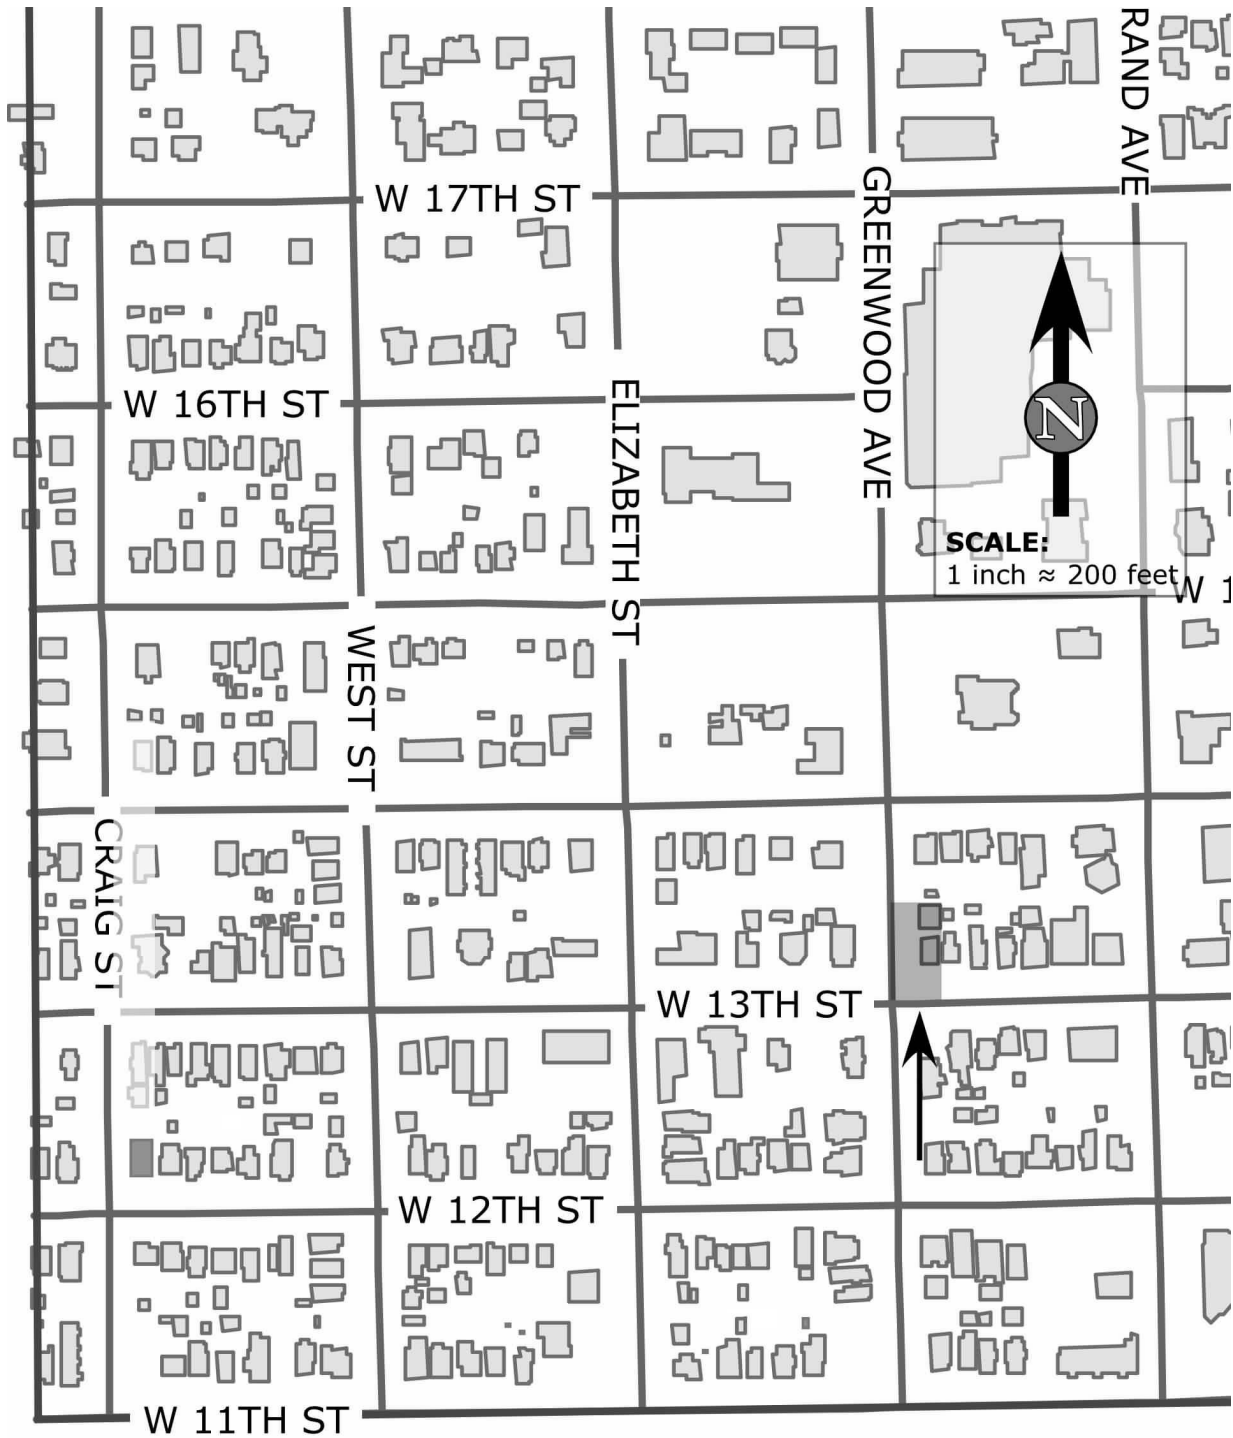
SITE SKETCH MAP

**This property is located on terrain sloping downward from north to south, with an elevation of around 4,700 feet above mean sea level. The neighborhood features modest, one- and two-story houses. Most of the houses here have an unusually shallow setback from West 13th Street, the busy, principal east-west thoroughfare through this area. This property is situated on the northeast corner of West 13th and North Greenwood streets. A planted-grass yard, with mature landscaping, surrounds the house, while shady elm and maple trees line the streets. A wood privacy fence, tinted green, encircles the backyard. A concrete parking area is located at the northwest corner of the property.**
