COLORADO CULTURAL RESOURCE SURVEY

Architectural Inventory Form

- 1. Resource number: **5PE.5646**
- 2. Temporary resource number: **077**
- 3. County: **Pueblo**
- 4. City: **Pueblo**
- 5. Historic building name: **Central Assembly of God Church**
- 6. Current building name: **Salvation Army Community Center**
- 7. Building address: **520 W 13th Street**
- 8. Owner name: **Salvation Army**
- Owner organization:
- Owner address: **119 W 6th Ave**
Pueblo, CO 81003

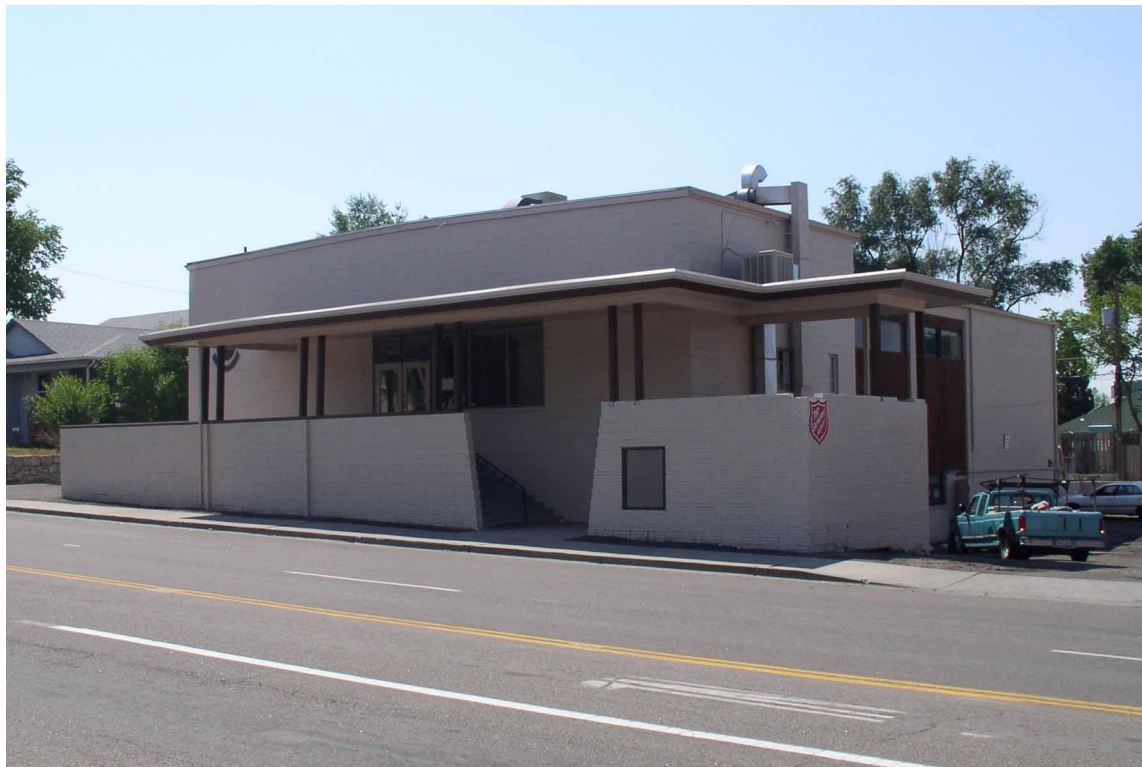
Oriented to the north, this building rests on a high, cream-painted concrete foundation. Basement windows, which appear in bands, are frosted, single-light fixed frame. A deep concrete-block well lines the windows on the east elevation. Because of the slope of the lot, descending east to west, the west elevation of the basement is entirely exposed. Cream-painted concrete blocks comprise the walls. The rest of the windows along the side elevations open at the second story level and are frosted, single-light fixed frame. Between these windows and the basement windows are spandrels of brown-painted, vertical wood siding. There are three bays per side. Windows on the north ends of the east and west elevations are 3-light casement, with cream-painted steel frames. Dominating the front (north) façade are large, plate-glass windows. A flat-roofed porch spans most of the façade and extends outward to the west. The porch consists of a high, ornamental concrete-block wall. Anchored to the wall are paired, brown-painted porch supports, which are 4-by-8-inch boards. The principal doorway opens east of center in the façade, beneath the porch. Concrete steps approach it from the west and a concrete ramp from the east. The doors are paired, plate-glass, in tan-painted steel frames. A 2-light, plate-glass transom is above them. All other doorways host tan-painted, metal slab doors. They open in the north and south ends of the east elevation, and south of center in the west elevation, providing direct access into the basement. A tan-painted, wood slab door opens in the second story of the north face of the southeast-facing, inside corner. It provides access to a steel staircase. A large, 2-piece, bronze plaque, depicting the seal of the Salvation Army, is attached to the east end of the façade. A rubber membrane roof covers the flat, which a parapet lines at its north end. The porch roof has broadly overhanging, canted eaves.
