COLORADO CULTURAL RESOURCE SURVEY

Architectural Inventory Form

I. IDENTIFICATION

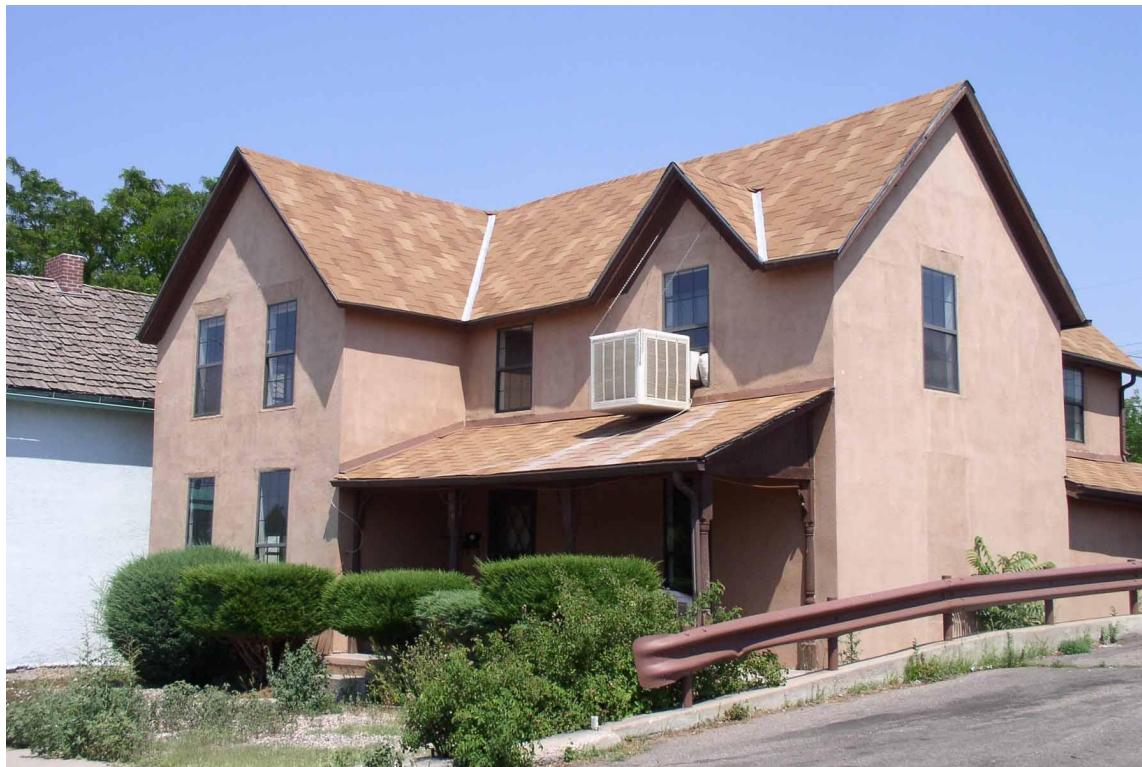
21. General architectural description:
Oriented to the south, this house rests on a sandstone foundation, covered in brown-painted stucco. The same stucco clads the exterior walls. Windows are 9-over-6-light in the first story and 6-over-6-light in the second story, single-hung sash, with brown, aluminum frames. The easternmost window opening in the front (south) façade's second story appears within a front-gabled wall dormer. A 1-beside-1-light, sliding-sash window opens near the center of the east elevation's second story. A shed-roof porch spans the entire inside (southeast-facing) corner. It has a concrete floor and brown-painted, turned supports, with scrolled brackets. A single concrete step approaches the porch on the west end of its south elevation. The principal doorway opens near the center of the asymmetrical façade. It hosts a brown-painted metal door, with a single light. This light has diamond-shaped glazing. The door opens behind a brown, aluminum-frame storm door. A small, shed-roof porch protrudes from the center of the rear (north) elevation. It has a concrete floor and square, wood supports. It provides access to another doorway, which hosts a brown-painted, wood slab door, opening behind a brown, aluminum-frame storm door. Another doorway opens in the second story of the west end of the rear elevation. It hosts a brown-painted wood slab door, providing access to an uncovered balcony. Surrounding the balcony is a simple, wood balustrade. Brown, interlocking asphalt shingles cover the cross-gabled roof, and the eaves are boxed with brown-painted wood fascia and soffit. A red-brick chimney emerges

from the junction of the east-west and easternmost north-south roof ridges.
