COLORADO CULTURAL RESOURCE SURVEY

Architectural Inventory Form

- 1. Resource number: **5PE.5654**
- 2. Temporary resource number:
- 3. County: **Pueblo**
- 4. City: **Pueblo**
- 5. Historic building name: **Lusk, Jack P., Duplex**
- 6. Current building name: **Pope, Anthony, Duplex**
- 7. Building address: **706 W 13th Street**
- 8. Owner name: **Anthony H. Pope**
- Owner organization:
- Owner address: **310 Garfield St  
Pueblo, CO 81004**

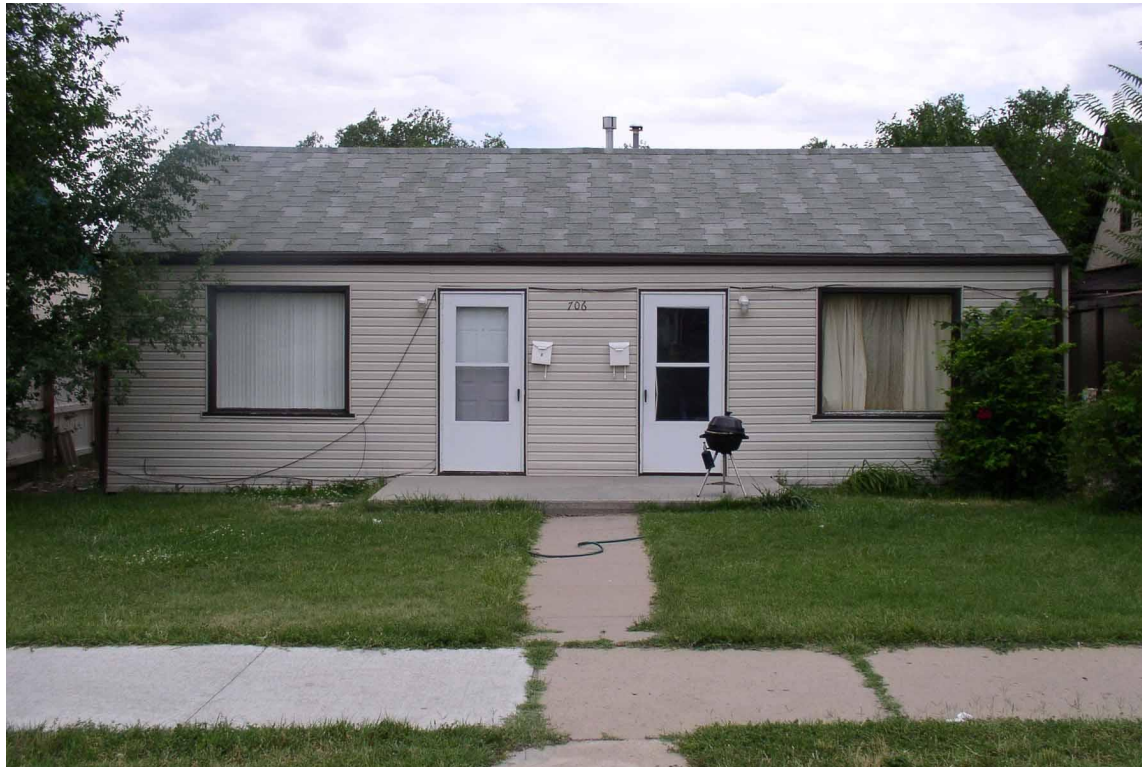
19. Primary external roof material: **Asphalt Roof**  
Other roof materials:
20. Special features: **Fence**
21. General architectural description:  
**Oriented to the north, this duplex rests on a concrete foundation. Tan vinyl siding clads the exterior walls. Windows are generally 2 (horizontal)-over-2 (horizontal), double-hung sash, with brown-painted wood frames and thin, brown-painted wood surrounds. Either end of the front (north) elevation hosts single-light picture windows. Two doorways open in the center of the symmetrical façade. They both host 6-panel, white-painted metal doors, opening behind white, aluminum-frame storm doors. Approaching the doors is a single-step concrete stoop. Doorways also open in the south sides of the east and west elevations. Both host the same doors and storm doors as in the façade. Green, interlocking asphalt shingles cover the side-gabled roof, and the house lacks overhanging eaves.**

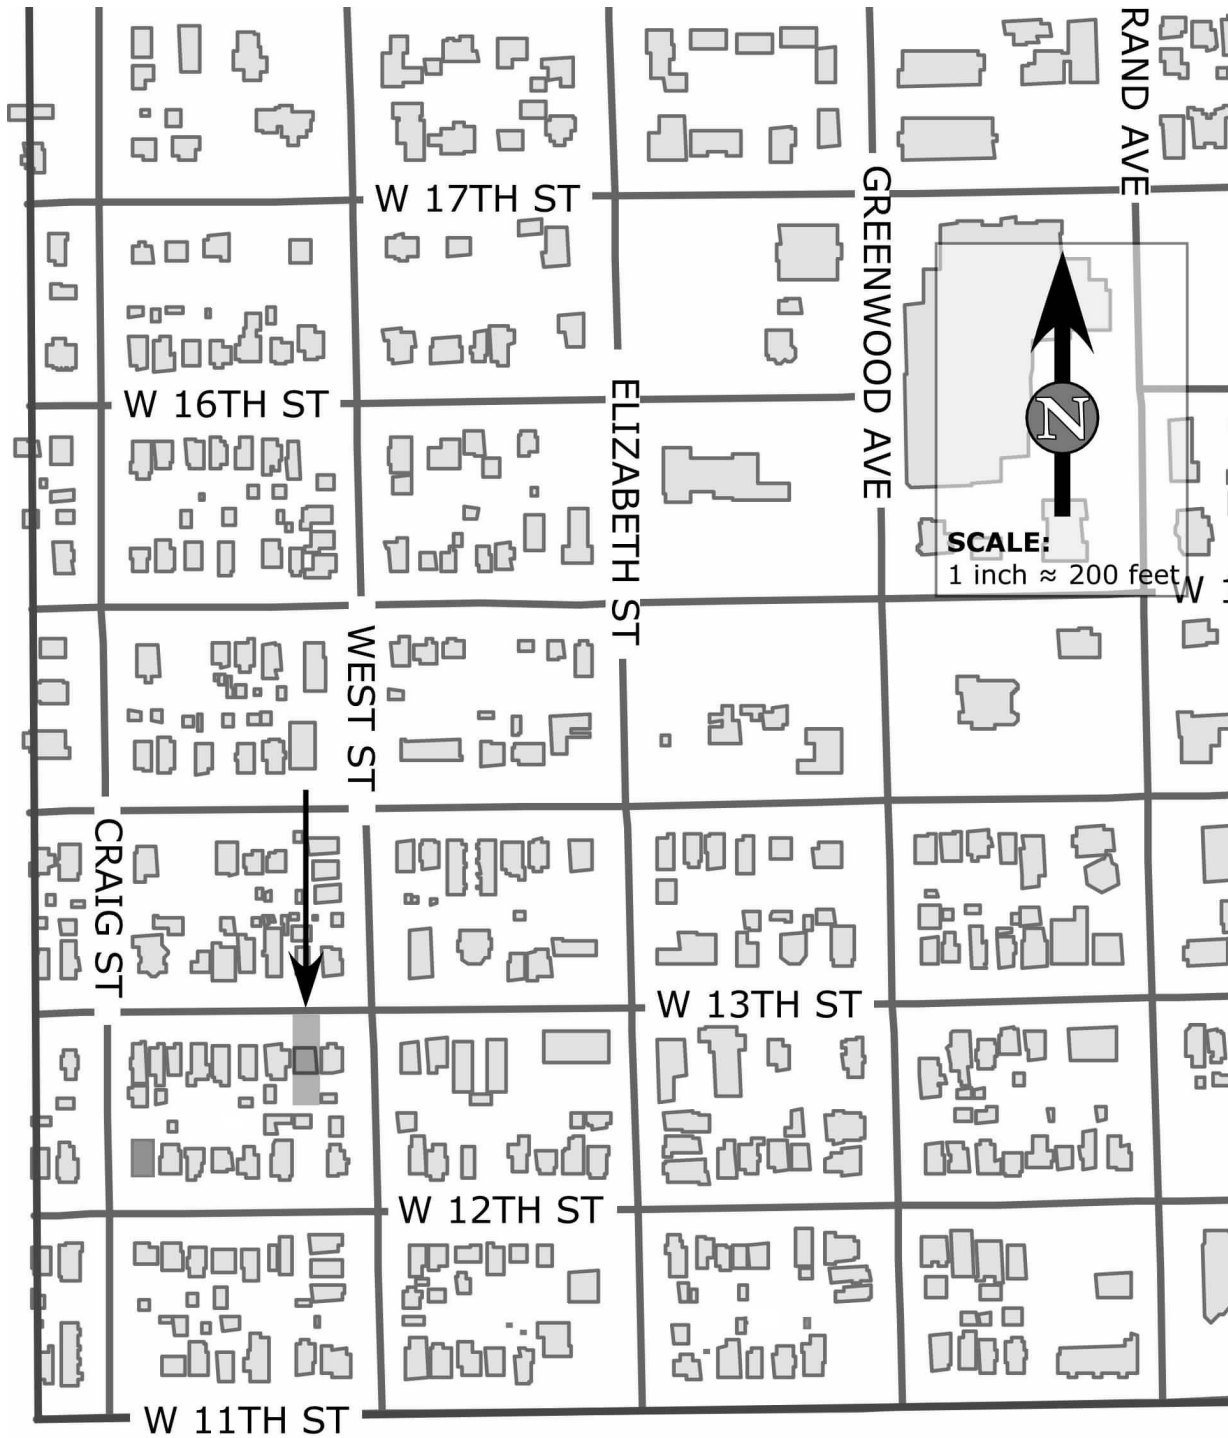
SITE SKETCH MAP

**Grass covers the strip separating the sidewalk from the street. A planted-grass yard, with mature landscaping, covers the northern portion of the lot. A gravel parking area dominates the back yard. A wood privacy fence delimits the east side of the property while a chain-link fence lines the west side.**
