COLORADO CULTURAL RESOURCE SURVEY

Architectural Inventory Form

- 1. Resource number: **5PE.5661** Parcel number(s):
- 2. Temporary resource number: **092** **525310006**
- 3. County: **Pueblo**
- 4. City: **Pueblo**
- 5. Historic building name: **McKenna-Smith House**
- 6. Current building name: **Riekena, Roger A. and Mary L., House**
- 7. Building address: **719 W 13th Street**
- 8. Owner name: **Roger A. and Mary L. Riekena**
- Owner organization:
- Owner address: **544 Starlite Dr.**
Pueblo, CO 81005

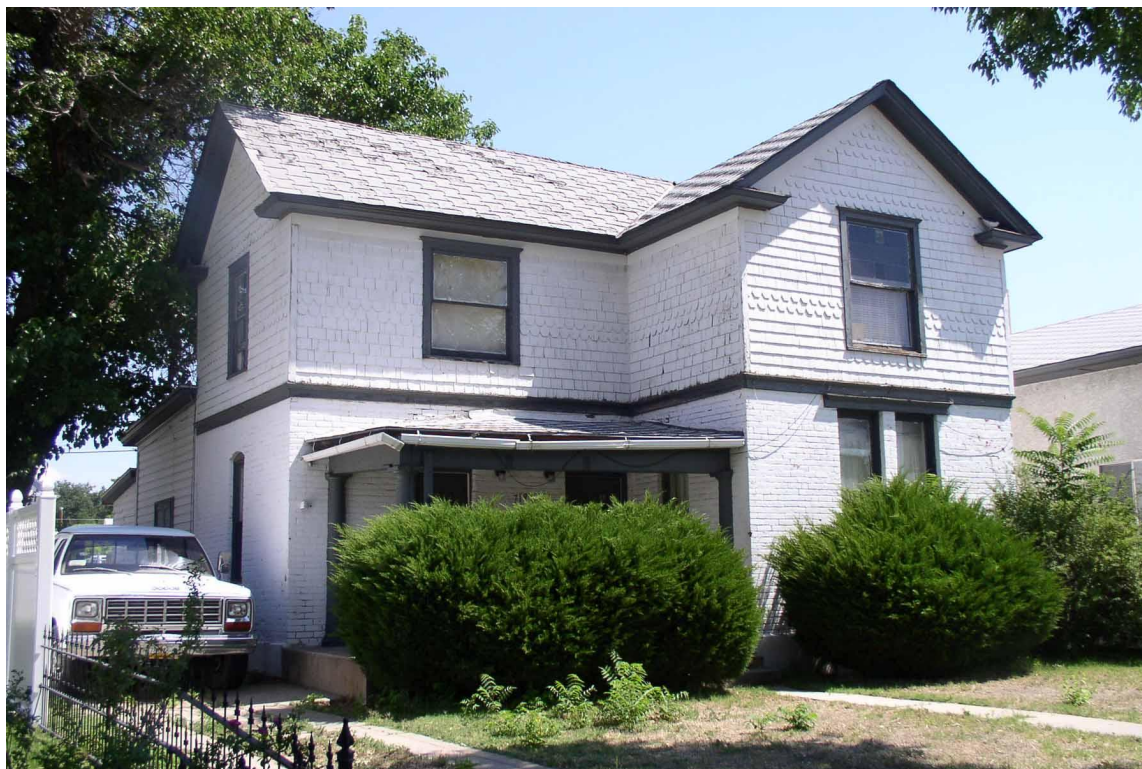
21. General architectural description:
Oriented to the south, this house rests on a sandstone foundation, encased in concrete. Most of the first story of this house consist of brick, painted white. White-painted, variagated wood shingle siding clads the exterior walls of the second story. White-painted, wood weatherboard covers single-story, shed-roofed additions to the north (rear) elevation. Windows are generally 1-over-1-light, double-hung sash, with blue-painted wood frames. Those opening in brick portions of the house have white-painted, rough-faced sandstone sills. Most open beneath segmental arches. However, a pair of windows opening in the east side of the front (south) facade's first story open beneath a common wood entablature, with projecting cornice. Windows opening in the frame portions of the house have blue-painted wood surrounds, with projecting cornices. Opening in the rear elevation and in the north end of the west elevation are 1-beside-1-light, n sliding-sash windows, with aluminum frames. A hipped-roof porch fills the inside (southwest-facing) gable. It has a concrete floor and blue-painted Doric columns and engaged columns. Two concrete steps approach the porch on its east side. Opening beneath the porch roof are a pair of doorways, providing access to both of the house's two apartments. Both doorways host 10-paneld, blue-painted metal doors. Another doorway opens in the east end of the rear (north) elevation. It is sheltd beneath a shed-roofed structure of simple, wood supports, plywood walls, and a corrugated metal roof. Gray, interlocking asphalt shingles cover the cross-gabled roof. Blue-painted wood soffit and fascia, with projecting cornice, boxes the eaves. Framing the gables are eave returns.

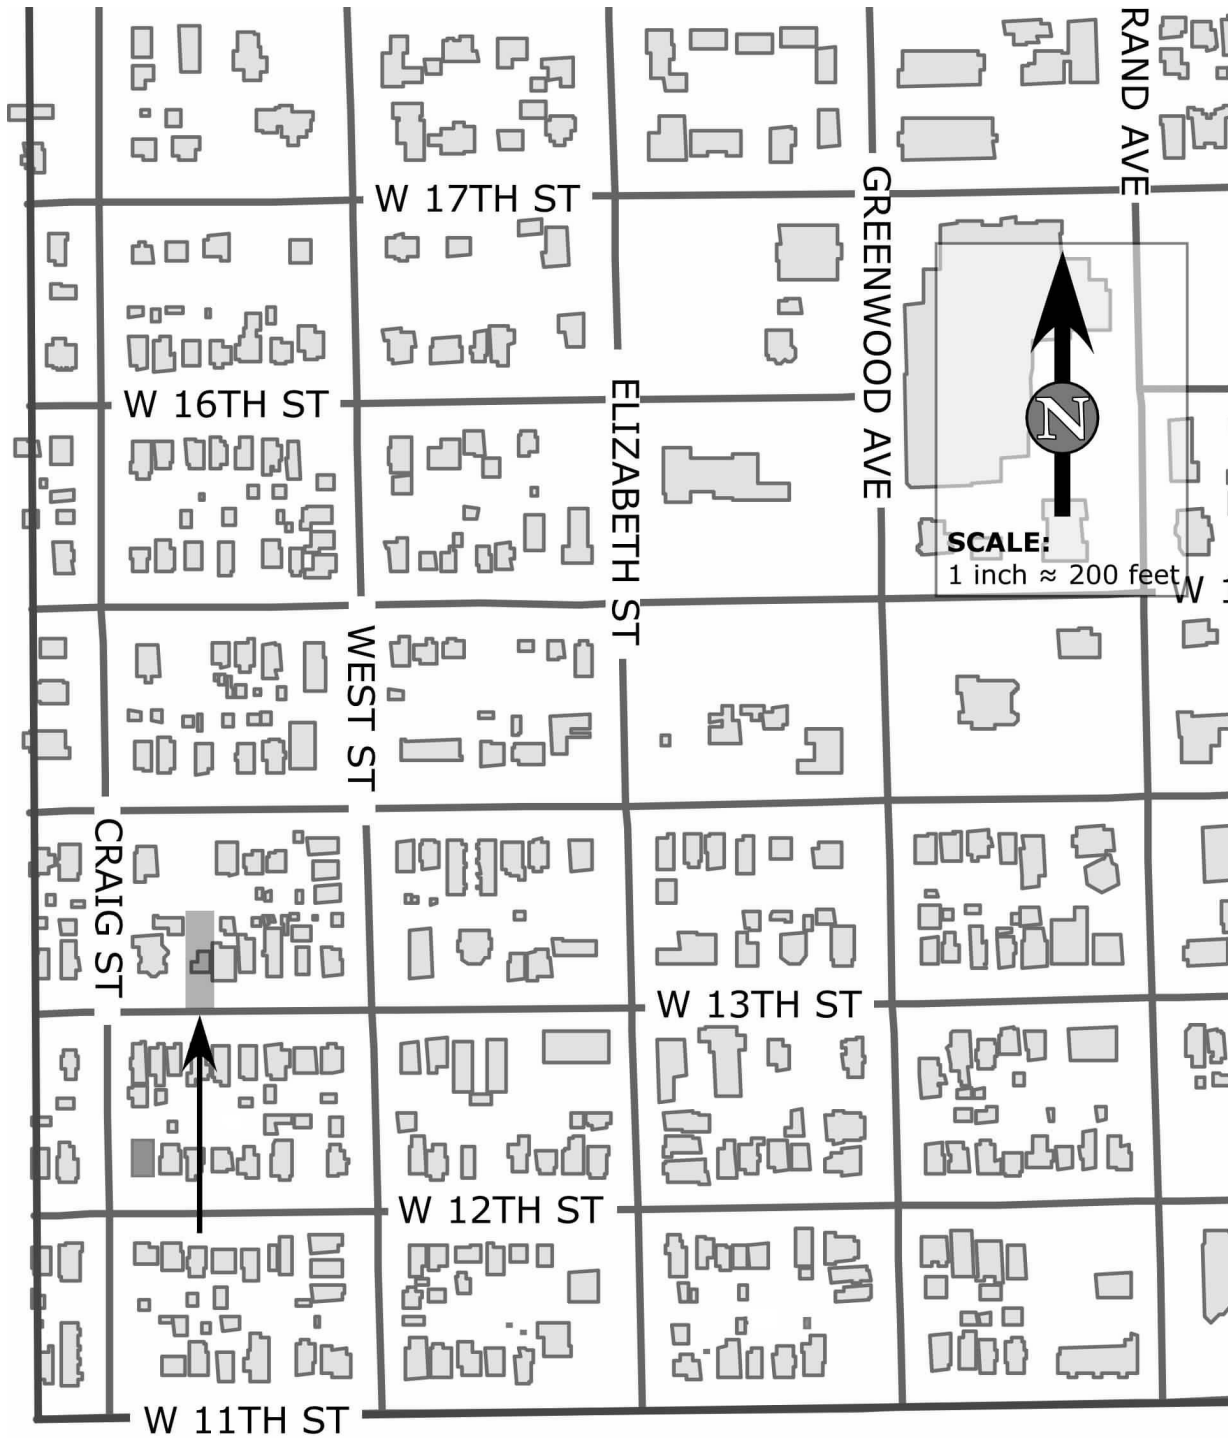
SITE SKETCH MAP

This property is located on terrain sloping downward from north to south, with an elevation of around 4,700 feet above mean sea level. The neighborhood features modest, one- and two-story houses and commercial buildings. Setbacks from West 13th Street, the busy, principal east-west thoroughfare through this area, are generally the same on this block. This property is situated on the north side of West 13th Street, between 715 West 13th Street to the east and 727 West 13th Street to the west. Grass covers the strip separating the pink sandstone sidewalk from the street. A planted-grass yard, with mature landscaping, covers the property. Running along the west side of the lot is a concrete 2-track driveway. A wood privacy fence encircles the backyard.
