COLORADO CULTURAL RESOURCE SURVEY

Architectural Inventory Form

- 1. Resource number: **5PE.517.39** Parcel number(s):
- 2. Temporary resource number: **525311006**
- 3. County: **Pueblo**
- 4. City: **Pueblo**
- 5. Historic building name: **Barber, Thomas, House**
- 6. Current building name: **Sutton-Heffel House**
- 7. Building address: **726 W 13th Street**
- 8. Owner name: **Frank S. Sutton and Sharon L. Heffel**
- Owner organization:
- Owner address: **726 W 13th St.**
- Pueblo, CO 81003**

48. Report title: Pueblo North Side Neighborhood Survey

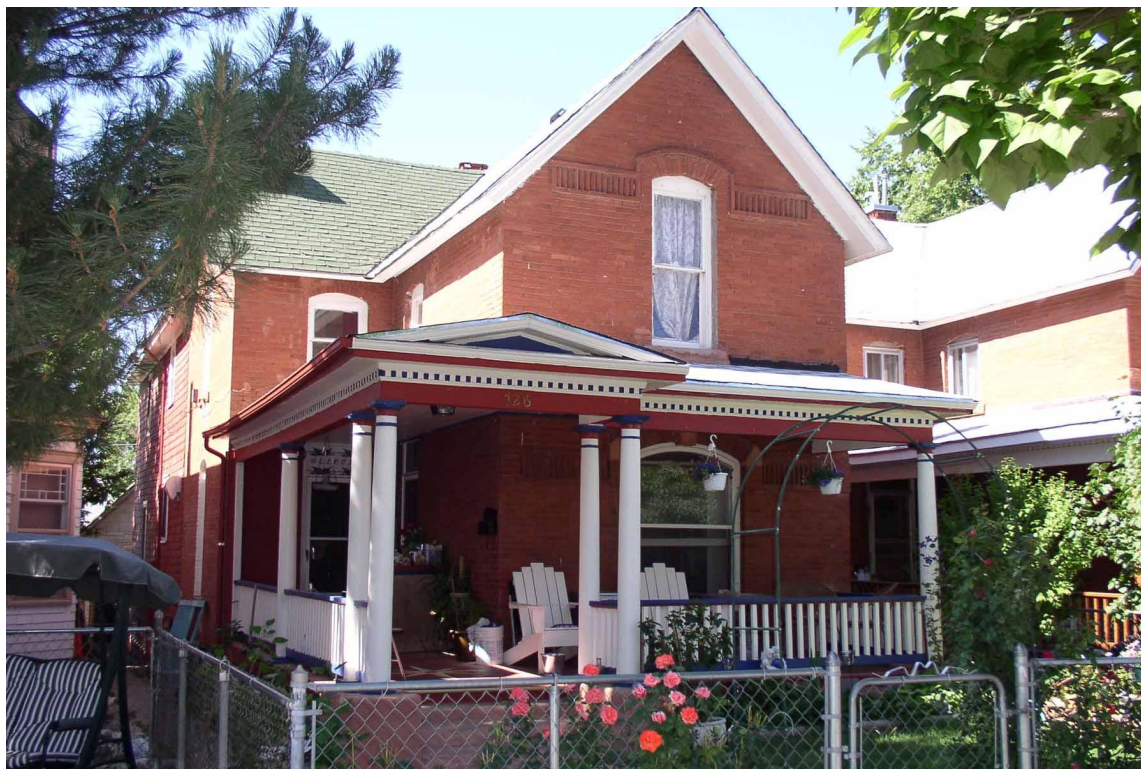
21. General architectural description:
Oriented to the north, this house rests on a buff-colored, rock-faced sandstone foundation arranged as coursed ashlar. Red bricks, with pink-tinted mortar, clad the exterior wall. Red-painted, square-cut wood shingles cover a 2-story addition to the rear (south) elevation. Windows are generally 1-over-1-light, double-hung sash windows, with white-painted wood frames. They open between pink, rough-faced sandstone sills and segmental arches. The window openings dominating both stories of the front (north) façade, have corbelled archivolt, with horizontal, corbelled bands extending east and west from the springers. The window in the first story has an arched upper sash and pink sandstone keystone and springers. A single-story, 3-sided canted bay protrudes from the center of the west elevation. It hosts sash windows featuring a narrow upper sash of stained glass in a cottage-style glazing pattern. A rose is depicted in the center of the upper sash. Above this bay open a pair of single-light hopper or awning windows. Windows opening in the rear addition are 3 (vertical)-over-1, double-hung sash, with white-painted wood frames and surrounds. A shed-roofed porch wraps around the northeast corner of the house. A compass point is painted on its red, wood floor at the northeast corner. The porch features round, Doric columns. Between then is a simple wood balustrade. Protruding from the east end of the porch's south elevation is a pediment. It shelters 3 concrete steps. The
