COLORADO CULTURAL RESOURCE SURVEY

Architectural Inventory Form

- 1. Resource number: **5PE.517.41** Parcel number(s):
- 2. Temporary resource number: **525311007**
- 3. County: **Pueblo**
- 4. City: **Pueblo**
- 5. Historic building name: **Kellogg, John D., House**
- 6. Current building name: **728 West 13th Street**
- 7. Building address: **728 W 13th Street**
- 8. Owner name: **Jose L. and Clara H. Manzanares**
- Owner organization:
- Owner address: **715 W 13th St.**
- Pueblo, CO 81003**

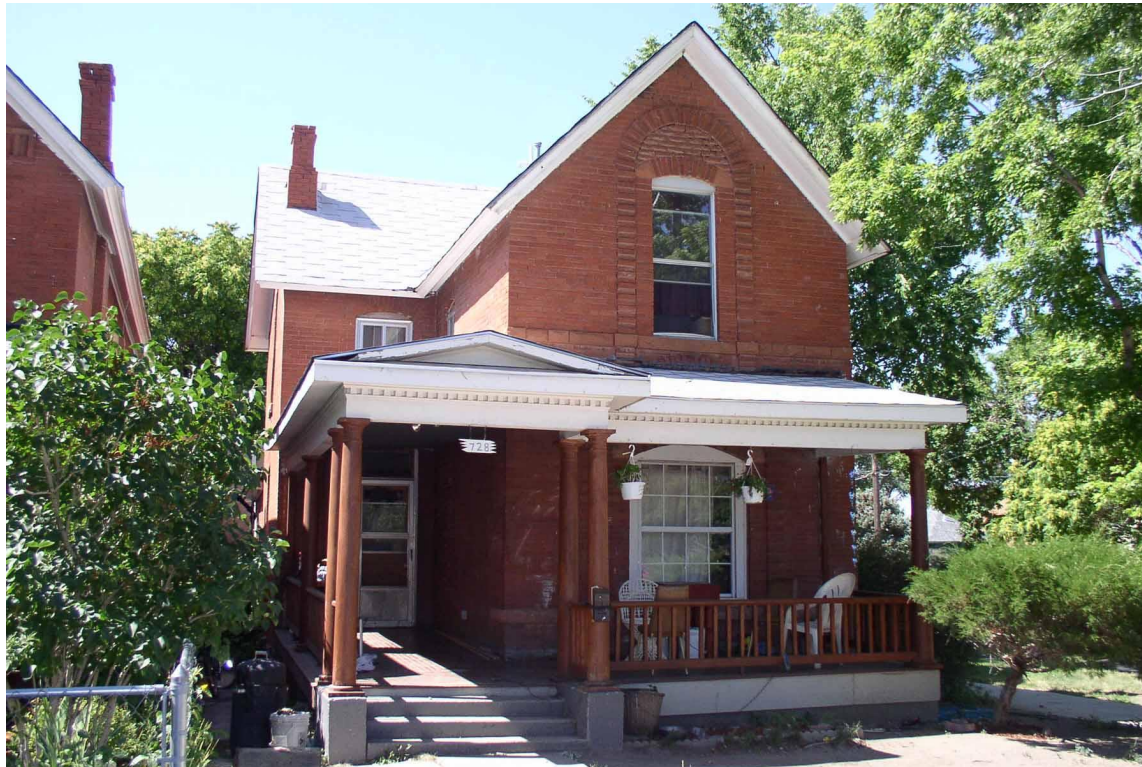
19. Primary external roof material: **Asphalt Roof/Composition Roof**
Other roof materials:
20. Special features: **Chimney**
Porch
Window/Segmental Arch
21. General architectural description:
Oriented to the north, this house rests on a buff-colored, rock-faced sandstone foundation arranged as coursed ashlar, with 3-light hopper basement windows. Red brick, with pink-tinted mortar, clads the exterior walls. Bands of pink, rough-faced sandstone correspond to the window sills on the first and second story, breaking up the masonry walls. Windows are generally 1-over-1-light, double-hung sash, with white vinyl frames. Some windows have plastic inserts to make them appear as 8-over-8-light windows. They open between rock-faced sandstone sills and segmental arches. Windows dominating both stories of the front (north) façade and the west elevation feature pronounced archivolt consisting of alternating smooth and rough-faced bricks. A round arch of alternating, projecting bricks surrounds the windows. A shed-roof porch wraps around the northeast corner of the house. The porch supports are red-painted, wood, Doric columns. Spanning between them is a simple, wood balustrade. A pediment protrudes from the east end of the porch's north elevation. It shelters 3 concrete steps. The porch has dentiled cornice. The principal doorway opens in the north face of the inside (northeast-facing) corner. It hosts a 5-panel wood door with cottage-style glazing, opening behind an aluminum-frame storm door. Above the door is a single-light transom. A doorway opening in the east face of the corner has been bricked shut. Another doorway opens in the rear (south) elevation. It hosts a white-painted wood slab door. Gray, interlocking asphalt shingles cover the cross-gabled main roof and all other roof surfaces. White-painted wood soffit and fascia, with projecting cornice, box the eaves. An engaged chimney and hearth protrudes from the north end of the west elevation. It features a corbelled hearth and chimney cap. Chimneys also protrude

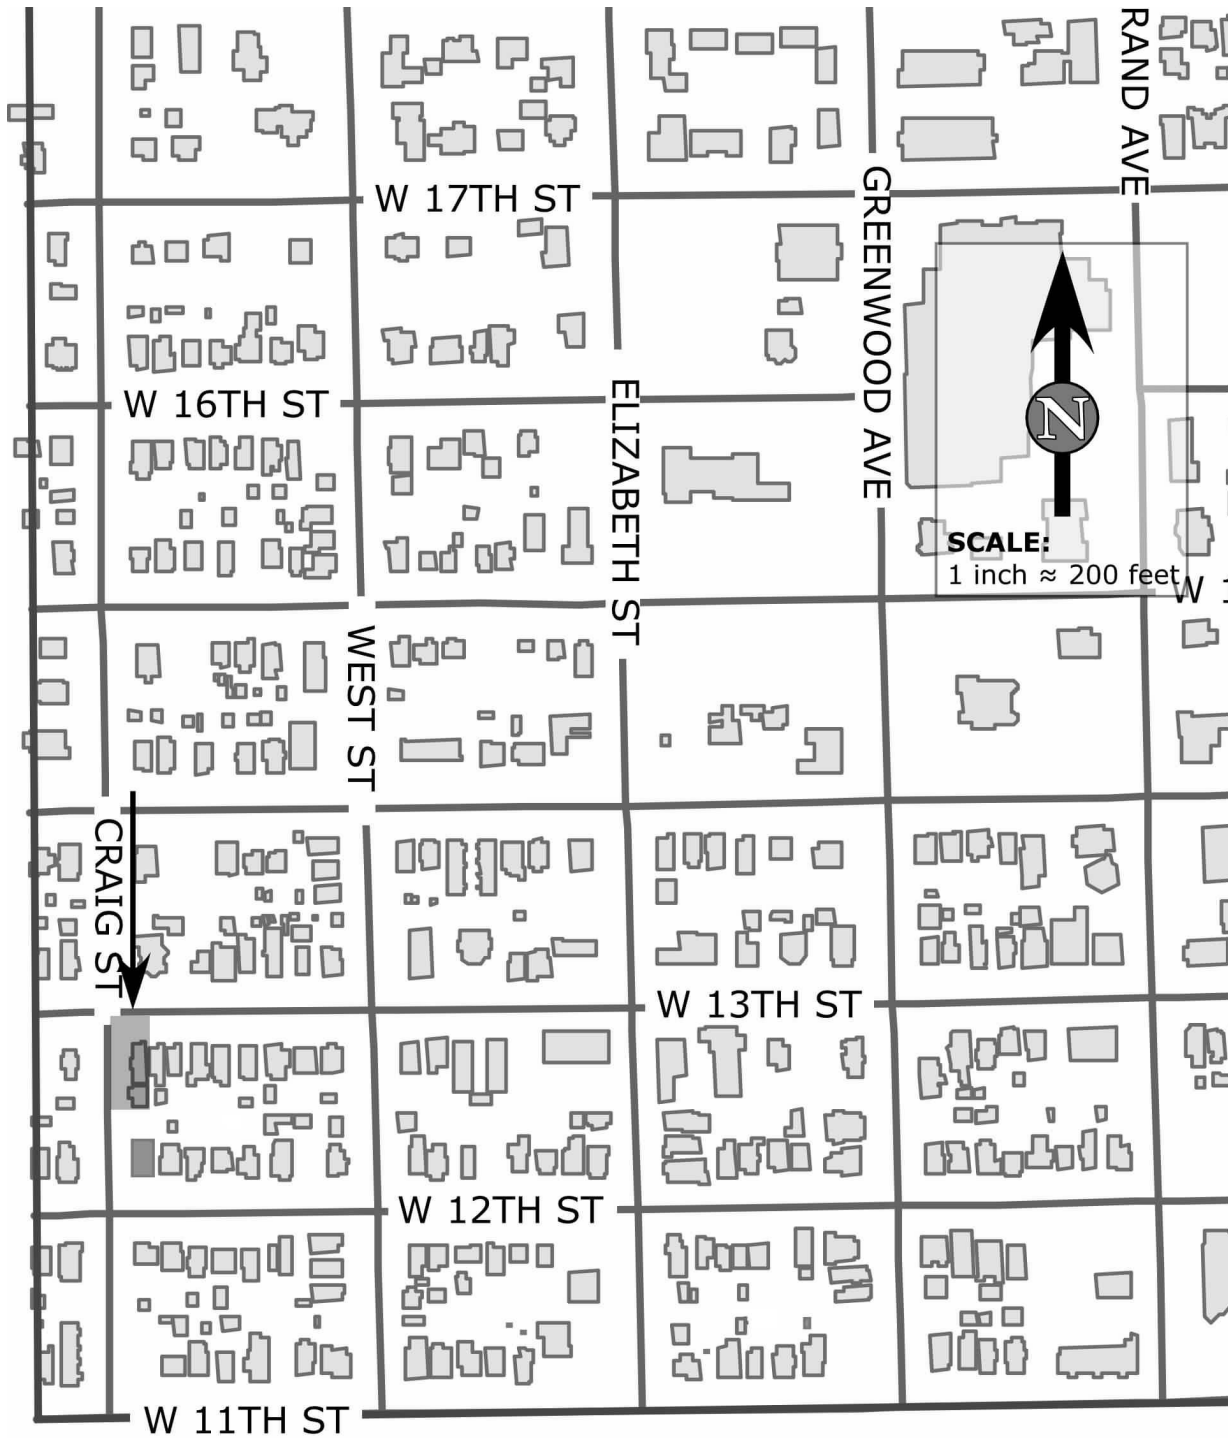
SITE SKETCH MAP

This property is located on terrain sloping downward from north to south, with an elevation of around 4,700 feet above mean sea level. The neighborhood features modest, one- and two-story houses. Setbacks from West 13th Street, the busy, principal east-west thoroughfare through this area, are generally the same on this block. This property is situated on the southeast corner of West 13th and Craig streets. A grass strip separates the sidewalk from West 13th Street. Surrounding the house is a planted-grass yard, with mature landscaping. Large maple trees line the west side of the property. The lot lacks a backyard because of the density of associated buildings.
