COLORADO CULTURAL RESOURCE SURVEY

Architectural Inventory Form

I. IDENTIFICATION

- 1. Resource number: **5PE.5678**
- 2. Temporary resource number:
- 3. County: **Pueblo**
- 4. City: **Pueblo**
- 5. Historic building name: **Berno, Peter, House**
- 6. Current building name: **508 West 14th Street**
- 7. Building address: **508 W 14th Street**
- 8. Owner name: **Housing Authority of Pueblo**
- Owner organization:
- Owner address: **1414 N Santa Fe Ave**
Pueblo, CO 81003

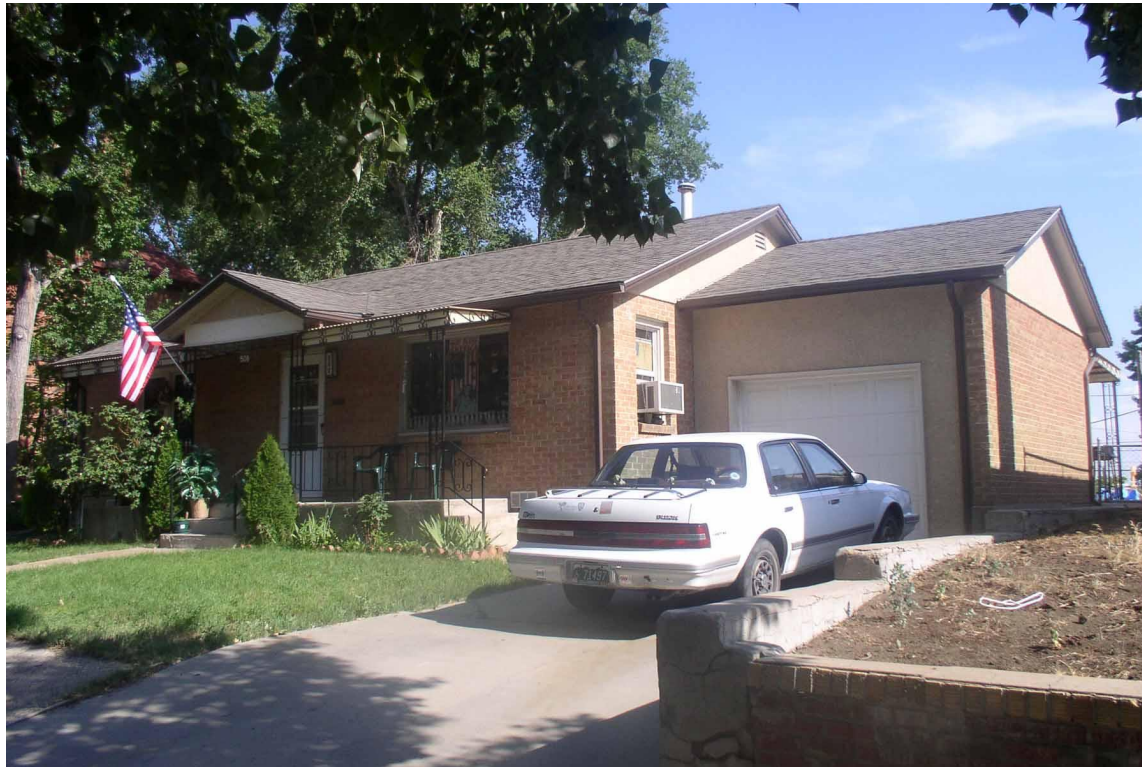
19. Primary external roof material: **Asphalt Roof/Composition Roof**
Other roof materials:
20. Special features: **Fence**
Garage/Attached Garage
Porch
21. General architectural description:
Oriented to the north, this house rests on a concrete foundation. A tan, raked-brick veneer clads the exterior walls. Tan stucco covers the gables. Windows are generally 1-over-1-light double-hung sash, with white vinyl frames and aluminum-frame storm windows. They have brick sills. The west end of the front (north) façade hosts a single-light picture window. A shed-roofed porch spans most of the façade. It has a concrete floor and wrought-iron railing, Wrought-iron supports brace the translucent fiberglass roof. Protruding from the center of the porch roof is a pediment. It shelters the two concrete steps approaching the porch at its center. The principal doorway opens in the center of the symmetrical facade. It hosts a wood slab door, opening behind a white vinyl-frame storm door. A side-gabled garage is attached to the west elevation. A 1-car, 16-panel, steel, overhead retractable garage door, painted white, dominates its front elevation. Around the garage door is a tan stucco cladding. Two doorways open in the rear (west) elevation. The eastern door opens beneath a front-gabled hood, on knee brackets. The western door opens onto a concrete patio, sheltered beneath a fiberglass roof, on wrought-iron supports. It hosts a tan-painted slab door. Gray-green asphalt shingles cover the side-gabled roof, and tan-painted wood soffit and brown fascia box the eaves.
