COLORADO CULTURAL RESOURCE SURVEY

Architectural Inventory Form

- 1. Resource number: **5PE.5685** Parcel number(s):
- 2. Temporary resource number: **525409010**
- 3. County: **Pueblo**
- 4. City: **Pueblo**
- 5. Historic building name: **Haubrich, G.T., House**
- 6. Current building name: **608 West 14th Street**
- 7. Building address: **608 W 14th Street**
- 8. Owner name: **U.S. Bank National Association**
- Owner organization: **22687 Old Canal Rd**
- Owner address: **Yorba Linda, CA 92887**

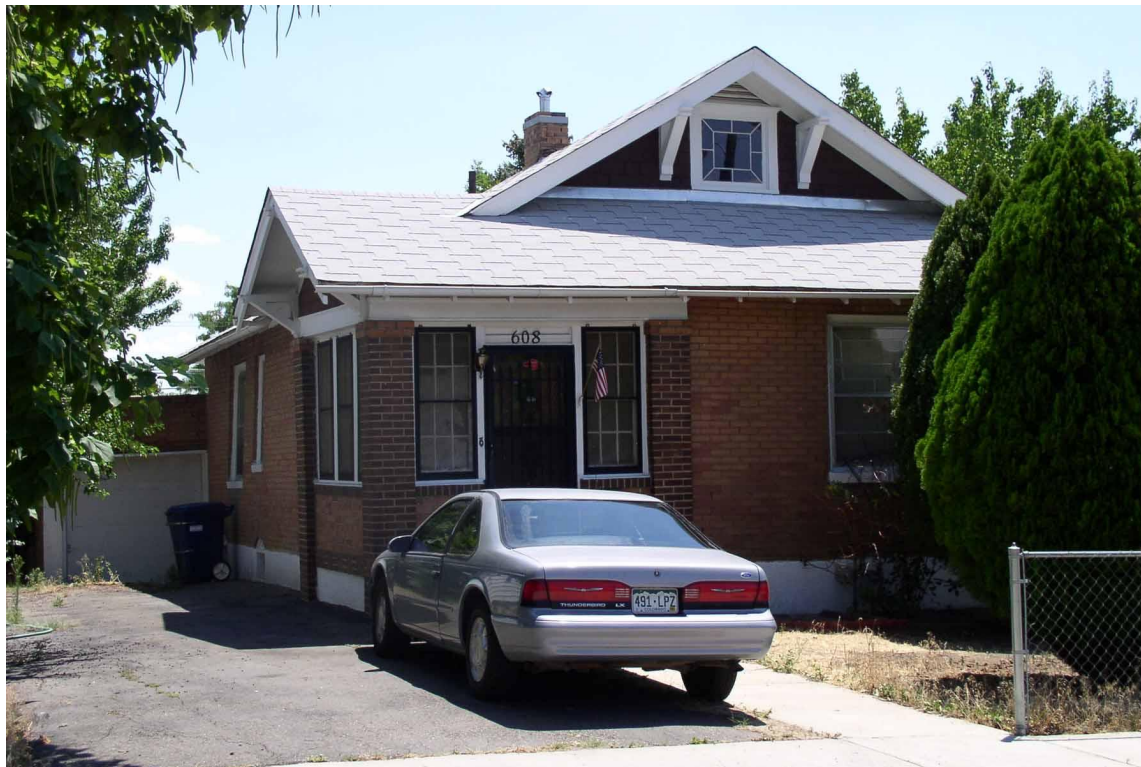
21. General architectural description:
Oriented to the north, this house rests on a white-painted concrete foundation, with 3-light hopper basement windows. A red-brown brick veneer clads the exterior walls, and brown-painted square-cut wood shingles cover the gable ends. Most windows are 6-over-6-light, double-hung sash, with white-painted wood frames, aluminum-frame storm windows, and concrete sills. Paired windows feature 9-over-9-light windows in a rectangular glazing pattern. A 9-light awning, hopper, or sash window, with same glazing pattern, pierces the front (north-facing) gable. An enclosed, integral porch fills the northeast corner of the house. Spanning between the dark-brown-brick porch piers is a red-brown brick kneewall and 6-over-6-light windows. A doorway opens in the center of this porch's north elevation. Another porch spans a portion of the rear elevation, apparently sheltering a doorway. Attached to the house's southeast corner is a single-car garage. Its front (north) elevation hosts a steel, overhead-retractable garage door, painted white. Gray interlocking asphalt shingles cover the gable-on-hip main roof and all other roof surfaces. The rafter ends are exposed and knee brackets appear beneath the gables. A brick chimney protrudes from the roof ridge.

NOTE: Due to inaccessibility and dense foliage, not every detail of this house could be recorded from public rights-of-way.

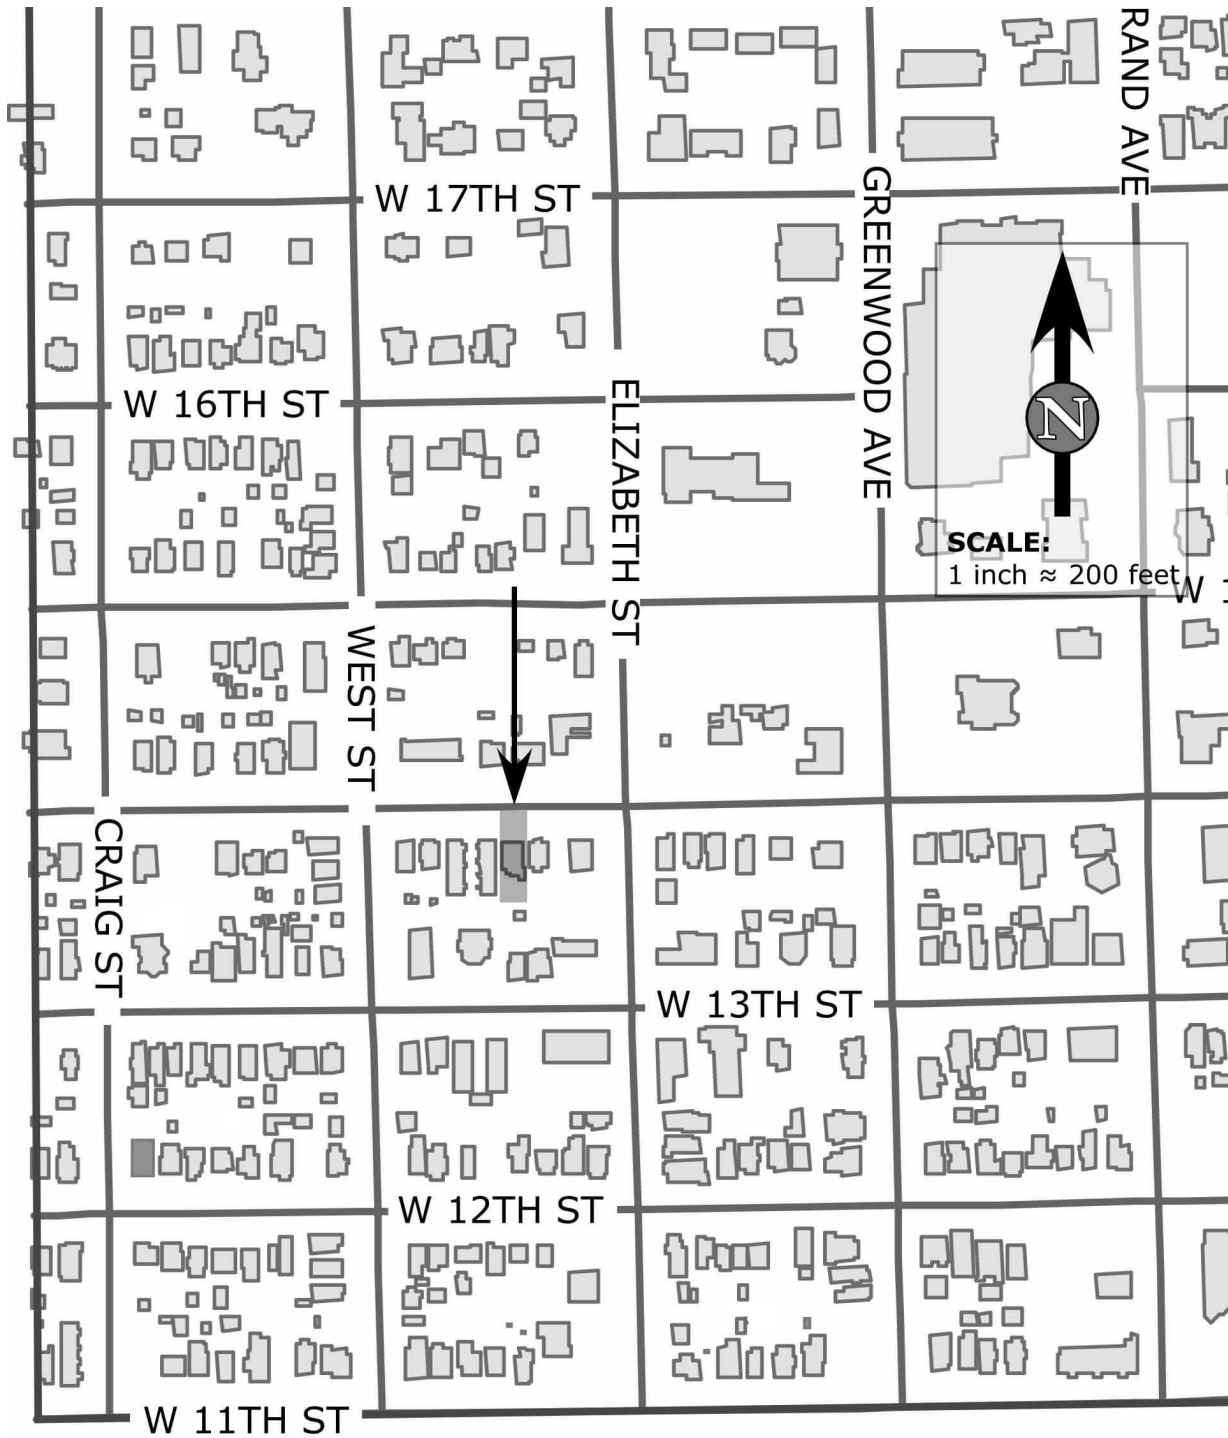
SITE SKETCH MAP

This property is located on terrain sloping downward from northwest to southeast, with an elevation of around 4,700 feet above mean sea level. The neighborhood features modest, one- and two-story houses. Setbacks from West 14th Street are generally the same on this block. This property is situated on the south side of West 14th Street, between 608 West 14th Street to the east and 616-620 West 14th Street to the west. Grass covers the strip separating the sidewalk from the street. A planted-grass yard, with mature landscaping, covers the property. However, dense foliage largely conceals the house. A combination of chain-link and wood privacy fences surrounds the yard.
