COLORADO CULTURAL RESOURCE SURVEY

Architectural Inventory Form

- 1. Resource number: **5PE.5691** Parcel number(s):
- 2. Temporary resource number: **525310002**
- 3. County: **Pueblo**
- 4. City: **Pueblo**
- 5. Historic building name: **Miller, William H., House**
- 6. Current building name: **Montez-Moore House**
- 7. Building address: **712 W 14th Street**
- 8. Owner name: **Charles G. Montez and Susan M. Moore**
- Owner organization:
- Owner address: **5 Wren Way**  
**Pueblo, CO 81005**

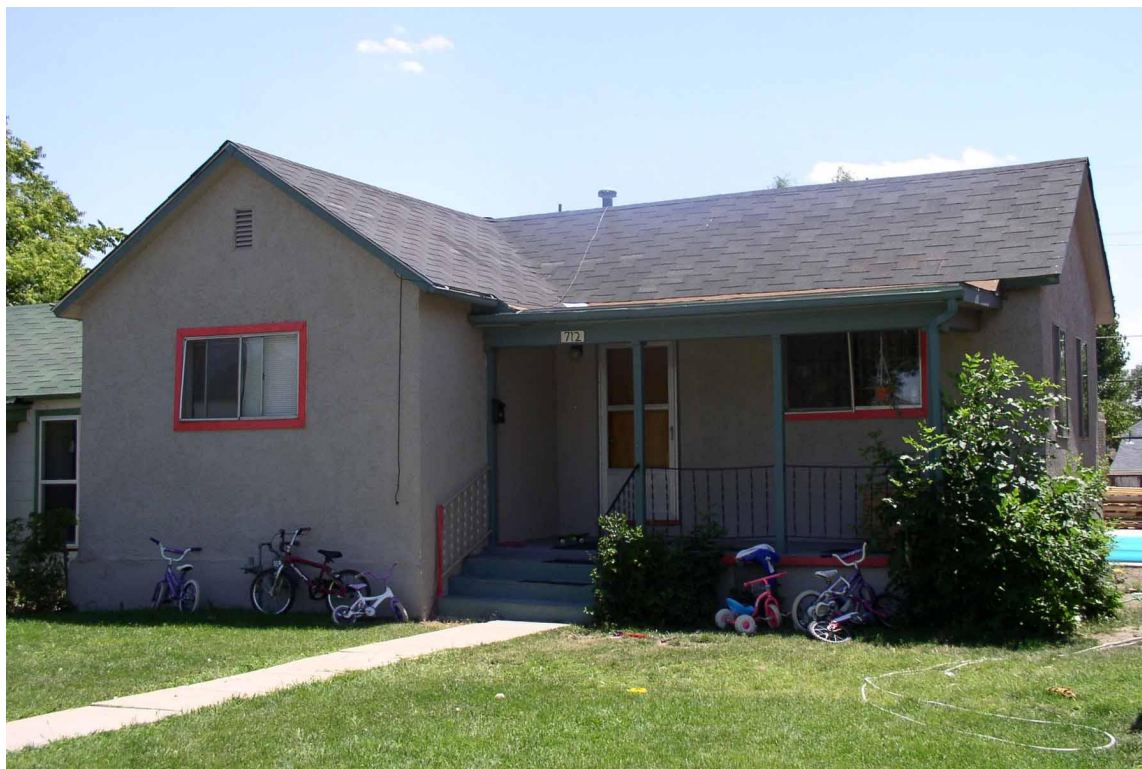
**This house is oriented to the north. Gray stucco entirely conceals the foundation. The same stucco clads the exterior walls. Windows are 1-beside-1-light, sliding-sash, with aluminum frames and pink-painted wood surrounds. A shed-roofed porch fills the inside (northwest-facing) corner of the house. It has a concrete floor, aluminum and wrought-iron railings, and blue-painted, square wood supports. Three concrete steps approach the porch on the easternmost third of its north elevation. The principal doorway aligns with these steps. It hosts a wood slab door, opening behind an aluminum-frame storm door. Another doorway opens west of center in a flat-roofed addition across the rear (south) elevation. It hosts a wood slab door, opening behind an aluminum-frame storm door. It provides access to an uncovered, wood deck. Black, interlocking asphalt shingles cover the cross-gabled roof, and gray-painted wood soffit and blue-painted wood fascia box the eaves.**
