COLORADO CULTURAL RESOURCE SURVEY

Architectural Inventory Form

- 1. Resource number: **5PE.5692**
- 2. Temporary resource number:
- 3. County: **Pueblo**
- 4. City: **Pueblo**
- 5. Historic building name: **Hill-Burke House**
- 6. Current building name: **Martinez, John and Melissa, House**
- 7. Building address: **714 W 14th Street**
- 8. Owner name: **John Emilio Martinez and Melissa Joy Martinez**
- Owner organization:
- Owner address: **1415 Craig St**
Pueblo, CO 81003

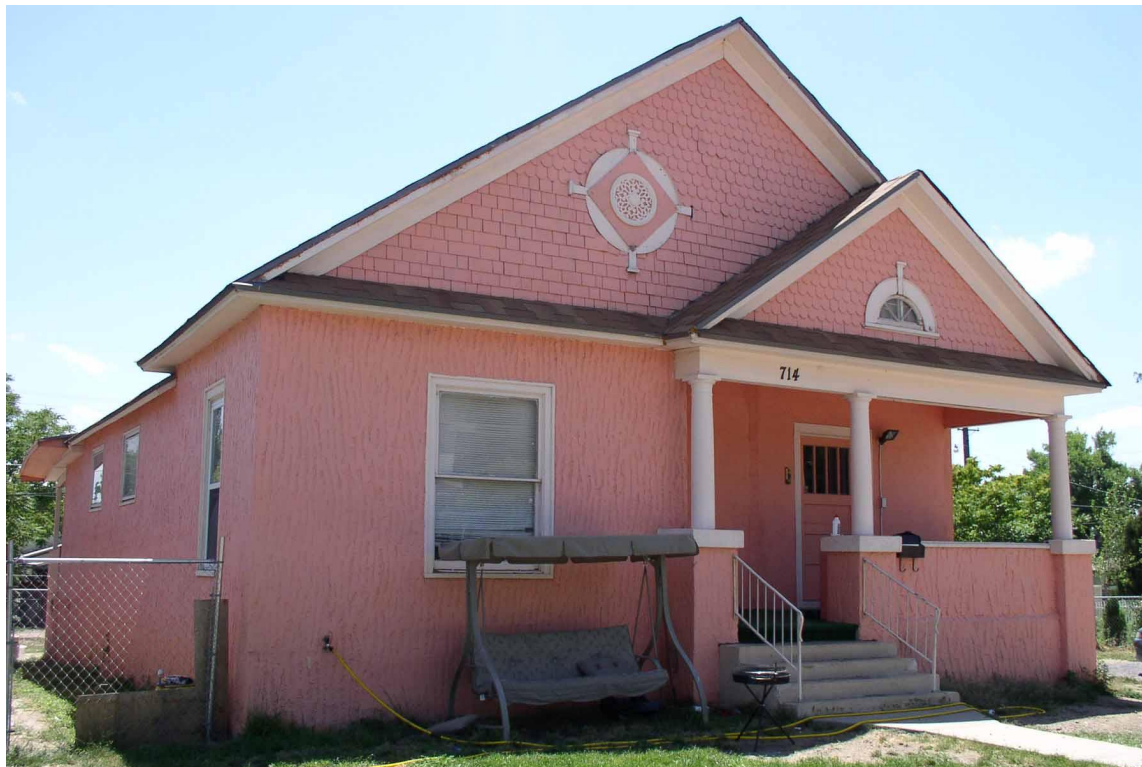
21. General architectural description:
This house is oriented to the north. Pink-painted stucco entirely conceals the foundation. An enclosed, basement stairwell protrudes from the center of the rear (south) elevation. It has a shed roof and wood slab door. The same stucco clads the exterior walls. Pink-painted variegated wood shingles cover the gables. Windows are 1-over-1-light, double-hung sash, with white-painted wood frames and surrounds. A single-light, fixed-frame window opens beneath its own gable, south of center in the west elevation. Two openings pierce the two gables facing north. The smaller gable has a half-circular window, opening behind a wire mesh. A full-circular window pierces the main gable east of center. It has been boarded shut and now hosts an interlaced decorative element. An integral porch is located within the northwest corner of the house, beneath a slightly projecting gable. It has a stucco-covered kneewall. Resting on stucco-clad pedestals are white-painted, wood, Doric columns. Approaching the porch on the east side of its north elevation are 4 concrete steps, with white-painted, wrought-iron railings. The principal doorway opens in the west side of the asymmetrical facade. It hosts a 3-panel, 5-light (vertical), glass-in-wood-frame door, painted pink. A small, integral porch is located in the southeast corner of a shed-roofed addition across the rear (south) elevation. A white-painted, wood slab door opens in the east face of this inside (southeast-facing) corner. Wood steps, with a simple, wood balustrade, approach the porch from the east. Brown, interlocking asphalt shingles cover the front-gabled

roof. White-painted wood soffit and fascia box the eaves. The gables are pedimented. A red-brick chimney protrudes from the center of the roof.
