COLORADO CULTURAL RESOURCE SURVEY

Architectural Inventory Form

- 1. Resource number: **5PE.5724** Parcel number(s):
- 2. Temporary resource number: **525144005**
- 3. County: **Pueblo**
- 4. City: **Pueblo**
- 5. Historic building name: **Moore, Peter and Anneliese, House**
- 6. Current building name: **Moore, Peter and Anneliese, House**
- 7. Building address: **614 W 16th Street**
- 8. Owner name: **Peter Pat and Anneliese M. Moore**
- Owner organization:
- Owner address: **614 W 16th St**  
**Pueblo, CO 81003**

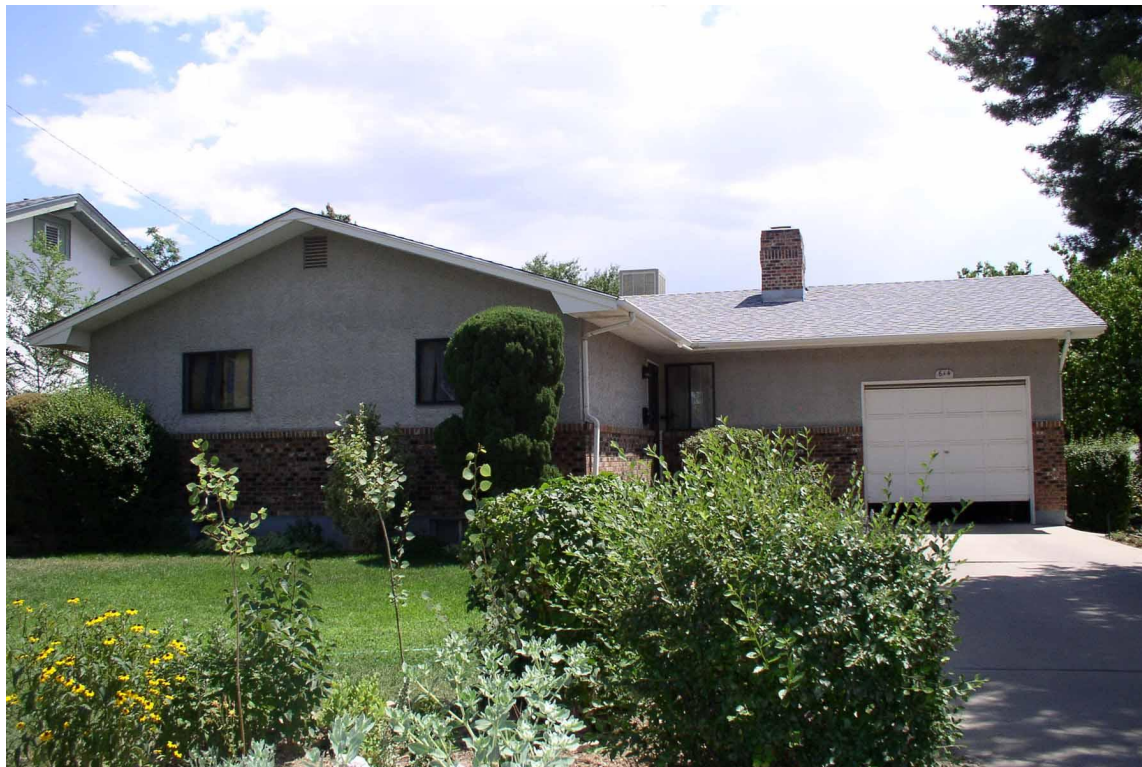
**Porch**
21. General architectural description:  
**Oriented to the north, this house has a gray-painted concrete foundation, with 1-beside-1-light, aluminum-frame, sliding-sash windows. A light-gray stucco clads the exterior walls. A brown-brick veneer extends up approximately 4 to 5 feet from the foundation across the front (north) facade and the west face of the inside corner. Windows are generally 1-beside-1-light, sliding sash, with brown aluminum frames. The principal doorway opens in the east face of the inside corner. A concrete stoop, with wrought-iron railing, flanks the stoop. Opening in the west end of the side-gabled portion of the house is a white, 20 panel, overhead retractable garage door. An integral porch is situated in the center of the rear elevation. Opening onto the porch is a brown-painted, 6-panel door. Gray asphalt shingles cover the cross-gabled roof. White-painted wood fascia and soffit box the broadly overhanging eaves. A stout, brown-brick chimney protrudes from the west side of the east-west roof slope.**
