COLORADO CULTURAL RESOURCE SURVEY

Architectural Inventory Form

- 1. Resource number: **5PE.6578** Parcel number: **525124002**
- 2. Temporary resource number:
- 3. County: **Pueblo**
- 4. City: **Pueblo**
- 5. Historic building name: **Vactor G. Garnett House**
- 6. Current building name: **Katharin B. Housel House**
- 7. Building address: **616 West 20th Street**
- 8. Owner name: **Katharin B. Housel**
- Owner organization:
- Owner address: **616 W 20th St
Pueblo, CO 81003**

Pueblo North Side Neighborhood, Phase II

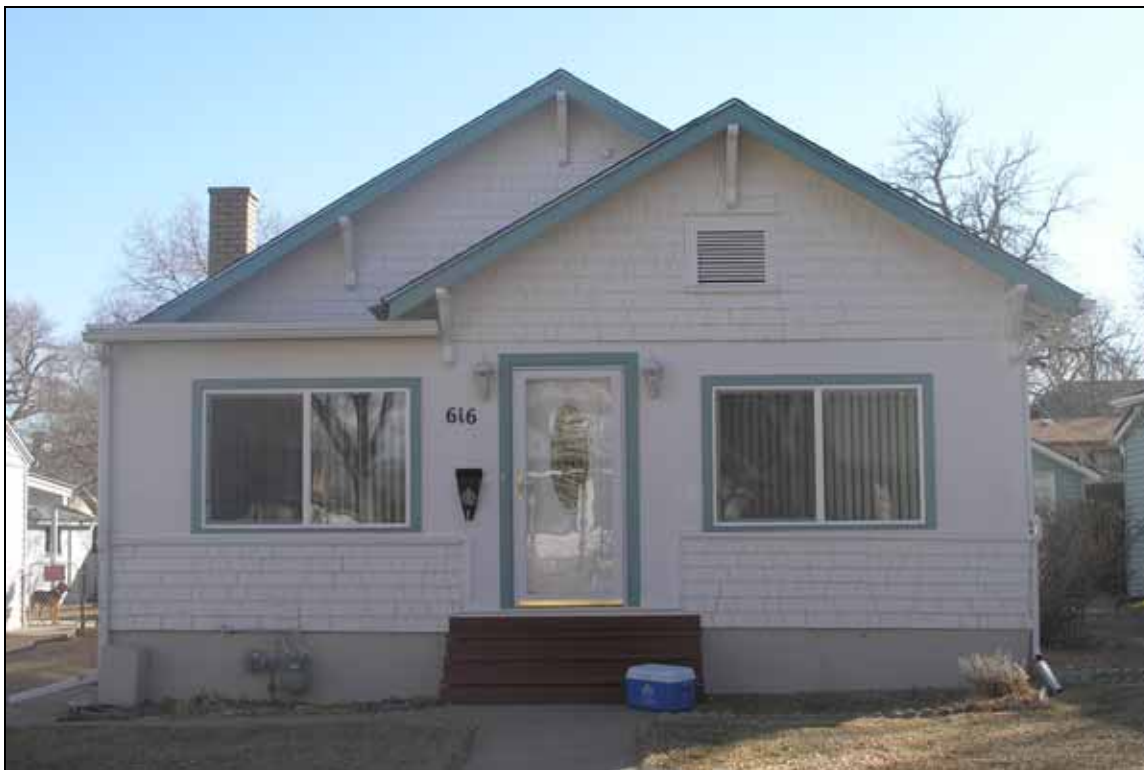
19. Primary external roof material: **Asphalt Roof/Composition Roof**
 Other roof materials:
20. Special features: **Chimney**
21. General architectural description:
Oriented to the north, this house rests on a gray-painted concrete foundation. White-painted, square-cut wood shingles clad the exterior walls. Enclosing the former front porch is white-painted stucco. Windows are generally 3 (vertical)-over-1-light, double-hung sash, with white-painted wood frames and blue-painted wood surrounds. A rectangular bay shallowly protrudes from the east elevation, south of center. Flanking either side of a tan-brick hearth and chimney, corbelled shallowly from the north end of the east elevation, are 2-light hopper, awning, or casement windows. Piercing the front porch are 1-beside-1-light, sliding-sash window, with white-vinyl frames and blue-painted wood surrounds. Enclosing the western third of the rear porch/mudroom is a band of 4-light hopper, awning or casement windows. The remaining portion of the rear porch/mudroom has bands of 1-beside-1-light, sliding-sash windows, with aluminum frames. The principal doorway opens near the center of the asymmetrical front (north) facade. It hosts a white-painted, paneled metal door, with an oval light, opening behind an aluminum-frame storm door. Approaching the doorway are wood steps. A secondary doorway opens east of center in the rear (south) elevation. It host a wood slab door, opening behind a white-painted, aluminum storm door. The doorway provides access to a small, unsheltered wood stoop, surrounded by a wood balustrade. Gray asphalt shingles cover the gable-on-hip main roof and all other roof surfaces. The rafter ends are exposed and the gables host knee brackets. A tan-brick chimney, with corbelled cap, protrudes from the south end of the roof ridge.
