COLORADO CULTURAL RESOURCE SURVEY

Architectural Inventory Form

I. IDENTIFICATION

- 1. Resource number: **5PE.5845**
- 2. Temporary resource number:
- 3. County: **Pueblo**
- 4. City: **Pueblo**
- 5. Historic building name: **Tudor, Leavitt M., House**
- 6. Current building name: **Barnhill, Douglas L. Jr. and Barbara Sue, House**
- 7. Building address: **1115 West Street**
- 8. Owner name: **Douglas L. Barnhill Jr. and Barbara Sue Barnhill**
- Owner organization:
- Owner address: **1115 West St**
Pueblo, Colorado 81008

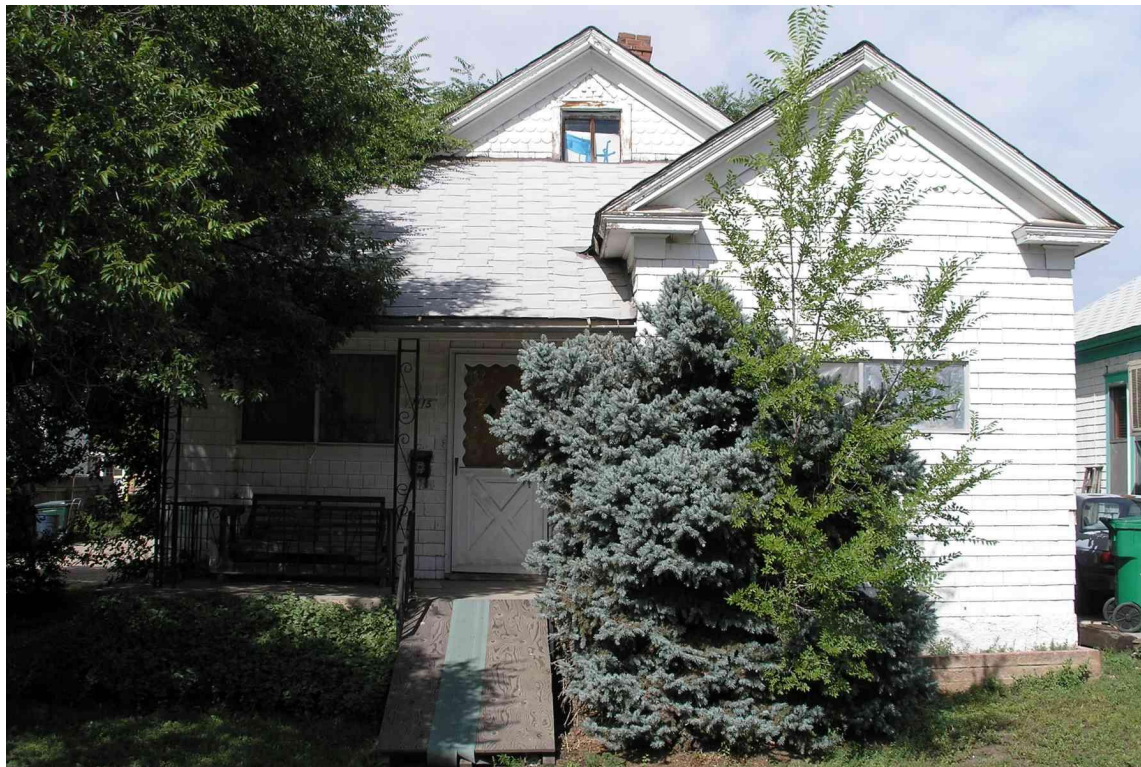
21. General architectural description:
Oriented to the east, this house rests on a white-painted concrete foundation. White-painted, square-cut wood shingles clad the exterior walls, and variegated wood shingles cover the gables. Windows are generally 1-beside-1-light, sliding sash, with aluminum frames. The east end of the south elevation hosts a 3-part sliding-sash window, with the central light fixed. It is sheltered beneath and aluminum awning. Opening in the west end of the south elevation is a 1-over-1-light, double-hung sash window. The gables host 2-light hopper or awning windows. A shed-roofed porch spans the inside (southeast-facing) corner. It has a concrete floor and decorative, wrought-iron supports. Approaching it on its east elevation, north of center, is a wood ramp. The porch shelters the principal doorway, which hosts a 4-light wood slab door, with diamond-shaped glazing. It opens behind a white, aluminum-frame storm door. Opening at the north end of the rear (west) elevation is a 2-light, 2-panel wood door, painted white, opening behind an aluminum storm door. Approaching it is a 4-step concrete stoop, with a pipe railing. Gray, interlocking asphalt shingles cover the gable-on-hip roof. White-painted wood soffit and fascia, with protruding cornice, box the eaves. The gables have eave returns. Red-brick chimneys protrude near the center of the roof and near the southwest corner.

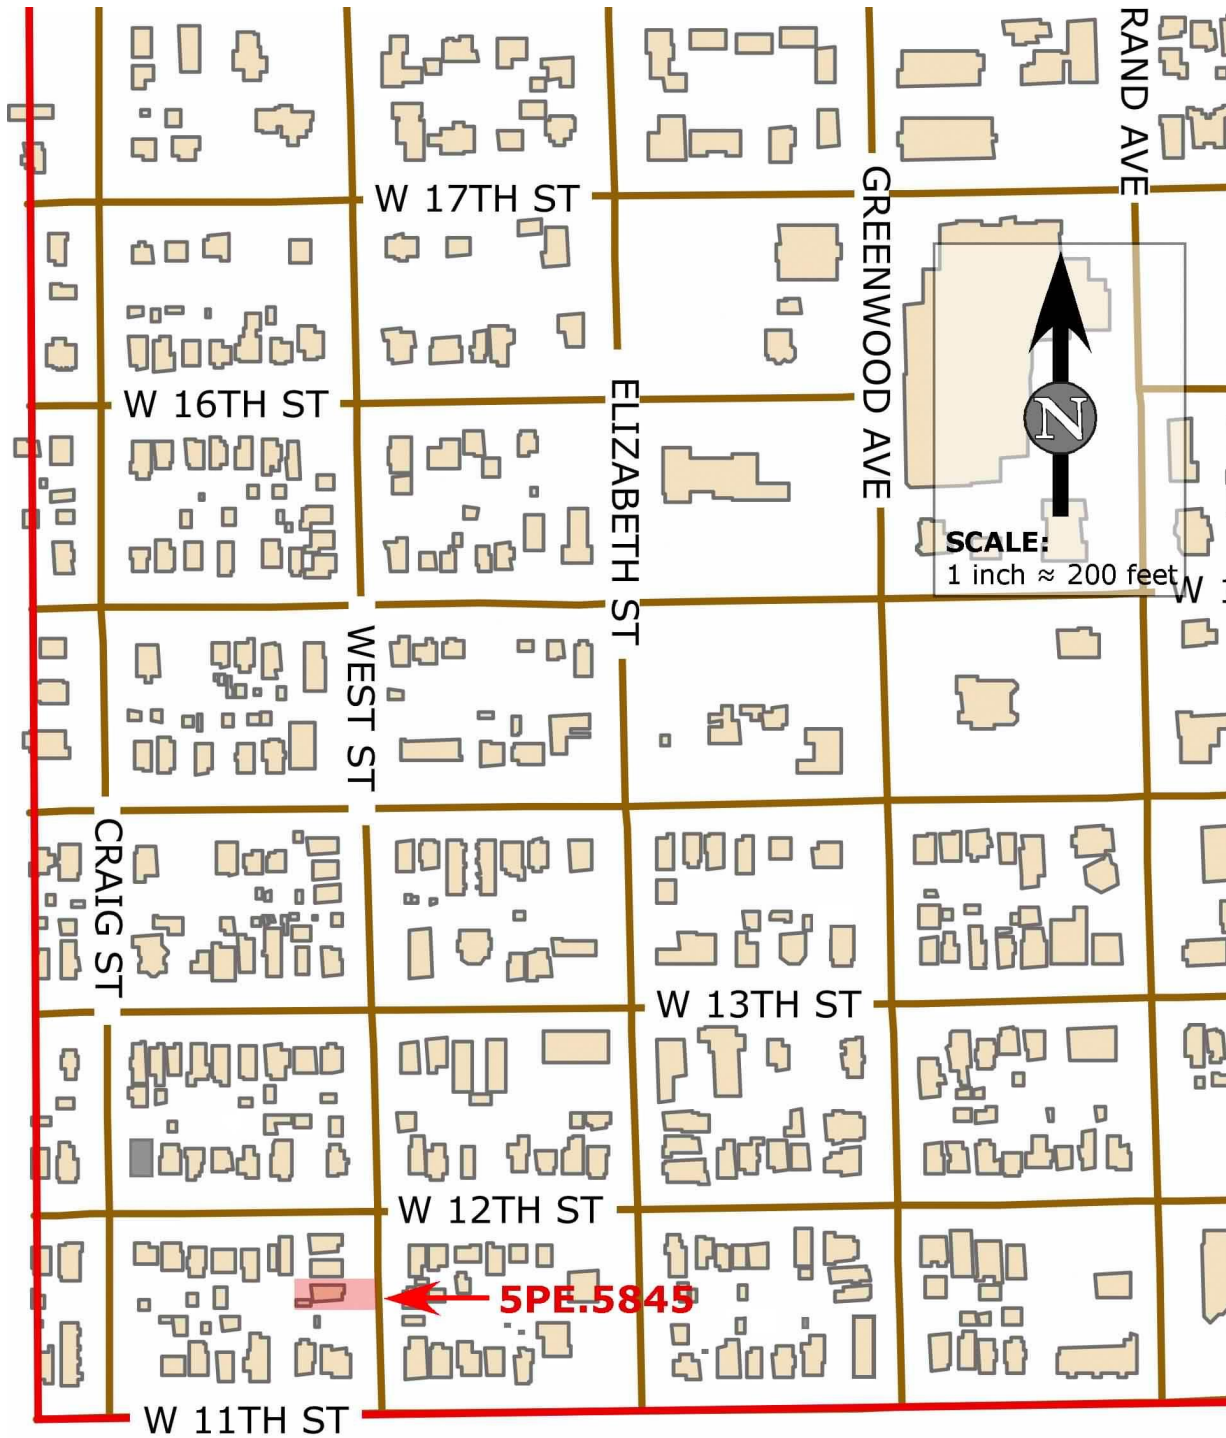
SITE SKETCH MAP

This property is located on terrain sloping downward from northeast to southwest, with an elevation of around 4,700 feet above mean sea level. The neighborhood features modest 1- and 2-story houses. Setbacks from West Street are generally the same on this block. This property is situated on the west side of West Street, between an east-west-oriented alley to the south and 1117 West Street to the north. Separating the street from the sidewalk is a grass-covered strip. A planted-grass yard, with mature landscaping, covers the lot. Between the alley and the house is a gravel parking area. A brick planter spans the front-gabled portion of the house. Railroad ties line the front yard.
