COLORADO CULTURAL RESOURCE SURVEY

Architectural Inventory Form

- 1. Resource number: **5PE.5847** Parcel number(s):
- 2. Temporary resource number: **525421004**
- 3. County: **Pueblo**
- 4. City: **Pueblo**
- 5. Historic building name: **Speck, George F., Houses**
- 6. Current building name: **1203 West Street**
- 7. Building address: **1203 West Street**
- 8. Owner name: **Casa de Oro, LLC**
- Owner organization:
- Owner address: **1268 20th Ln**
Pueblo, Colorado 81006

48. Report title: **Pueblo North Side Neighborhood Survey**

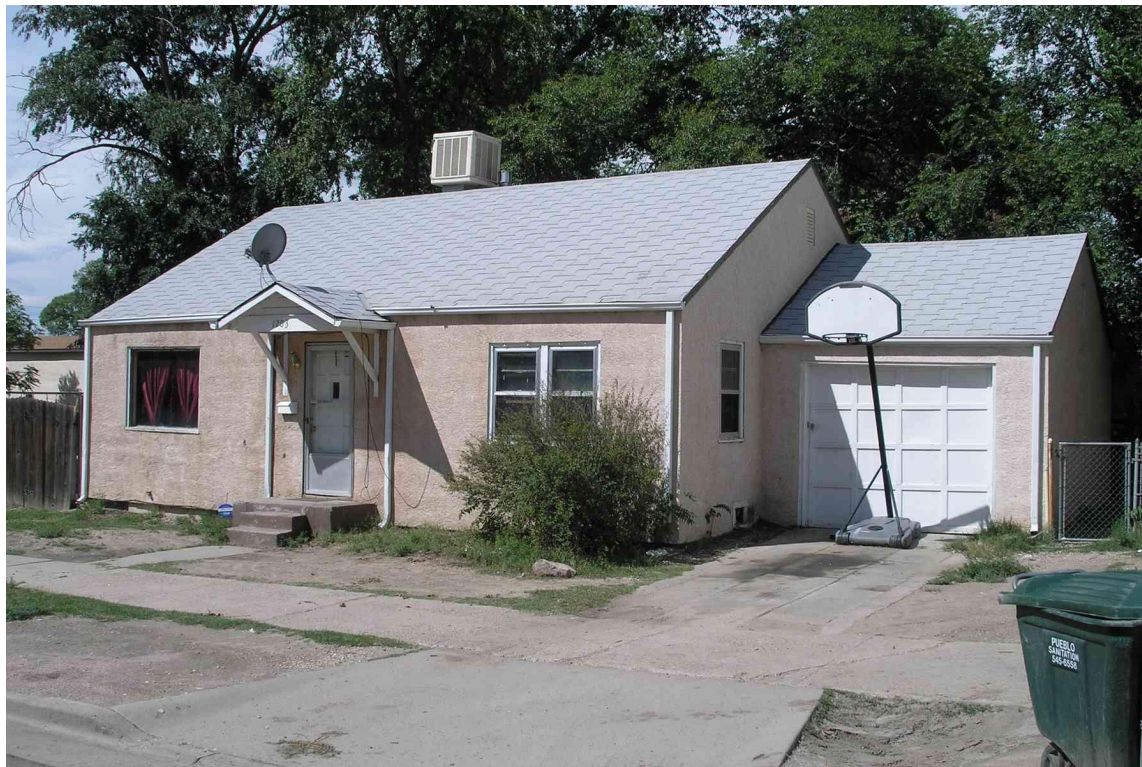
19. Primary external roof material: **Asphalt Roof**
Other roof materials:
20. Special features: **Fence**
Garage/Attached Garage
21. General architectural description:
Oriented to the east, this house rests on a concrete foundation. Pink stucco clads the exterior walls. Windows are generally 2 (horizontal)-over-2 (horizontal), double-hung sash, with brown-painted wood frames, aluminum-frame storm windows, and thin, white-painted surrounds. Both faces of the southeast corner host single-light picture windows. The principal doorway opens in the center of the front (east) façade. It hosts a 14-panel, single-light wood door, painted white, opening behind an aluminum-frame storm door. Sheltering the doorway is a front-gabled hood, on knee brackets. A 2-step concrete stoop approaches the doorway. Attached to the west end of the north elevation is a side-gabled garage. Dominating its east elevation is a 16-panel, wood, overhead-retractable garage door, painted white. Another doorway opens south of center in the rear (west) elevation. Gray, interlocking asphalt shingles cover the side-gabled main and garage roofs, and the building lacks overhanging eaves.

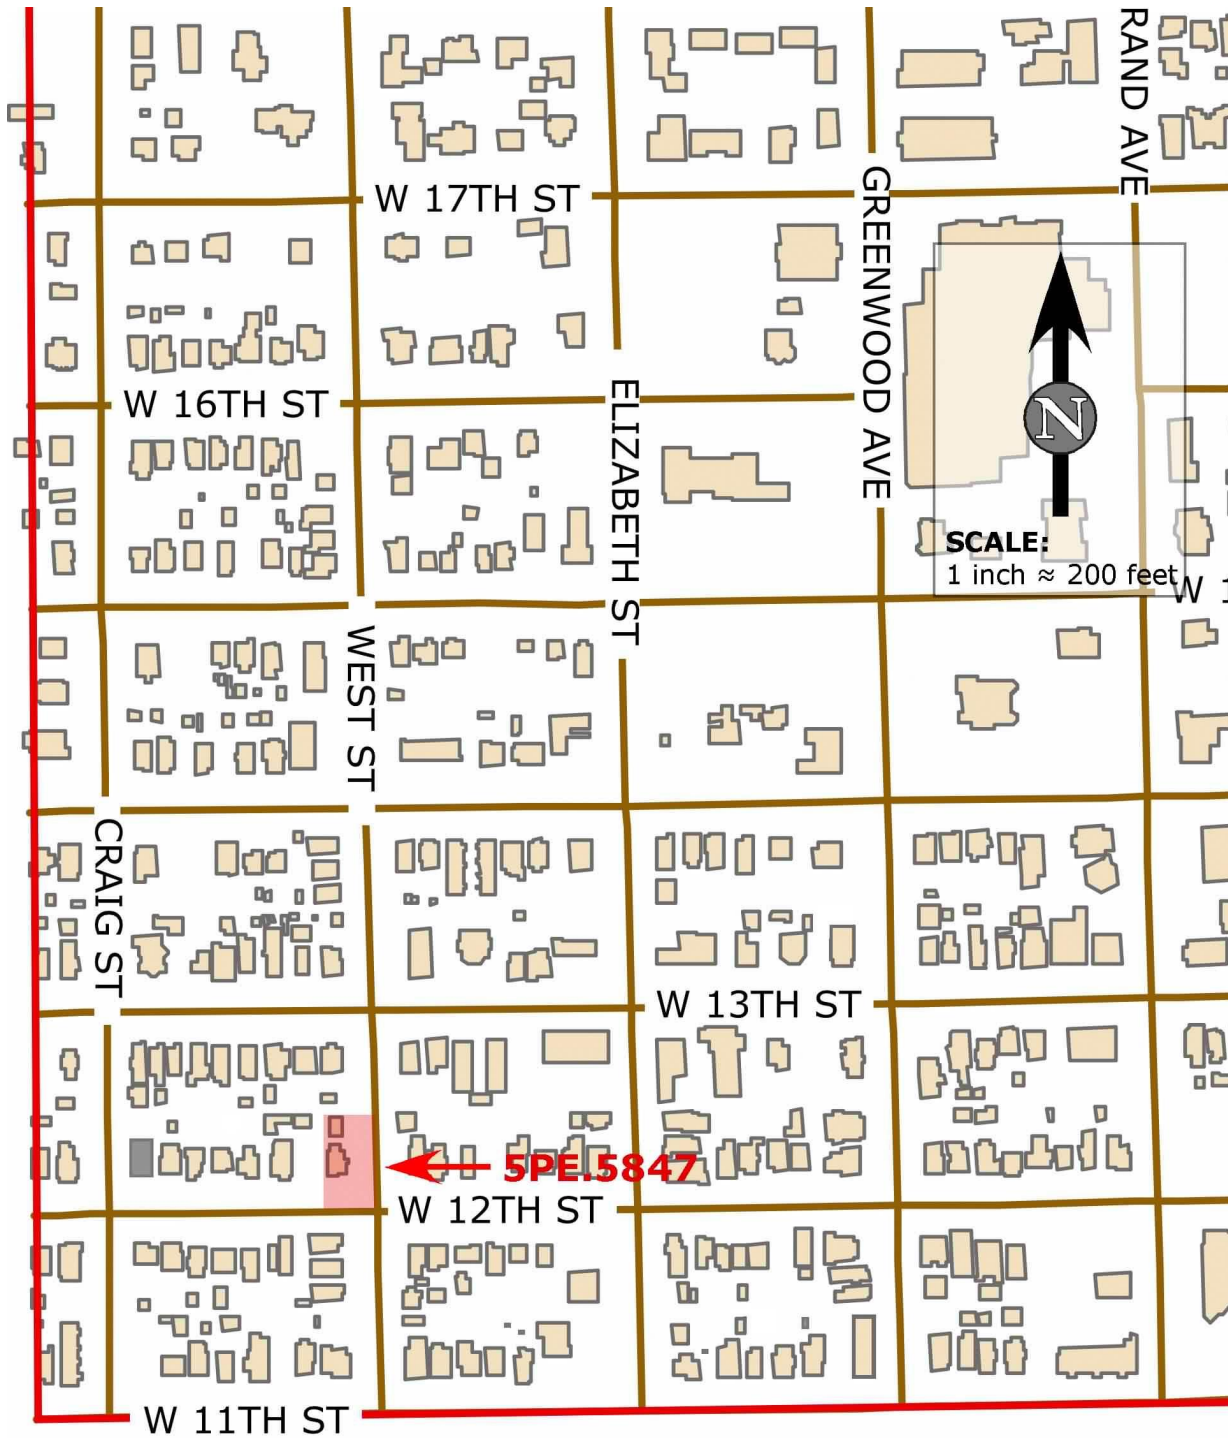
SITE SKETCH MAP

This property is located on terrain sloping downward from northeast to southwest, with an elevation of around 4,700 feet above mean sea level. The neighborhood features modest 1- and 2-story houses. Setbacks from West Street are generally the same on this block. This property is situated on the northwest corner of West and West 12th streets. Separating the streets from the sidewalks are packed-earth- strips. The yard lacks grass or landscaping. Encircling the south yard is a wood privacy fence, and a chain-link fence spans between the houses.
