COLORADO CULTURAL RESOURCE SURVEY

Architectural Inventory Form

- 1. Resource number: **5PE.5848**
- 2. Temporary resource number:
- 3. County: **Pueblo**
- 4. City: **Pueblo**
- 5. Historic building name: **1216-1218 West Street Duplex**
- 6. Current building name: **Baca, Carlos P. and Olive A., Duplex**
- 7. Building address: **1216-18 West Street**
- 8. Owner name: **Carlos P. and Olive A. Baca**
- Owner organization:
- Owner address: **87 Ironwood Dr
Pueblo, Colorado 81001**

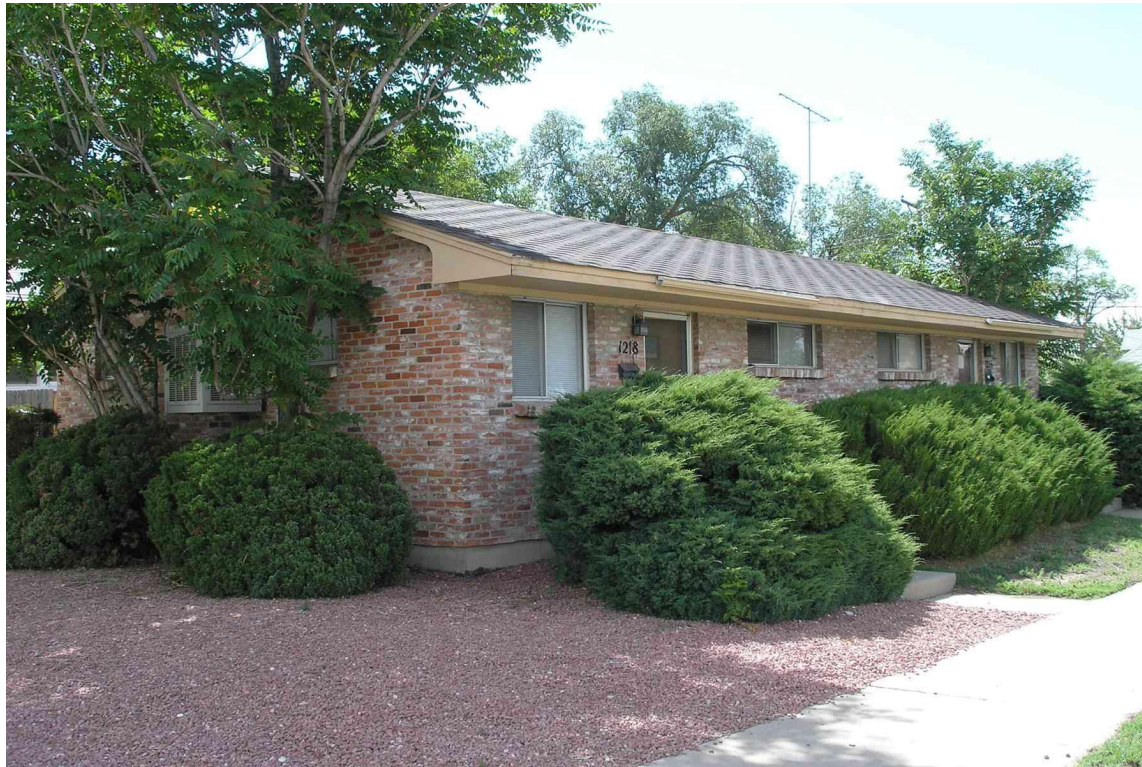
19. Primary external roof material: **Asphalt Roof/Composition Roof**
Other roof materials:
20. Special features: **Fence**
21. General architectural description:
Oriented to the west, this duplex rests on a concrete foundation. A red-brick veneer, with some of the bricks faintly white-washed. Clads the exterior walls. Windows are 1-beside-1-light, sliding sash, with aluminum frames and brick sills. The principal doorways for both addresses open in the centers of the southern and northern halves of the symmetrical front (west) façade. They host single-light wood doors, opening behind aluminum-frame storm doors. Concrete stoops approach the doorways. Doorways also open in either end of the rear (east) elevation. Brown, interlocking asphalt singles cover the side-gabled roof, and tan-painted wood fascia and soffit box the eaves.

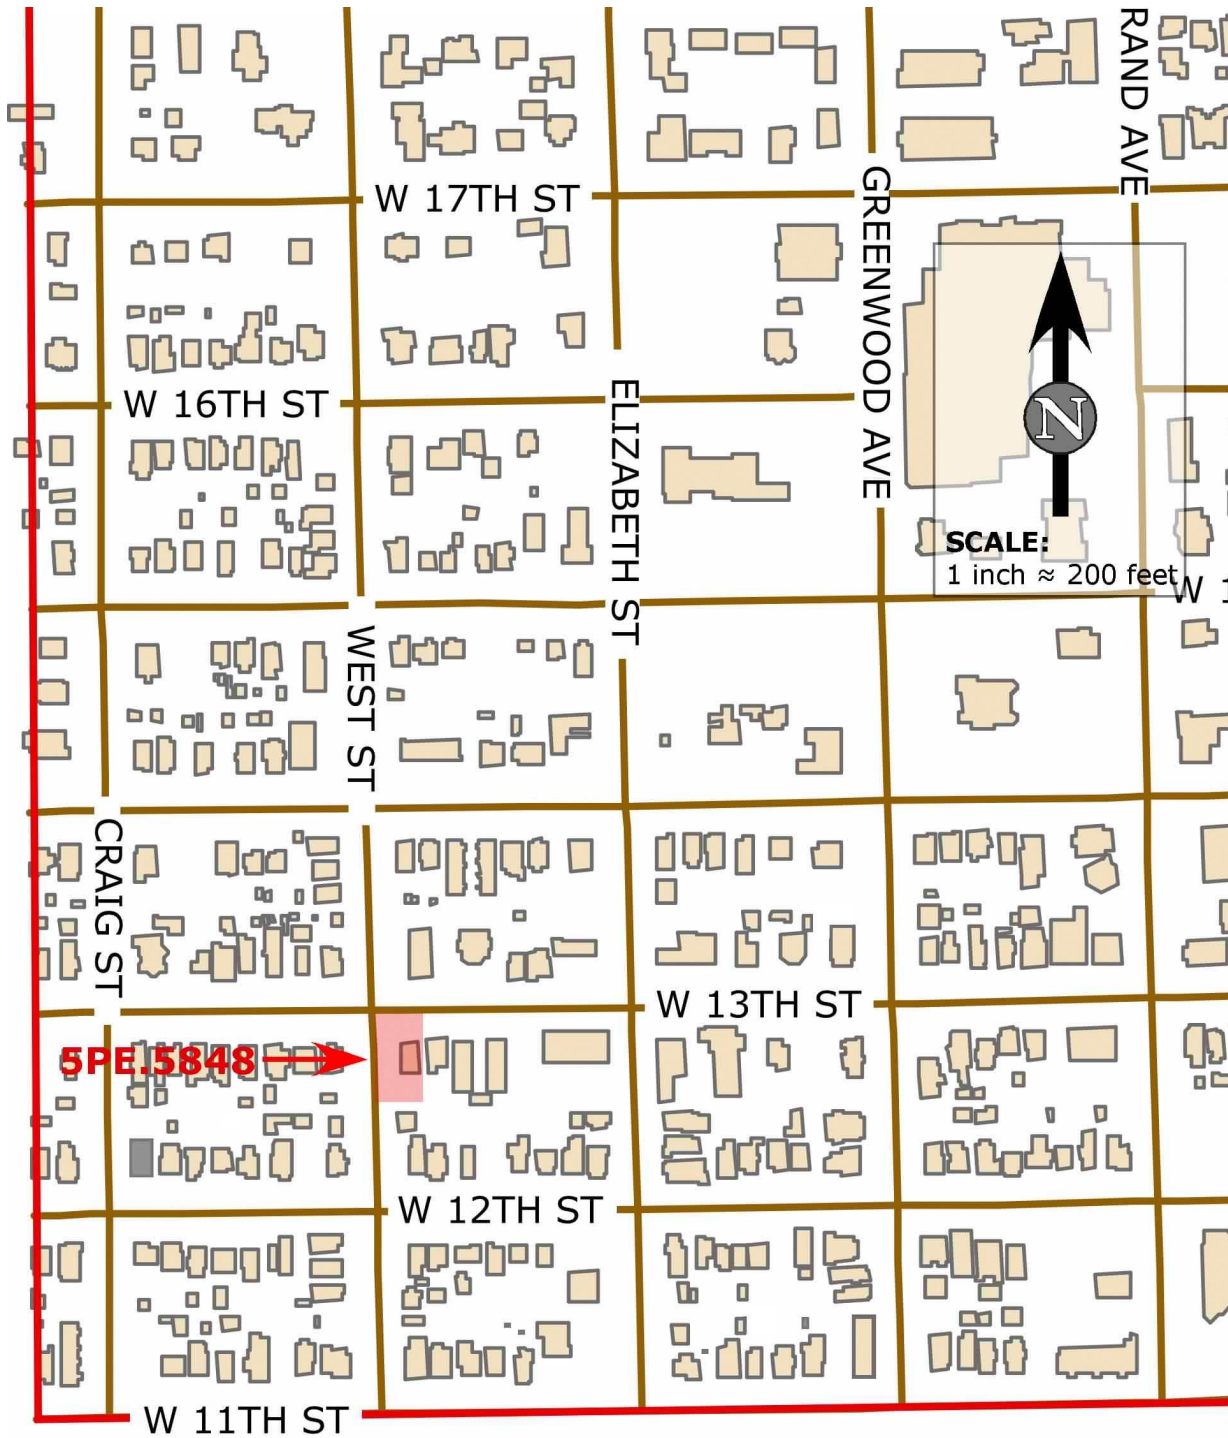
SITE SKETCH MAP

22. Architectural style: **Modern Movements**
Other architectural styles:
Building type: **Ranch Type**
23. Landscape or special setting features:
This property is located on terrain sloping downward from northeast to southwest, with an elevation of around 4,700 feet above mean sea level. The neighborhood features modest 1- and 2-story houses. Setbacks from West Street are generally the same on this block. This property is situated on the southeast corner of West and West 13th streets. Separating the streets from the sidewalks are grass-covered strips. A planted-grass yard, with mature landscaping, covers the lot, except for around the northwest corner of the house, which is covered with gravel. Encircling a portion of the back yard is a wood privacy fence.
