COLORADO CULTURAL RESOURCE SURVEY

Architectural Inventory Form

- 1. Resource number: **5PE.5851** Parcel number(s):
- 2. Temporary resource number: **525408003**
- 3. County: **Pueblo**
- 4. City: **Pueblo**
- 5. Historic building name: **Holt, Joseph Roscoe, House**
- 6. Current building name: **Cortese, Darren A., House**
- 7. Building address: **1321 West Street**
- 8. Owner name: **Darren A. Cortese**
- Owner organization:
- Owner address: **434 S Nathrop Dr**
Pueblo West, CO 81007

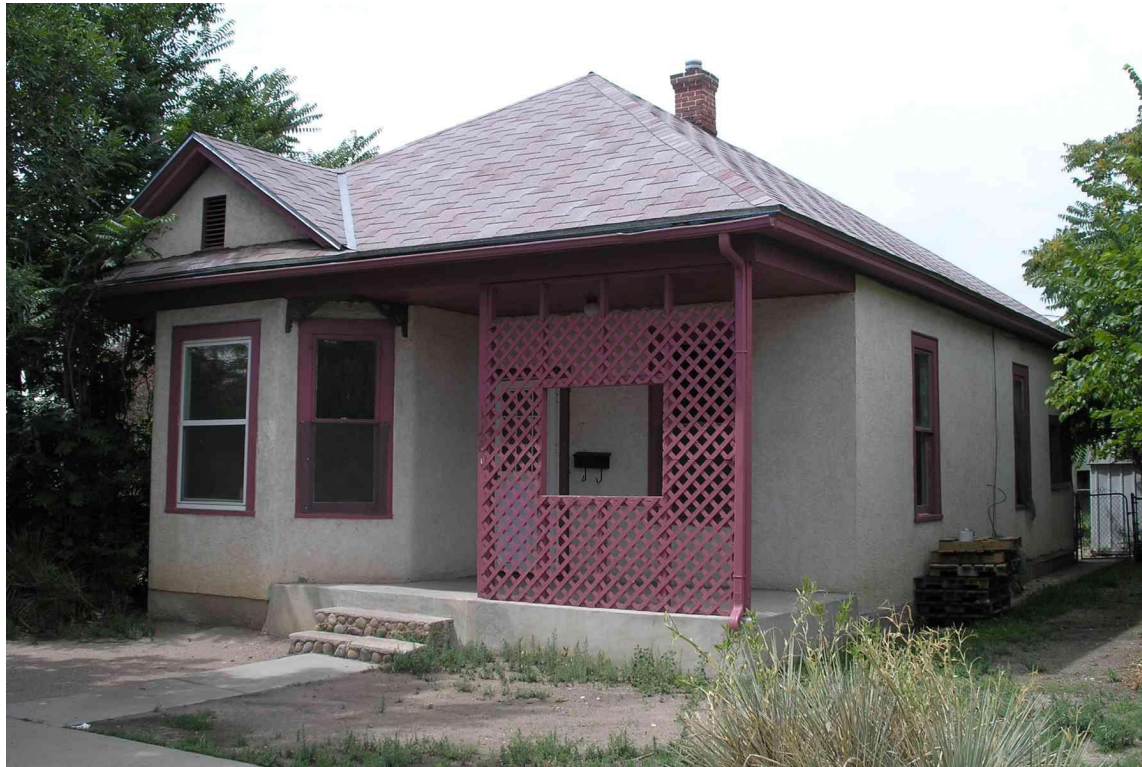
19. Primary external roof material: **Asphalt Roof/Composition Roof**
Other roof materials:
20. Special features: **Fence**
Chimney
Porch
21. General architectural description:
Oriented to the east, this house rests on a concrete foundation. Cream stucco clads the exterior walls. Windows are generally 1-over-1-light, double-hung sash, with purple-painted wood frames and surrounds. The center of the south elevation hosts a 9-light casement window. A 4-light (vertical) awning window opens in the south end of the rear (west) elevation. Opening in the west end of the north elevation are paired, 2-light casement windows. The window opening in the 3-sided, canted bay, protruding from the south end of the front (east) façade, has white vinyl frames. Beneath the roof over the bay are brackets and pendants. Spanning the rest of the façade is an integral porch, with a concrete floor and purple-painted wood supports. Screening the center of the porch is purple-painted wood latticework. Approaching the south end of the porch's east elevation are concrete and cobblestone steps. The steps correspond to the principal doorway, which is sheltered beneath the porch. It hosts a white-painted, 6-panel wood door, opening behind a white, aluminum-frame storm door. Another doorway opens low in the north end of the rear elevation. It hosts a purple-painted, 1-light, paneled wood door, opening behind an aluminum-frame storm door. Gray-red, interlocking asphalt shingles cover the hipped roof, and purple-painted wood soffit and fascia, with projecting cornice, box the eaves. The gable is pedimented. A red-brick chimney protrudes near the apex of the central hip.

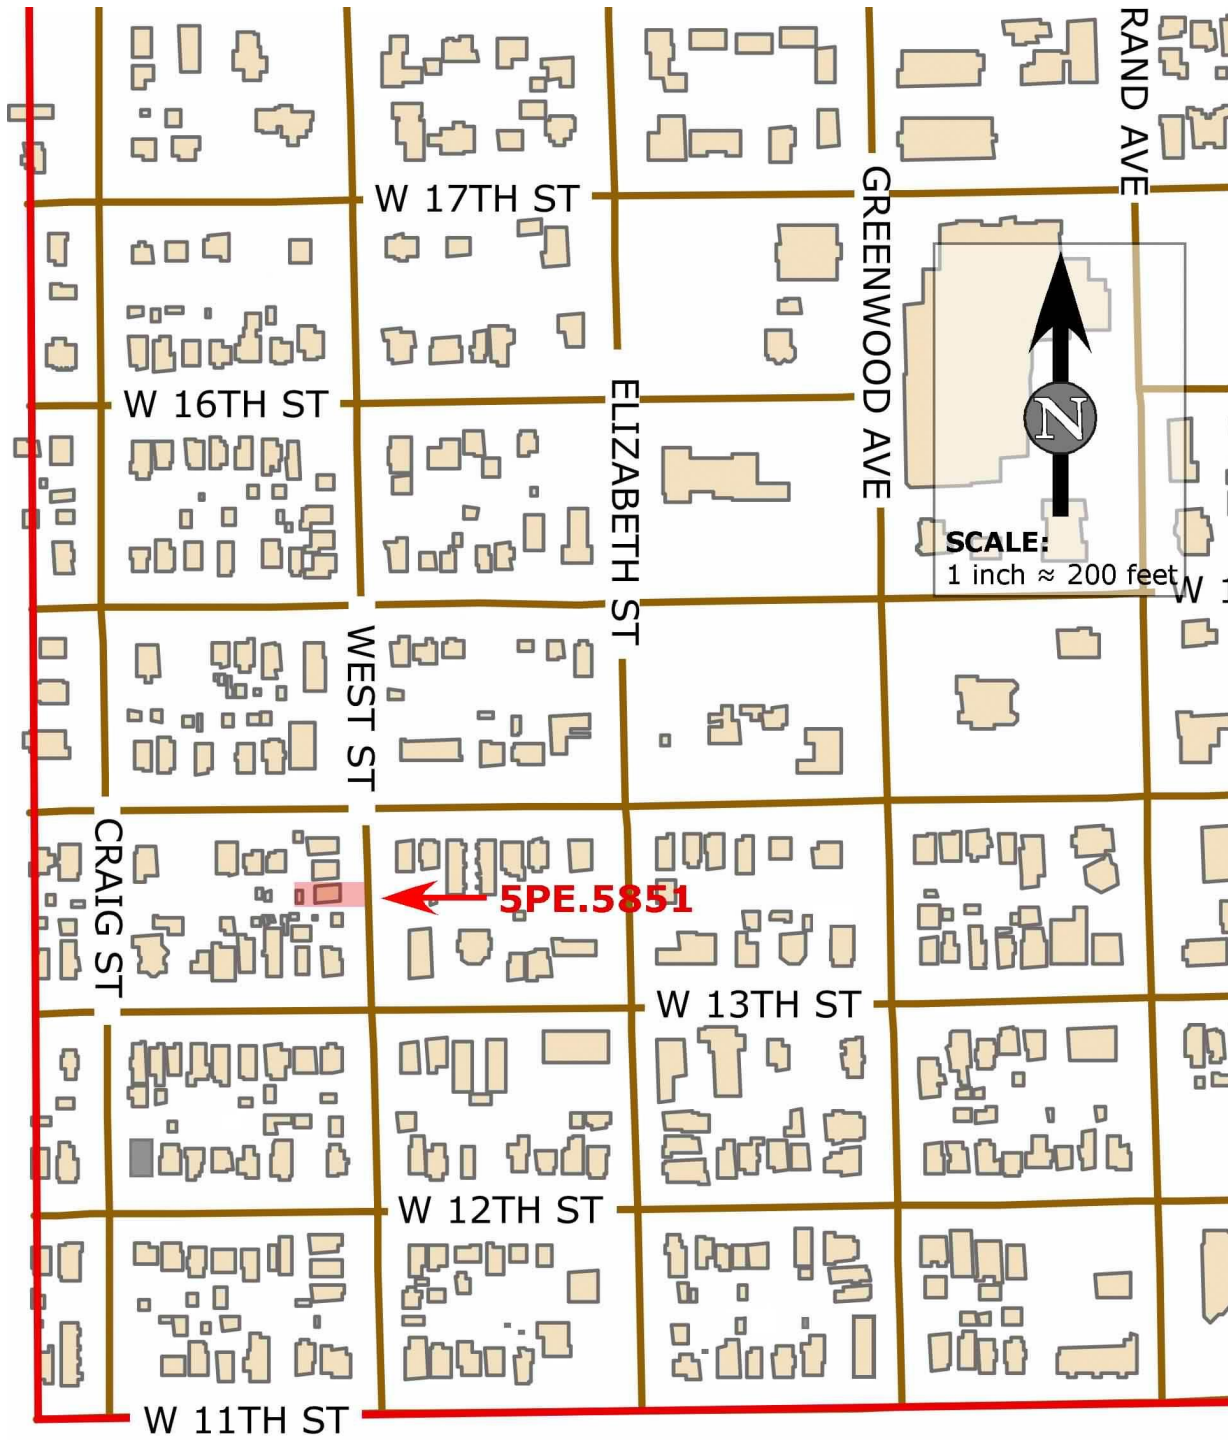
SITE SKETCH MAP

This property is located on terrain sloping downward from northeast to southwest, with an elevation of around 4,700 feet above mean sea level. The neighborhood features modest 1- and 2-story houses and apartment buildings. Setbacks from West Street are generally the same on this block. This property is situated on the west side of West Street, between an east-west-oriented alley to the south and 1323 West Street to the north. Separating the street from the sidewalk is a grass-covered strip. A planted-grass yard, with mature landscaping, covers the lot. Encircling the back yard is a wood privacy fence.

Describe: A single-car garage is located on the southwest corner of the property. Oriented to the south, it rests on a concrete foundation. Cream stucco clads the exterior walls and purple-painted, vertical board-and-batten siding covers the gables. Dominating the front (south) elevation is a 16-panel, steel, overhead-retractable garage door, painted white. Gray-red, interlocking asphalt shingles cover the front-gabled roof, and the rafter ends are exposed.

Describe: A standard kit-built shed is located between the house and the garage, along the northern edge of the property. Oriented to the south, the structure lacks a formal foundation. The walls consist of white-painted sheet metal. Paired, sliding doors of the same description dominate the front (west) elevation. The front-gambrel roof also consists of sheet metal.
