COLORADO CULTURAL RESOURCE SURVEY

Architectural Inventory Form

- 1. Resource number: **5PE.5852** Parcel number(s):
- 2. Temporary resource number: **525408002**
- 3. County: **Pueblo**
- 4. City: **Pueblo**
- 5. Historic building name: **Chamberlin, Nathaniel H., House**
- 6. Current building name: **1323 West Street**
- 7. Building address: **1323 West Street**
- 8. Owner name: **Horseshoe Bay Investments, Inc.**
- Owner organization:
- Owner address: **13 Silverweed Ct**
Pueblo, Colorado 81001

48. Report title: **Pueblo North Side Neighborhood Survey**

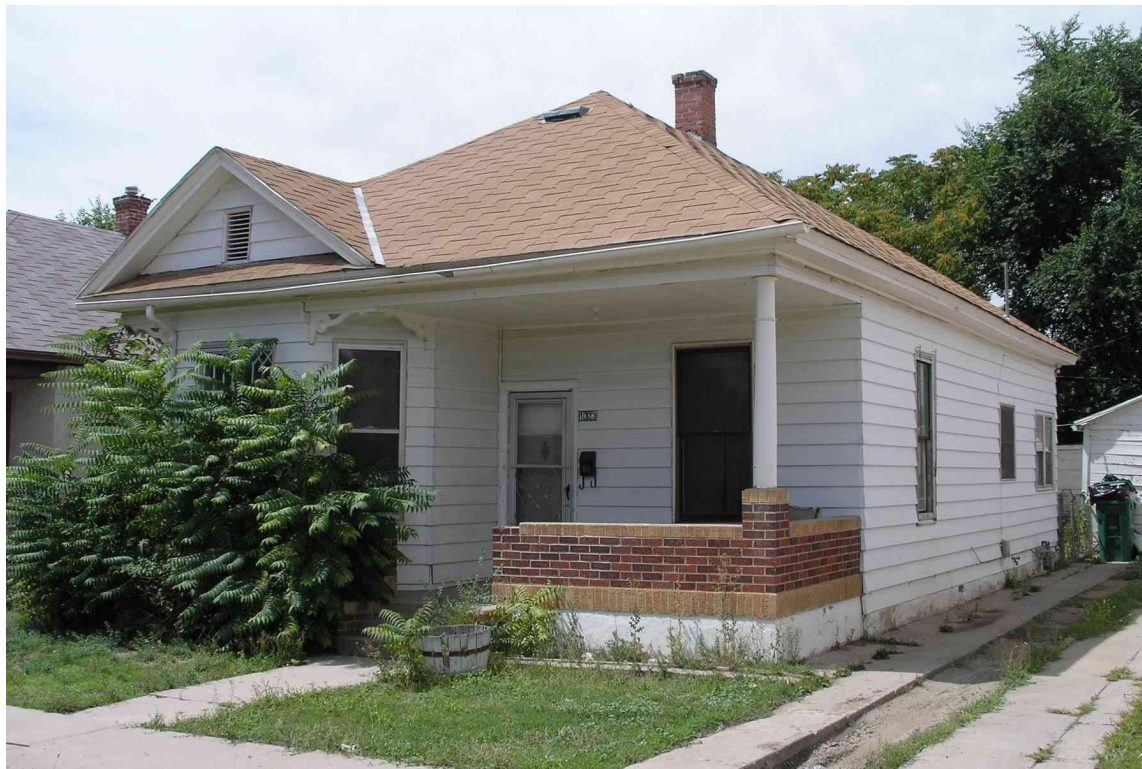
19. Primary external roof material: **Asphalt Roof/Composition Roof**
Other roof materials:
20. Special features: **Fence**
Chimney
Porch
21. General architectural description:
Oriented to the east, this house rests on a white-painted concrete foundation. White aluminum siding clads the exterior walls. Windows are generally 1-over-1-light, double-hung sash, with black-painted wood frames and aluminum-frame storm windows. The window opening in the center of a 3-sided, canted bay, protruding from the south end of the front (east) façade, has a narrow upper sash, with cottage-style glazing. Beneath the roof over the bay are brackets and pendants. Spanning the rest of the façade is an integral porch, with a concrete floor; a red and brown, raked-brick kneewall; and a single, round support at the northeast corner. Approaching the south end of the porch's east elevation are concrete steps. The steps correspond to the principal doorway, which is sheltered beneath the porch. It hosts a wood slab door, opening behind an aluminum-frame storm door. Another doorway opens in the rear elevation. Brown, interlocking asphalt shingles cover the hipped roof, and white-painted wood soffit and fascia, with projecting cornice, box the eaves. The gable is pedimented. A red-brick chimney protrudes near the apex of the central hip.

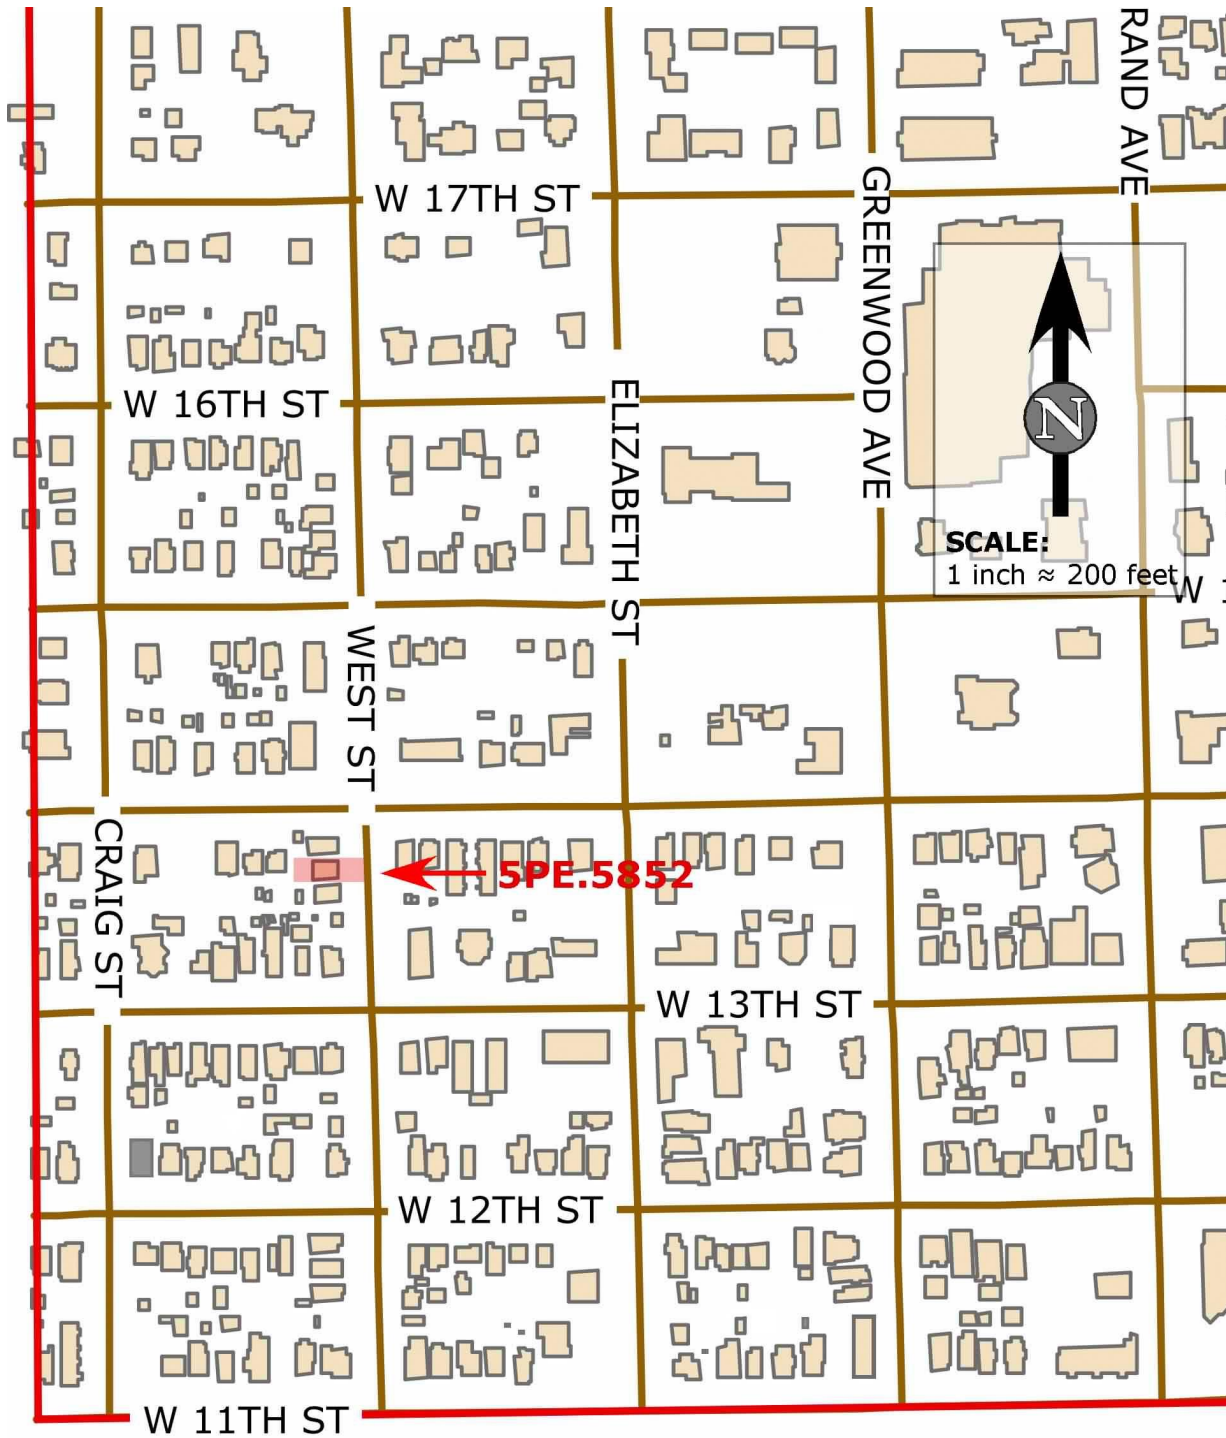
SITE SKETCH MAP

This property is located on terrain sloping downward from northeast to southwest, with an elevation of around 4,700 feet above mean sea level. The neighborhood features modest 1- and 2-story houses and apartment buildings. Setbacks from West Street are generally the same on this block. This property is situated on the west side of West Street, between 1321 to the south and 1325 West Street to the north. Separating the street from the sidewalk is a grass-covered strip. A planted-grass yard, with mature landscaping, covers the lot. Encircling the back yard is a woven-wire fence.

Describe: **A single-car garage is located directly northwest of the house. Oriented to the east, the building appears to lack a formal foundation and has a wing extending from the west half of the south elevation. White-painted, horizontal planks clad the exterior walls. Dominating the front (east) elevation are paired, white-painted, horizontal wood plank doors, opening on metal strap hinges. Brown, interlocking asphalt shingles cover the cross-gabled roof.**
