HPC-21-02

SUBJECT: Certificate of appropriateness for façade rehabilitation

LOCATION: 119 Central Plaza

CULTURAL LISTING: Tutt Building, constructed 1890, HABS number 5PE.585, listed on National Register of Historic Places on May 17, 1984 (#84000894), local landmark in 2002 by Ordinance 6888.

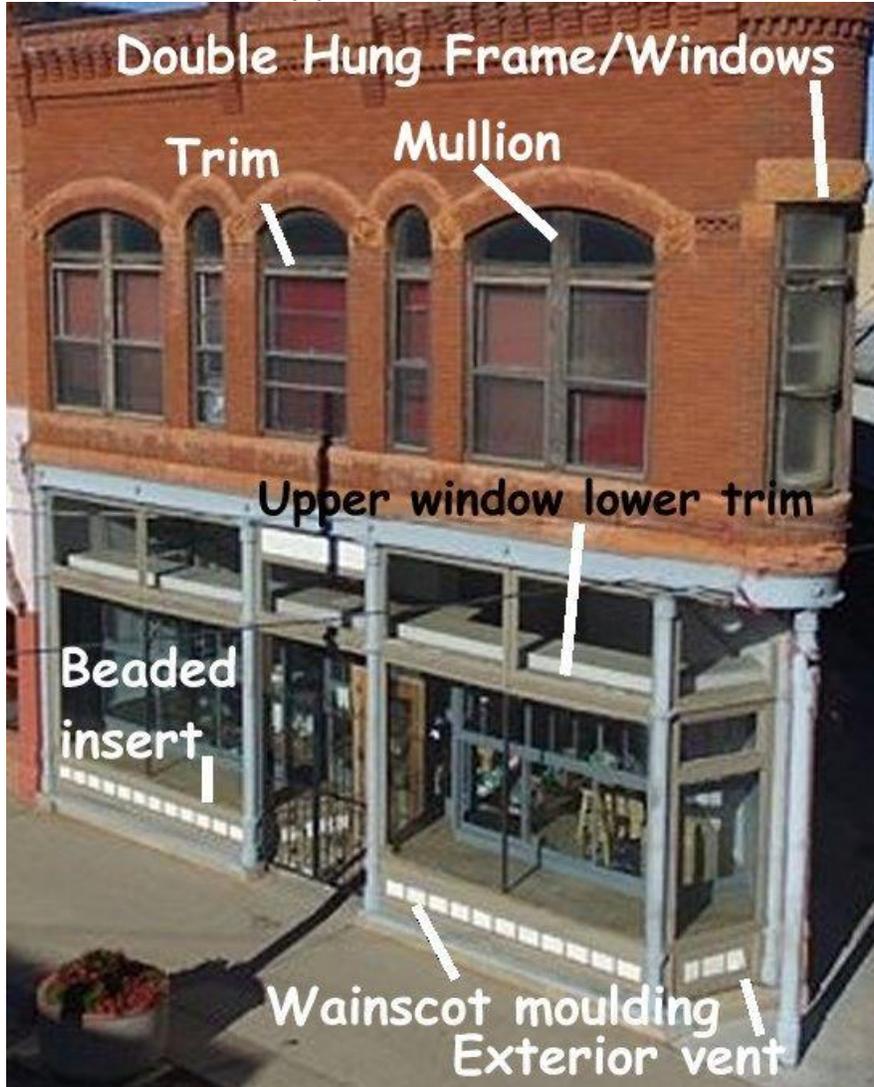
(B) APPLICANT PHOTOS

The applicant submitted a detailed request for the Certificate of Appropriateness (Attachment E) which indicated that “the façade has suffered from neglect and intense daily sunlight The powder blue paint has faded, while much of the light and dark brown paint has faded and delaminated.

Much of the wood moulding has aged poorly and is overdue to be replaced. Many moulding sections were not installed from single lengths of wood and have since split at their seams and deformed. Fortunately, much of the moulding and trim shaded from the sun and rain only needs minor sanding, filling, and paint.

The curved, double hung windows located on the 2nd floor at the corner had deteriorated and were removed. The stiles of the upper double hung window had previously been replaced with 2x4s and permanently secured to the frame. Its meeting rail was unsalvageable. The lower window was unusable-the stiles had separated from the rails due to wood decay. The sash pulleys, cords, and weights were no longer in use. The sun had permanently yellowed the polycarbonate windowpanes and were no longer transparent. The style of the original window stiles and rails was duplicated to the extent possible.”

1. Replacing and/or repairing and painting damaged moulding, window trim, and mullions,
2. Repairing the upper east corner window framing followed by installing a new double hung curved window and a new permanent upper pane,
3. Removing the front door entryway exterior ceiling vent and repairing the vent hole,
4. Removing the lower east corner exterior vent, and replacing it with a panel matching adjacent panels,
5. Repainting of all façade features.

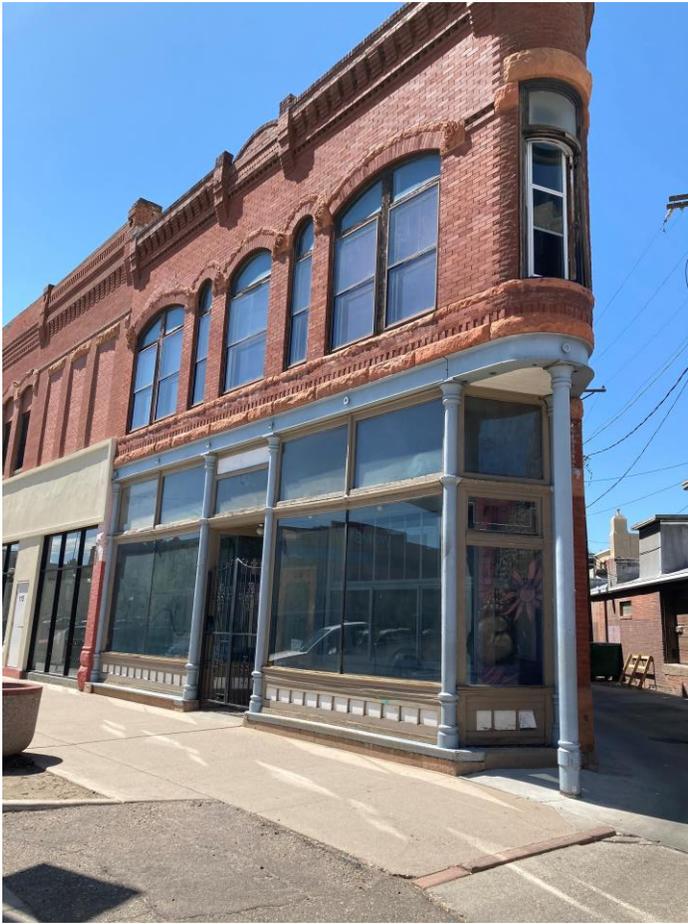
(C) SITE PHOTOGRAPHS

The two story red brick building fronts on Central Plaza and has a secondary façade along the alley. The primary façade consists of plate glass windows with transoms and wainscoting. The second floor contains double hung windows and a unique curved window at the “tip” of the triangle. All second story windows also have transoms.
