HPC-19-05

SUBJECT: **Certificate of Appropriateness for veranda rehabilitation**

LOCATION: 229 West 12th Street

CULTURAL LISTING: Bowen Mansion, constructed 1892, HABS number 5PE.493, listed on National Register of Historic Places on January 9, 1978 (#78000877), local landmark designated on September 9, 2002 by ordinance 6888

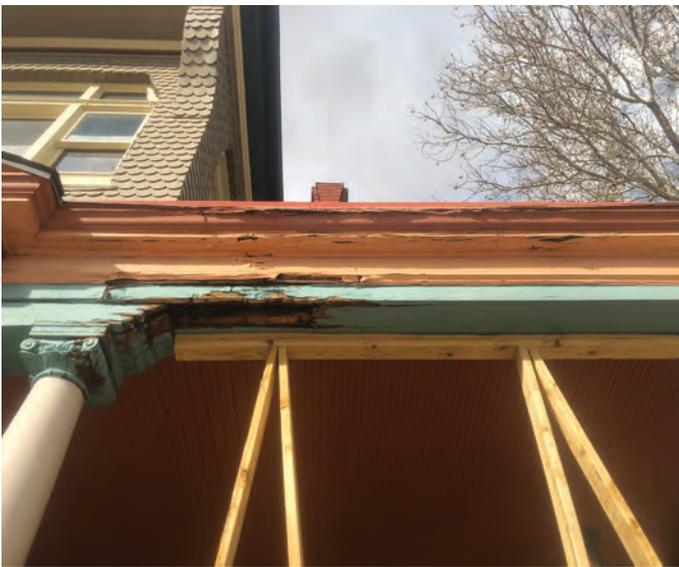
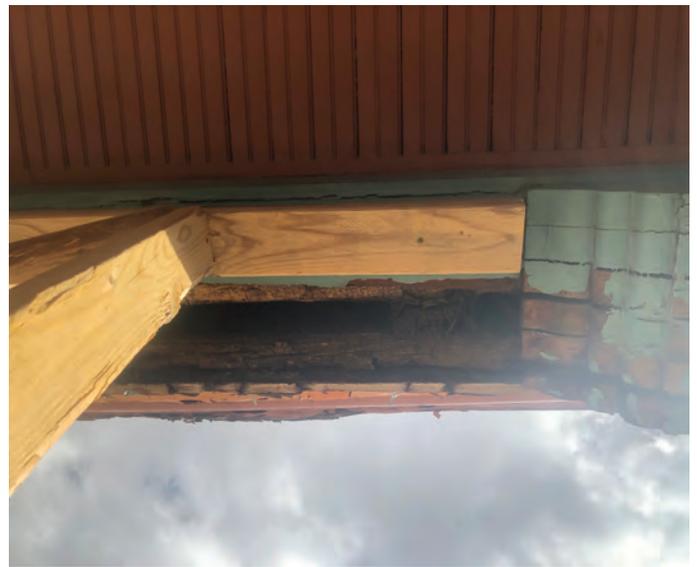
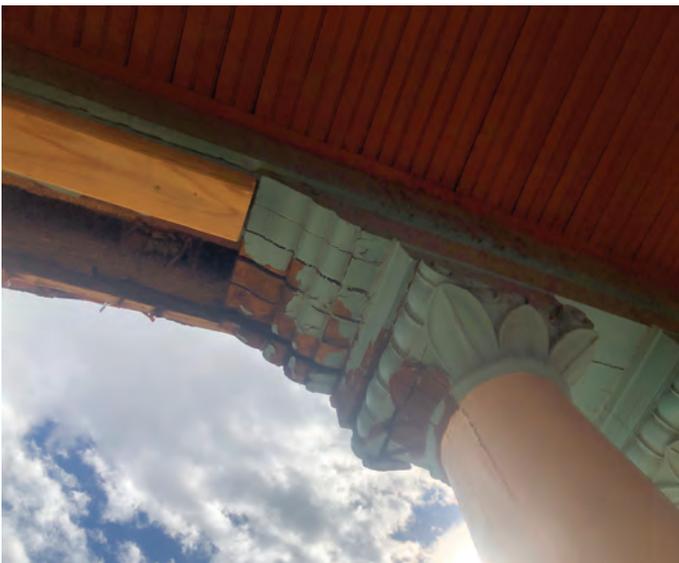
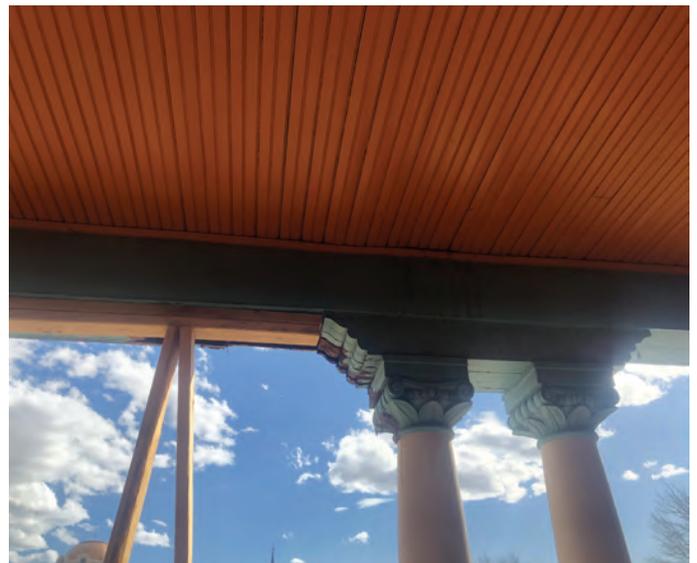
Although the roof was replaced a couple of years ago, the water damage to the veranda was extensive, and created a dry rot condition that continues to get worse, as the structural member is no longer able to hold the weight above. We propose to remove and replace in-kind the materials necessary to have a sound veranda. The techniques and products proposed meet the Standards of Appropriateness, as well as the SOI standards.

- Remove a portion of the exterior fascia and bead board ceiling to expose the structural beam underneath
- Catalog and number all pieces
- Determine extent of dry rot and replace with new pine dimensional lumber
- Where possible, epoxy consolidate the historic material before replacement. Where not feasible, material will be replaced in-kind with straight grain pine
- Prime and paint using color scheme attached (exact placement not yet determined)

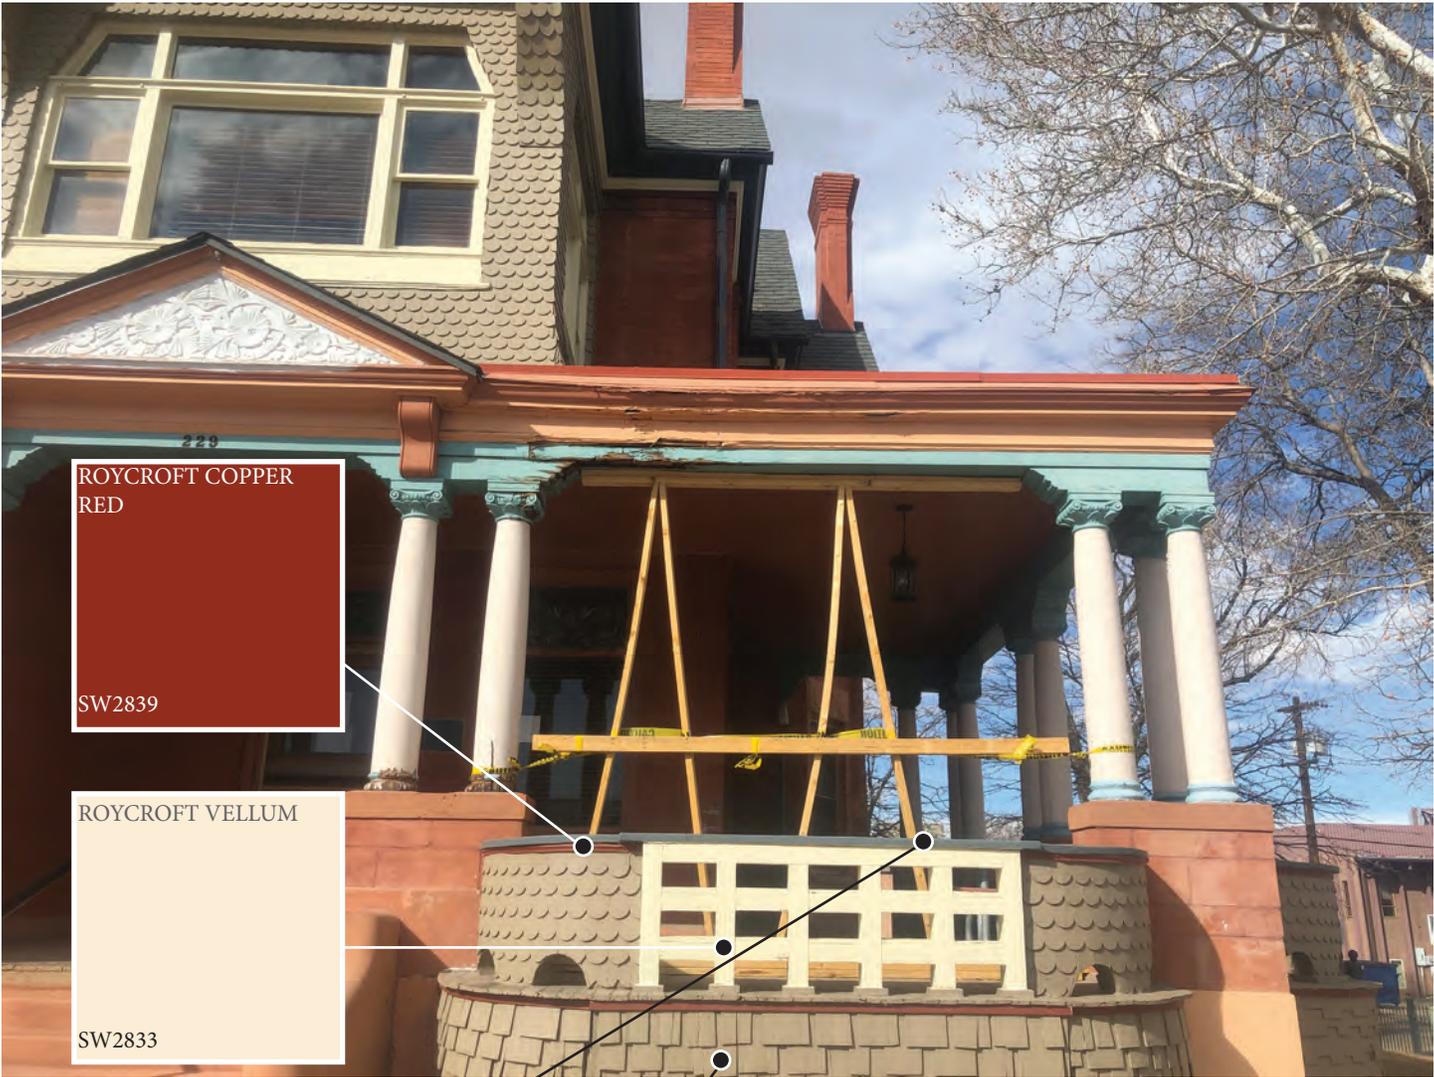
ROYCROFT COPPER
RED
SW2839

ROYCROFT VELLUM
SW2833

ROYCROFT PEWTER
SW2849

WEATHERED SHINGLE
SW2841

All colors are part of Sherwin-Williams Historic Exterior color palate. These colors were used as part of the roof replacement project, where the roof affected adjacent painted areas.
