HPC-18-07a

SUBJECT: **Revision to Certificate of Appropriateness to modify the roof-top by adding screened telecommunication antennas**

LOCATION: 230 South Union Avenue

CULTURAL LISTING: DeReimer Block, 1883, contributing resource to Union Avenue Historic District, nationally designated in 1982; zoned historic business (H-B) in 4/8/1985 by ordinance 5216

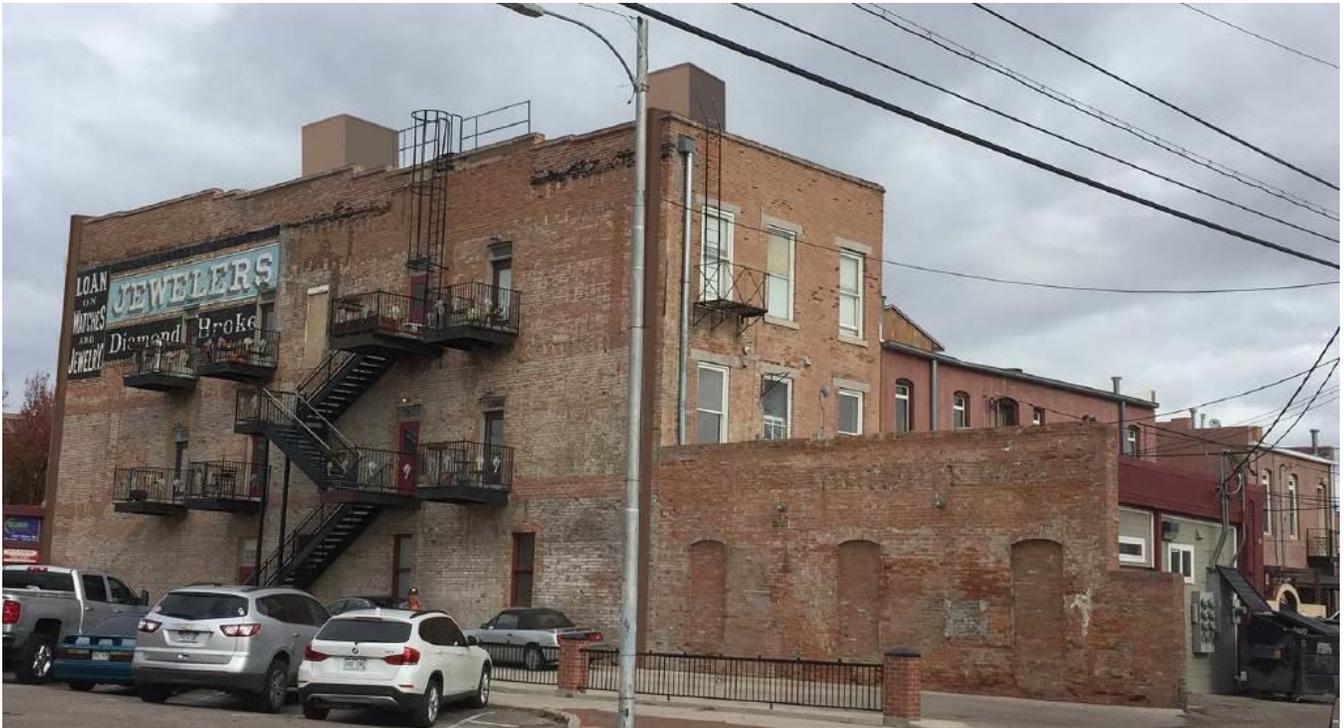
PROPOSED, REVISED

1. Install roof-top mechanical and service equipment on the roof.
2. Screen said equipment with a structure that matches the color of the building.
3. Reinforce structure with steel beams bolted to side walls, over roof, and through parapets.

skylights, or a penthouse).¹⁴ While it is not highly visible from the public ways at Union & C Street adjacent to the building, it may be visible at a distance when entering the historic district from the Union Avenue bridge.

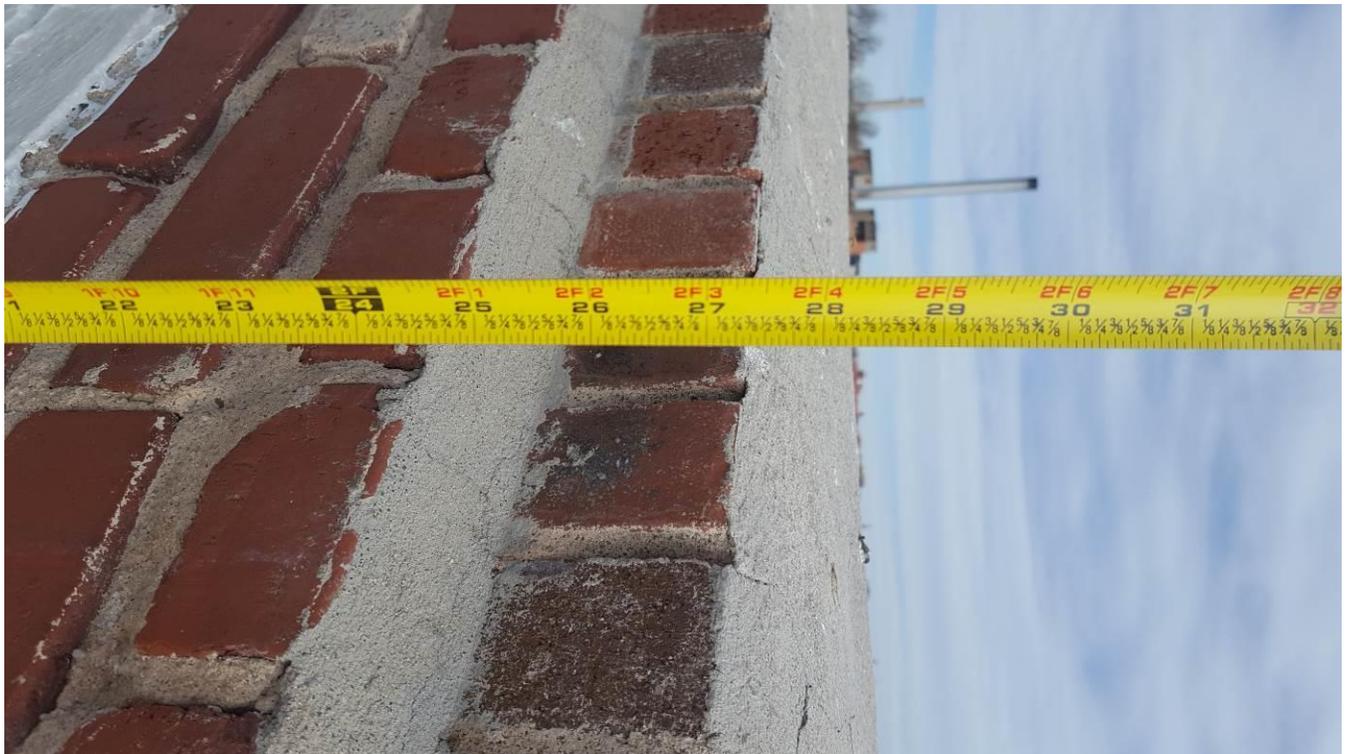
HIGHEST DEPTH OF PARAPET (27")
