HPC-22-18-Paint Color (Multiple Addresses)

November 16, 2022

To: Historic Preservation Commission
From: Wade Broadhead, Senior Planner
Through: Scott Hobson, Acting Director of Planning and Community Development
Location: 320, 322, 324, and 326 S. Union Ave
Applicant: Fred Gonzales
Owner: Henry Borunda
Year Built: Remodeled 1945
Legal Description: Lot 4, Block 58, South Pueblo
Zone District: HB, Historic Business Zone District

Synopsis

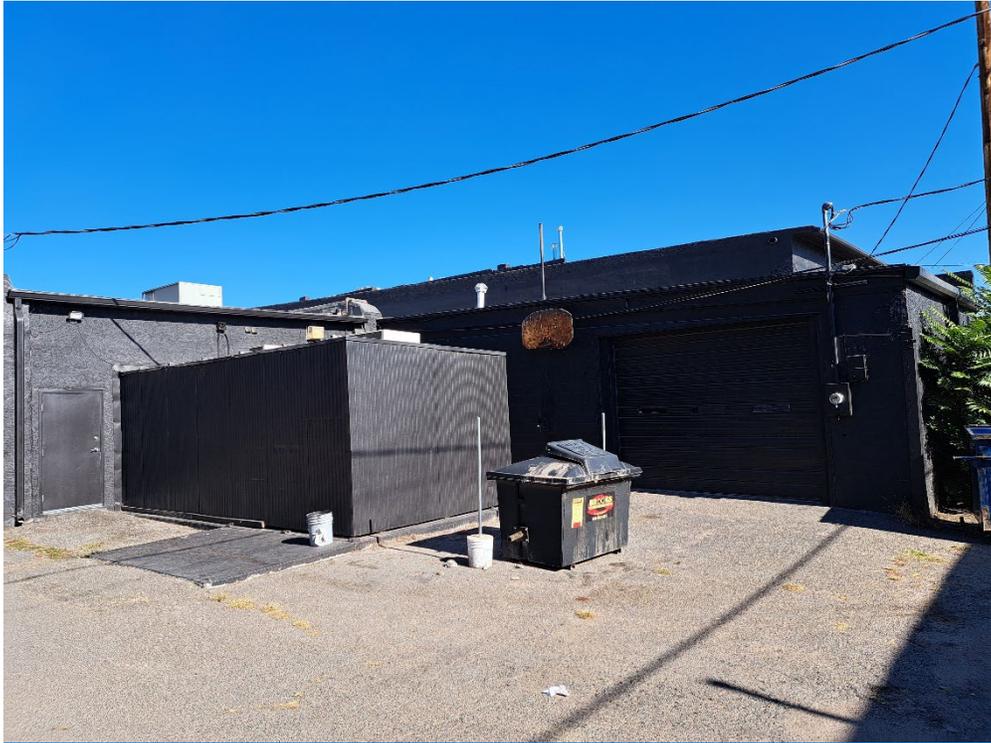
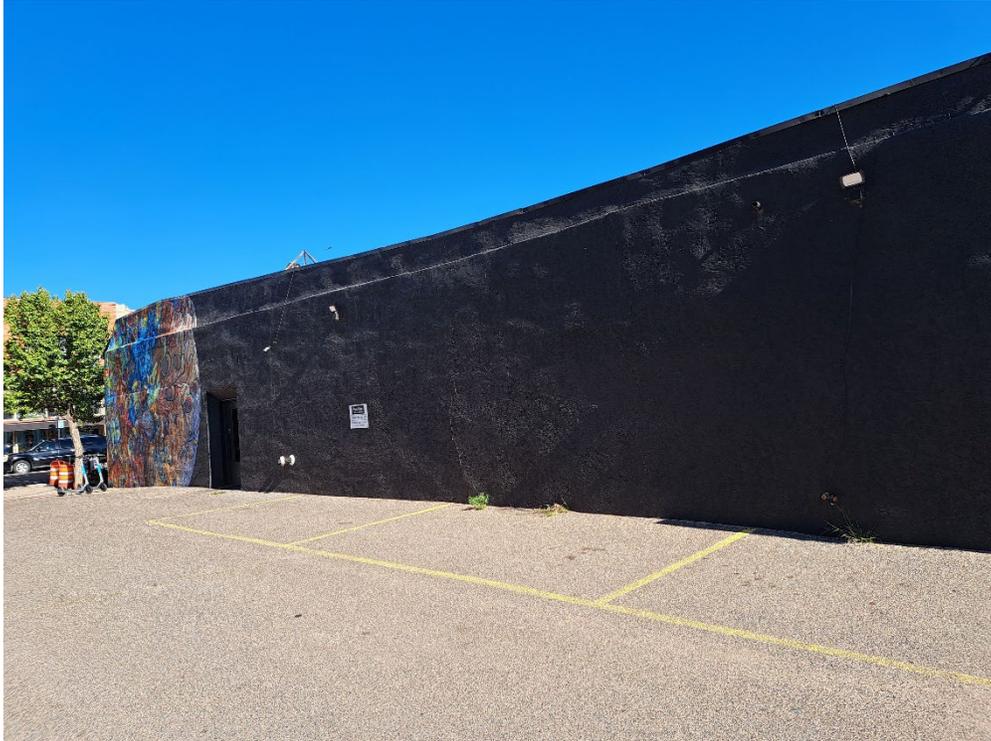
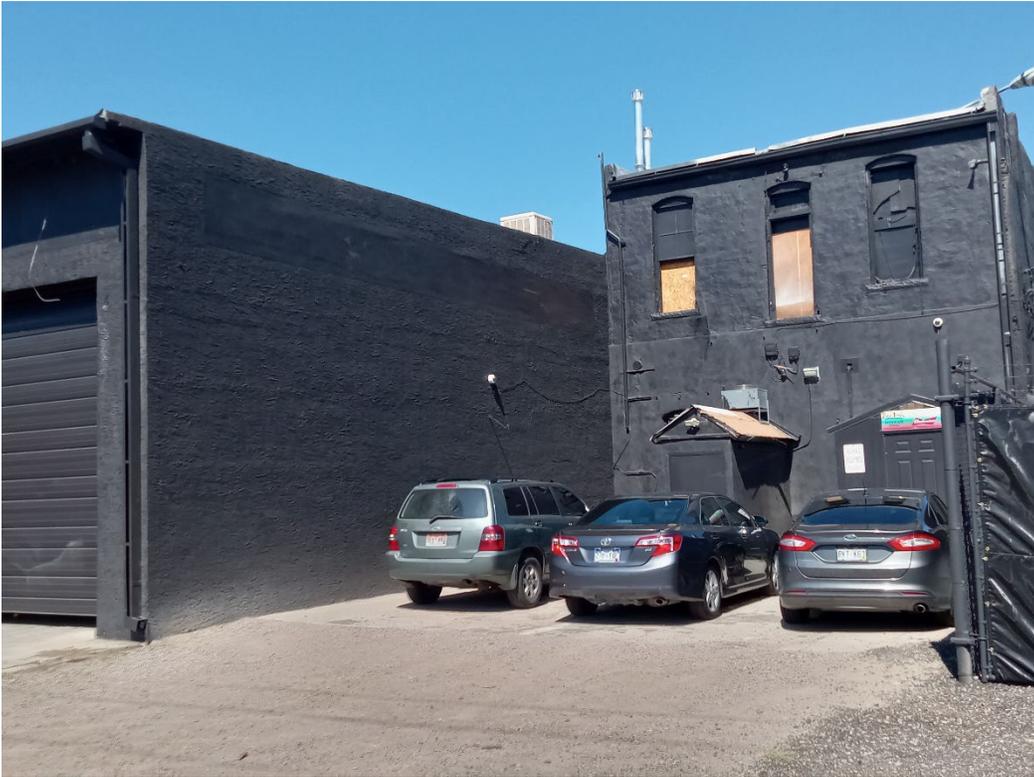
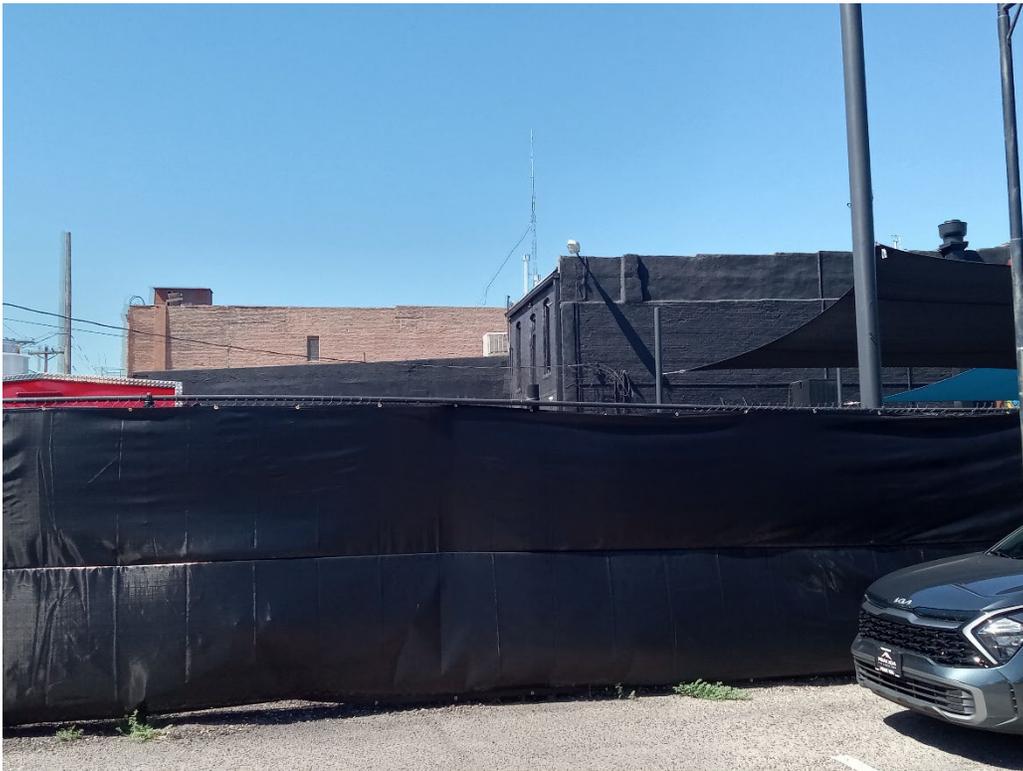
(B) SITE PHOTOGRAPHS

The subject properties consist of the two-story red brick building (320 S. Union), constructed in 1883, and the one story, glazed yellow brick building that was constructed prior to 1905 and remodeled in 1945 (322, 324, and 326 S. Union). The paint work was conducted in August of 2022. The black paint was applied to the northeast wall and full rear façade of 320 Union. Black was also applied to the entire rear facades of 322, 324, and 326 S. Union. The surfaces covered were mostly stucco. Some exposed brick at 320 S. Union Ave and wooden historic window frames at the same address were also painted over. Newer, non-historic, storage buildings, garage and other doors were also painted black.

Finding: The rear and sides of the buildings were painted black in August 2022. The guidelines state that if building surfaces are painted, the paint color should be similar to a brick tone to harmonize with the historic district. Black, while a historically used color, was mainly used for trim and accent, and rarely were entire facades painted black during the period of significance in the district (1880-1921).

Finding: While most facades were covered in stucco some wooden original window frames were painted over. A part of the northeast façade at 320 S. Union was exposed original brick with chicken wire that was also painted over.

Finding: The applicant painted over exposed brick on the northeast façade wall of 320 S Union.

The black rear and side façade paint does not conform to the Pueblo Historic Business District Guidelines or Standards of Appropriateness; therefore, a COA cannot be issued, and modifications shall be removed. The owner may submit a revised application with modifications to the black paint to meet the criteria of the HB Guidelines and Standards of Appropriateness.
