## HPC-23-09

**To:** Historic Preservation Commission  
**From:** Wade Broadhead, Senior Planner  
**Through:** Scott Hobson, Acting Director of Planning and Community Development  
**Location:** 215 W 10<sup>th</sup> St  
**Applicant:** Weston Burrer  
**Owner:** Pueblo County  
**Year Built:** 1908  
**Legal:** All of Courthouse Square and adjacent portion of vacated 11<sup>th</sup> Street in County Addition  
**Zone District:** S-1, Governmental Zone District

### Synopsis

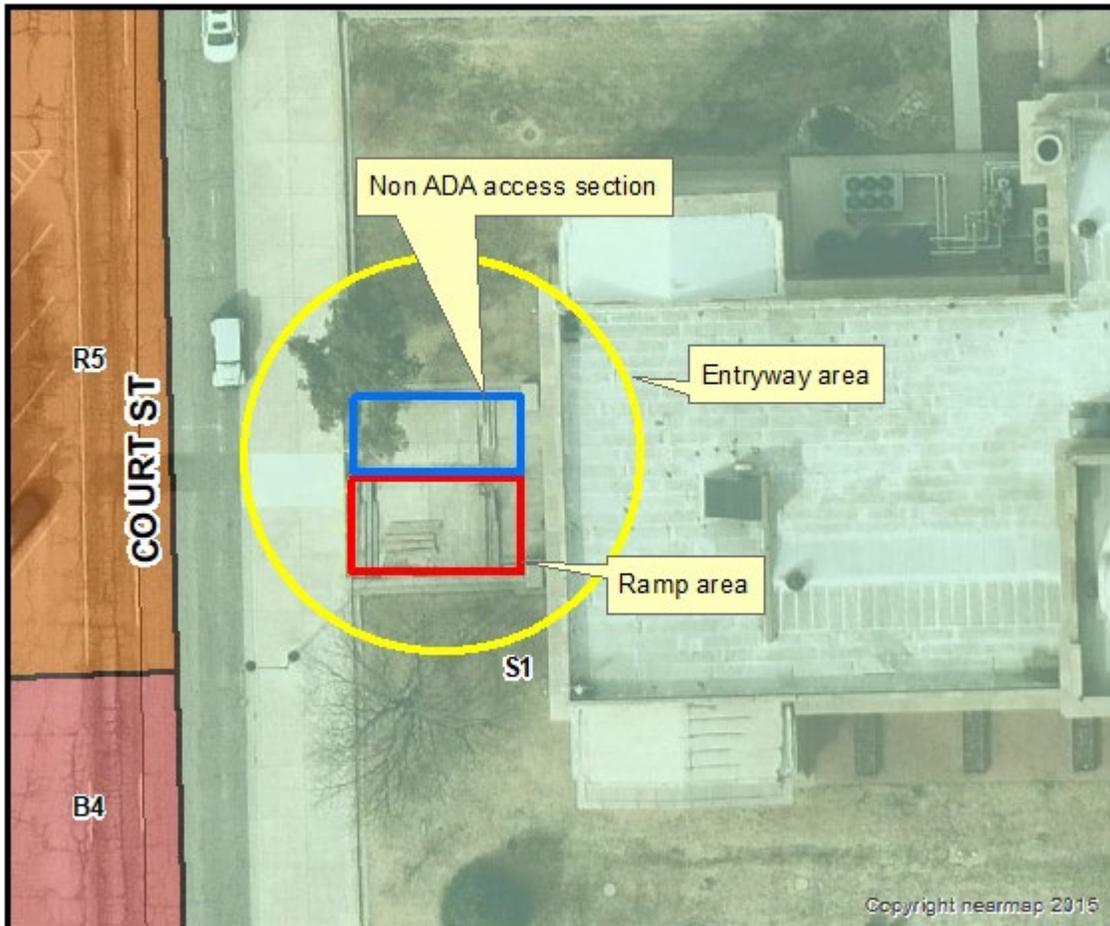
**B1. Staff site plan of proposed request**

The western entryway to the courthouse enters via the sidewalk along Court Street and had one large set of stairs going down to the main building entrance. This stair access area measures 35 ft by about 40 ft. The ramp will occupy the southern section of this sunken access area and will be constructed from concrete with a metal railing. Due to the water leak, the existing granite stairs are damaged and the risers and tread do not meet building code so they will be removed. The stairs will be replaced with code

compliant concrete stairs. Staff recommends keeping the natural gray color of the concrete to ‘read’ and signify that these new stairs are a later addition and not tint them red. The ramp ends at the landing to the doors and no portion of the existing building will be modified. The ramp will be divided from the non-accessible stairway by a series of three concrete planters. The planters will help negotiate and buffer the height difference between the ADA and non-ADA access ways coming from Court Street and add a new differentiated decorative element.

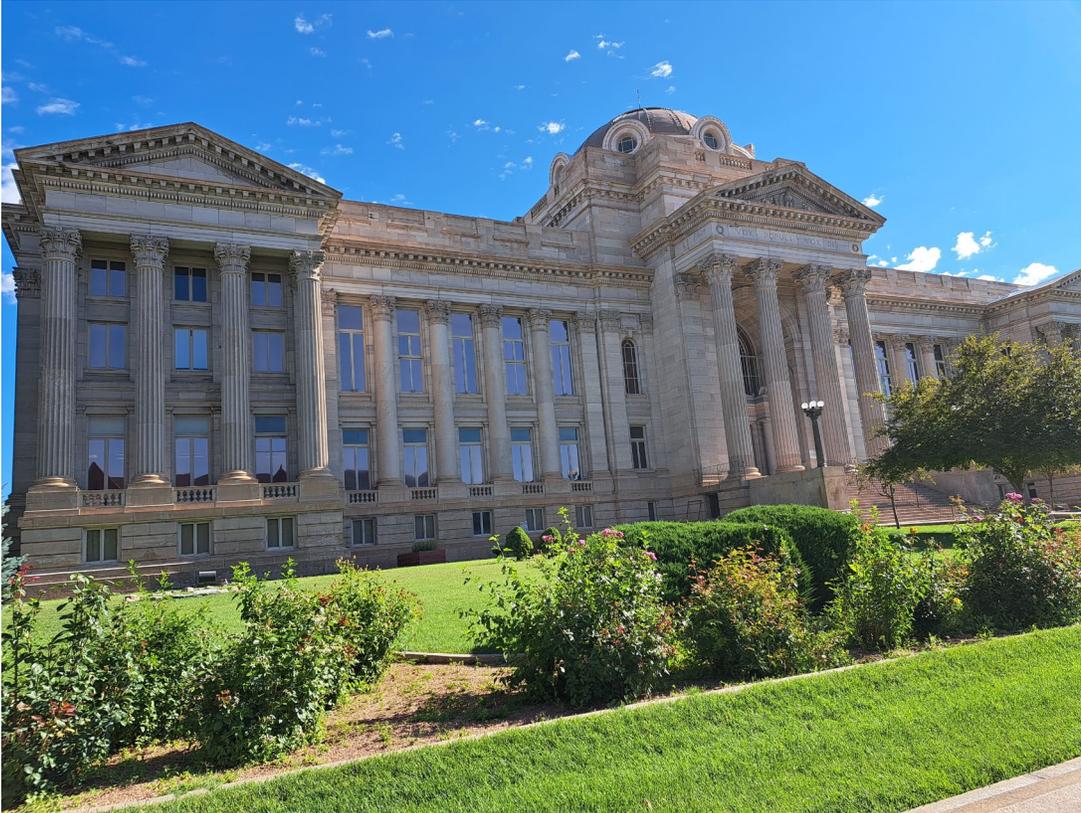
View of the primary facade

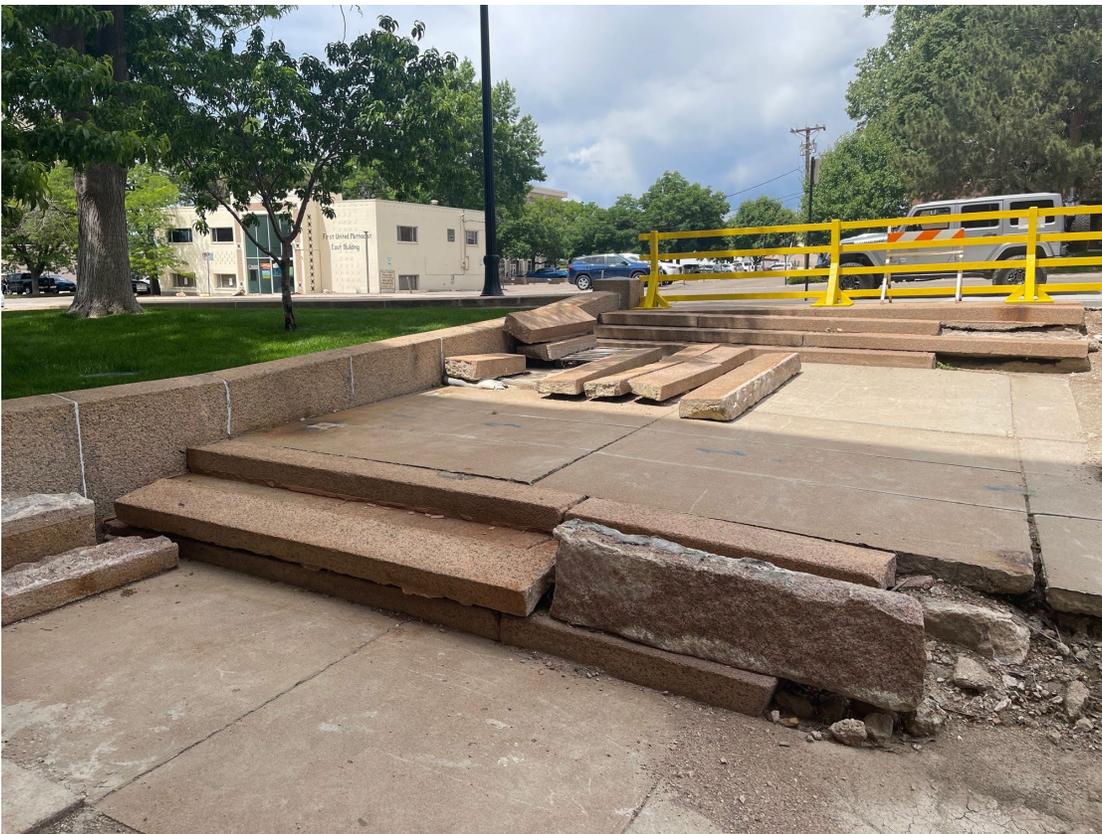
View of southern section of stairs

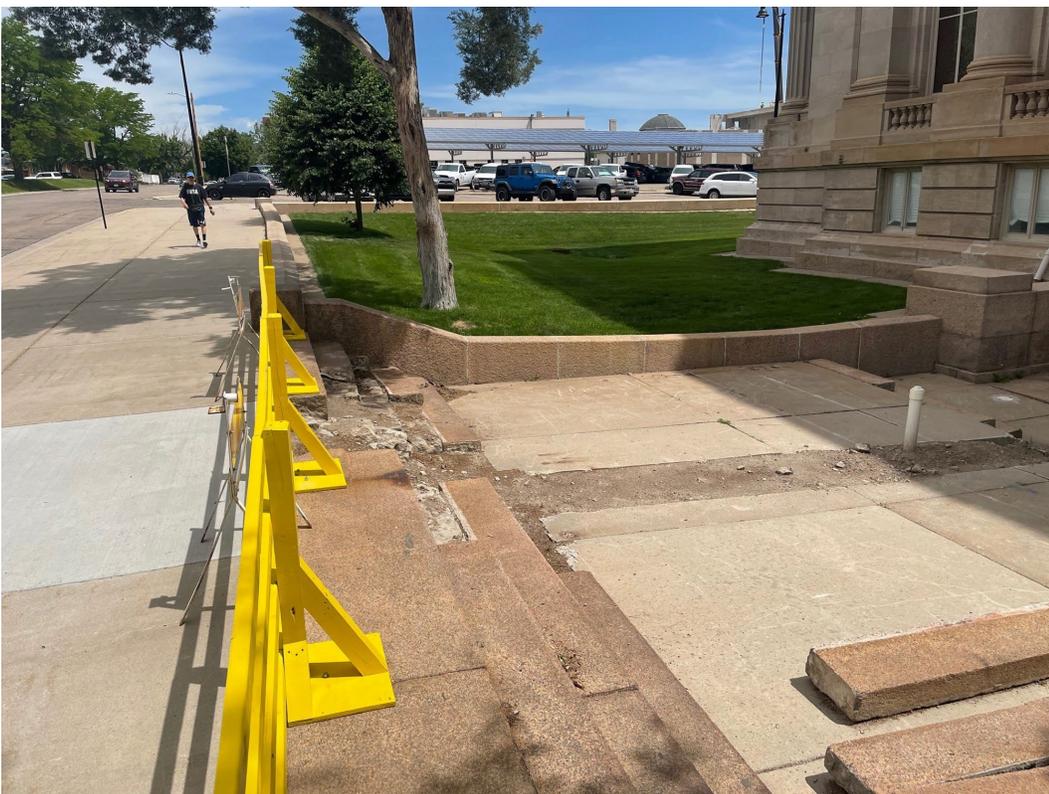
View of the top area of stairs where they meet Court Street
