COLORADO CULTURAL RESOURCE SURVEY

Architectural Inventory Form

- 1. Resource number: **5PE.4941** Parcel number: **1501421006**
- 2. Temporary resource number: **218EMesa**
- 3. County: **Pueblo**
- 4. City: **Pueblo**
- 5. Historic building name: **Prince House**
- 6. Current building name: **Jack and Theresa Manty House**
- 7. Building address: **218 East Mesa Avenue**
- 8. Owner name: **Jack and Theresa Manty**
- Owner organization:
- Owner address: **218 E. Mesa Avenue
Pueblo, CO 81006**

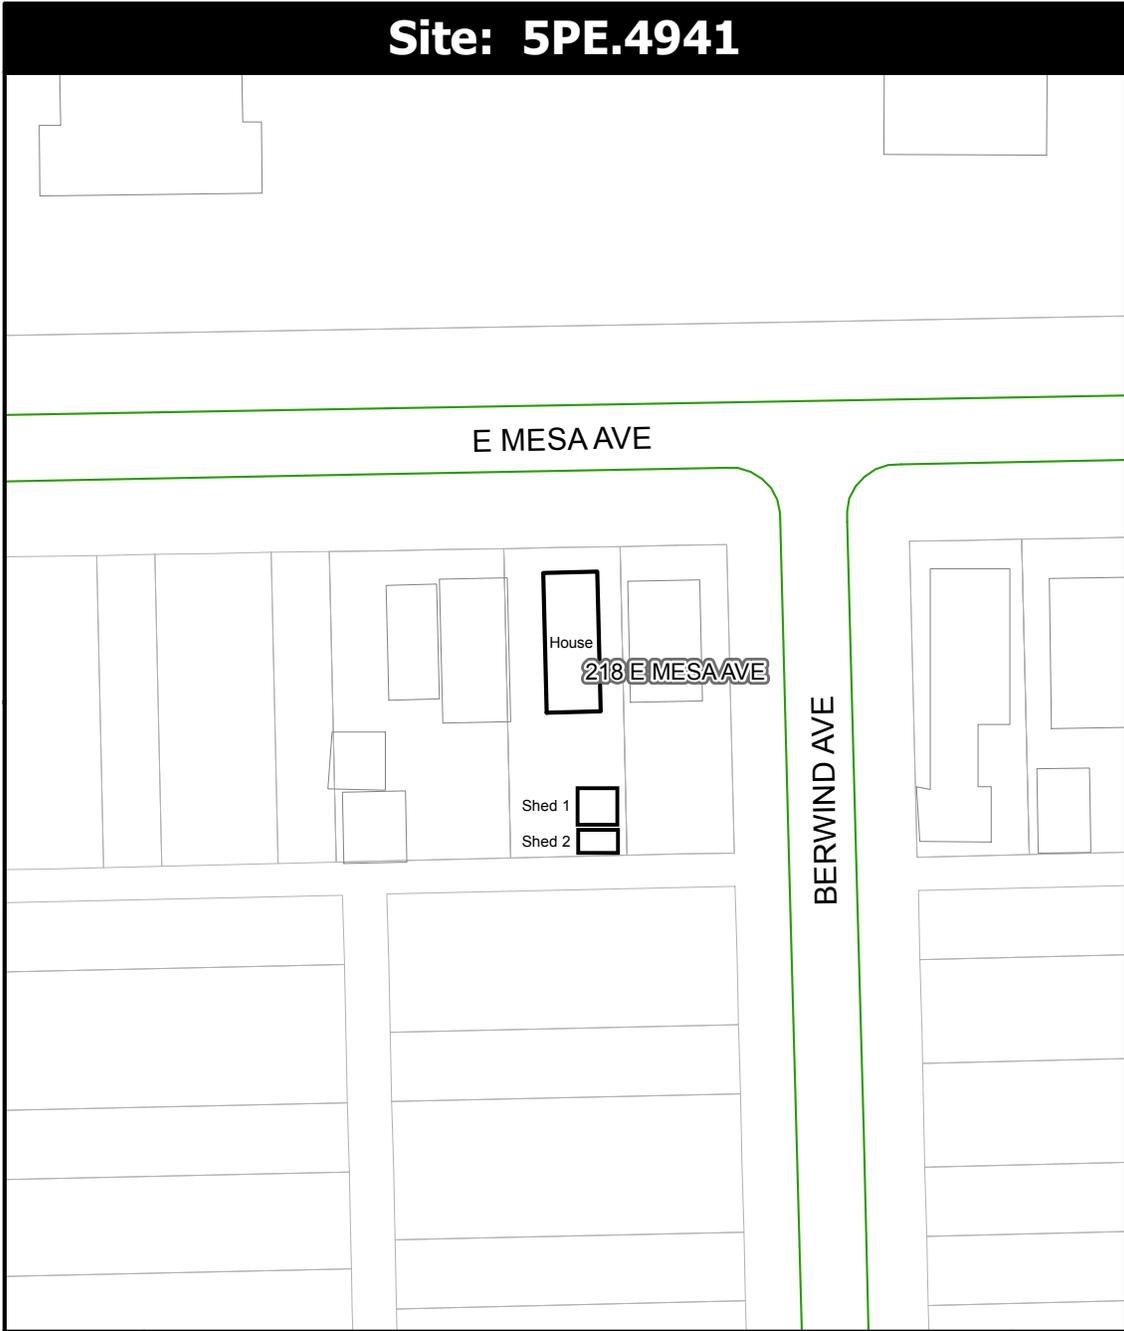
SKETCH MAP

1 inch = 50 feet
1:600

The property at 218 East Mesa Avenue contains a paved sidewalk and a slightly raised yard held back from the sidewalk by a concrete retaining wall and two steps to the current elevation of the lawn. The eastern front and side yard consist of manicured lawn, although the detached tree lawn adjacent to Mesa Avenue is dirt, with one trimmed evergreen shrub. The entire western side yard is made up of an elaborate garden.

The rectangular, front-gabled accessory building, clad in light-blue fiberboard, is located in the backyard, behind the main house. The roof is covered in asphalt composition shingles. The west elevation features two openings: a small square cutout in-filled with a plain board and a slightly recessed opening in-filled with fiberboard. The rear of this shed abuts Shed 2. There is a brick chimney. Neither the north nor the east elevations of this shed were visible from the public right-of-way.

The small, rectangular, shed-roofed, metal shed is located immediately behind (south) of Shed 1. The shed is white with a gray metal roof. Only the south elevation was visible from the public right-of-way.
