## HPC-15-01

**To:** Historic Preservation Commission  
**From:** Kelly Grisham, Planner  
**Through:** Steven Meier, Director of Planning and Community Development  
**Location:** **102 South Oneida Street**  
**Applicant:** Chuck Hitchcock, Signs by Scott, Ltd.  
**Owner:** Abel Tapia  
**Year Built:** 1869  
**Legal Description:** Lots 13 and 18, Block 90, South Pueblo  
**Zone District:** **I-3, Heavy Industrial**

**Request:** **Install signage on the Oneida Street façade and the parking facade**

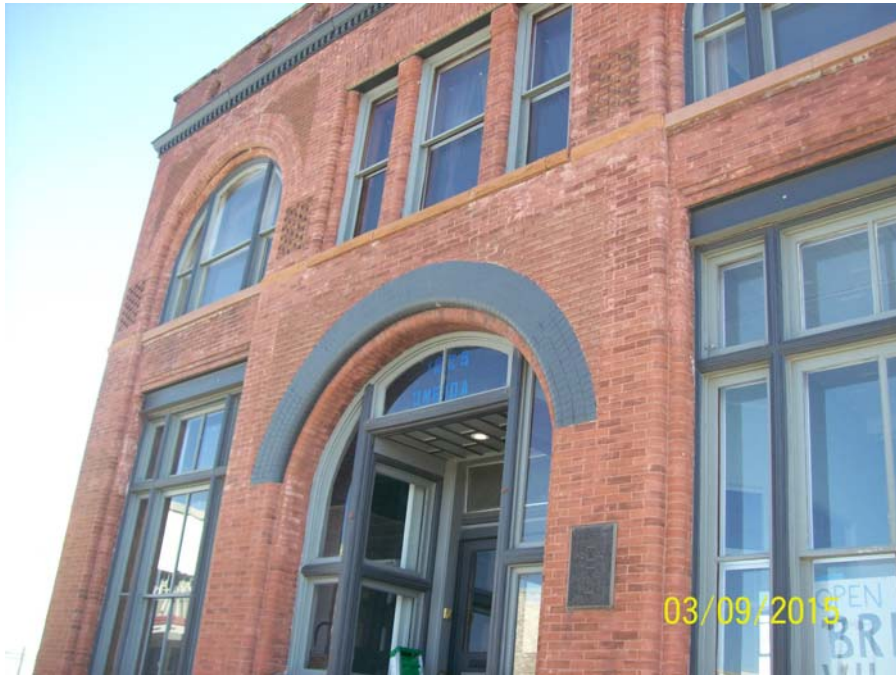
The first sign is a 24 square foot, individual letter, white flat acrylic sign with a blind stud mount. The sign measures 16 feet long by approximately 1 and a half feet tall and will sit on the northwestern façade of the building facing Oneida Street. Each letter will be installed individually by drilling holes in the mortar and backfilling the holes with silicone prior to mounting the studs in the wall. The building's northwestern (front) façade measures 44 feet which under the present sign code would allow 88 square feet of signage. According to Section 3.1.6 of the Standards of Appropriateness, several of the guidelines would prohibit this proposed sign: (1) signs should be consistent with (but not necessarily replicas of) design features of the period of significance for the structure; (2) signs of all types should be unobtrusive and blend in with the surrounding architecture; (3) Color for signs should be selected to harmonize with the overall building color scheme and historic character; (4) sign placement is important: new signs should not obscure significant features of the historic building. Signs above a storefront should fit within the historic signboard, for example. The signage proposed on the front façade of the building does not comply with the criteria listed above. In addition, the Standards of Appropriateness specifically states that signs should have no plastic elements. Acrylic is typically made of plastic; therefore, the proposed sign is not in conformance with the Standards of Appropriateness.

*Negative finding. The proposed signage on the front of the building would detract from the historic nature of the building and is not consistent with the period of significance of the structure. The use of white acrylic does not fit with the historic nature of this building; therefore, the sign proposed on this façade does not conform to the intent and purpose of this code.*

*Negative finding. The sign on the front of the building will negatively affect the special character of the building. The areas above the arched windows on the front of the building have a special brick detailing that should not be covered with signage. This building does not have a designated sign panel; however, there is field brick located in the approximate location of the proposed sign. Staff recommends if the Commission approves the signage, they require the applicant to place smaller signage so the sign will be above the special brick and below the window sill, thus preserving the special character of the building.*

**Photo #1. Overview of the Oneida St. façade.**

Staff recommends DENIAL of the front façade sign and APPROVAL for the side sign.

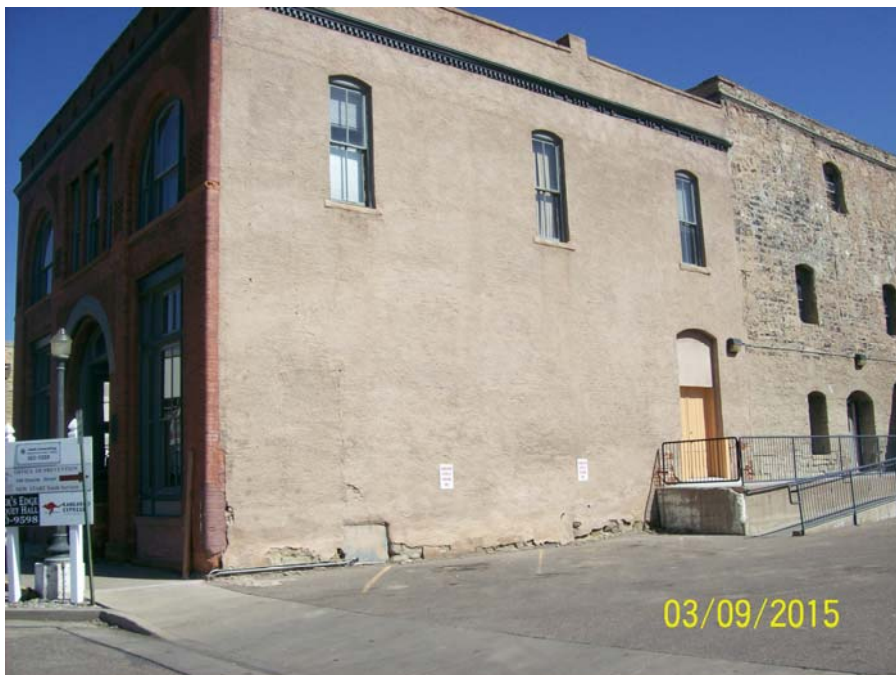
The second sign is an 88 square foot, vinyl wall sign, which can be removed without damaging any of the existing substrate of the wall if required. This sign is proposed on the façade of the building that has already been modified from the original character of the building. In addition, the applicant is proposing an application of the sign that will be removable in the future.

*Affirmative finding. The proposed signage on the side of the building is being added to an area of the building which has already seen significant changes from the original building; therefore, the sign proposed on this façade will conform to the intent and purpose of the code.*
2. The proposed work will preserve the special character, interest and value of the landmark or historic district and its environs.
  - Comments:

*Affirmative finding. The sign proposed on the side of the building will not affect the special character, interest or value of the landmark.*
3. The proposed work would not be an adverse impact on the exterior features of the landmark
  - Comments:

**Photo #2. Overview of the side façade.**
