COLORADO CULTURAL RESOURCE SURVEY

Architectural Inventory Form

- 1. Resource number: **5PE.6535** Parcel number: **525121004**
- 2. Temporary resource number:
- 3. County: **Pueblo**
- 4. City: **Pueblo**
- 5. Historic building name: **William Peach House**
- 6. Current building name: **Aaron R. and Charlotte Martinez House**
- 7. Building address: **1925 North Greenwood Street**
- 8. Owner name: **Aaron R. and Charlotte Martinez**
- Owner organization:
- Owner address: **1925 N Greenwood St  
Pueblo, CO 81003**

48. Report title: **Pueblo North Side Neighborhood Survey, Phase 2**

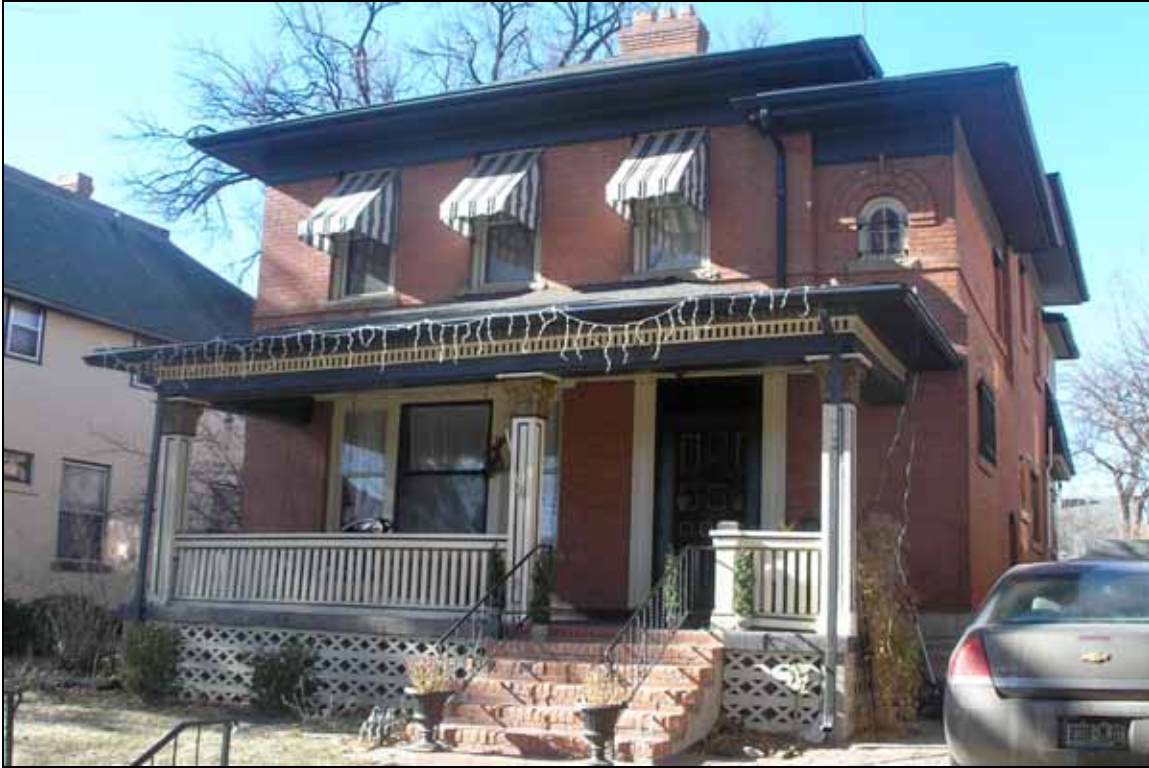
**Oriented to the east, this house rests on a foundation of random-coursed, rusticated-faced buff sandstone ashlar. Brick segmental arches crown the basement windows. The walls consist of red, pressed bricks set in a 6-over-1 Flemish bond, with tight, pink mortar. The brickwork features a protruding belt course aligned to the sills of the second-story windows. The northeast corner of the second story is corbelled inward. White-painted, horizontal wooden composition siding clads the exterior walls of a single-story addition to the southern half of the rear (west) elevation. Windows are generally 1-over-1-light, double-hung sash, with cream-painted wood frames and aluminum-frame storm windows. They open above rock-faced, sandstone sills. A tripartite window dominates the southern half of the asymmetrical front (east) facade's first story. Canvas awnings shade the windows opening in the second story of the facade. The extreme north end of the facade's second story hosts a small, round-arch casement window, opening behind a wrought-iron grille. The brick archivolt features corbelled springers and a projecting keystone. Wrought-iron grilles also cover hopper or awning windows opening in the east end of the north elevation's first story. They open beneath segmental arches, as do the windows in the first story of the south elevation. A band of small, 1-over-1-light windows enclose a second story porch within the northwest corner of the house. The west elevation of the rear addition hosts a tripartite picture window consisting of single-light casements flanking a fixed frame. A hipped-roof porch, with flared eaves, spans the facade. It has a concrete floor; wood balustrades; and square, paneled columns, with gold-painted Corinthian capitals. Enclosing the space beneath the porch are decorative concrete blocks. The porch roof features a dentiled cornice. Brick steps, flanked by wrought-iron railings, approach the porch north of center. They align to the principal doorway, which hosts a wide, 13-panel wood door, opening beneath a transom. A secondary doorway opens in the rear elevation and provides access to an unsheltered wood deck. Brown-painted wood fascia and beadboard soffit box the broadly overhanging, flared eaves. A brown-painted friezeband separates the walls from the soffit. Gray-green asphalt shingles cover the centrally hipped main roof and all other roof surfaces. A tall, red-brick chimney, with a corbelled cap and three terracotta chimney pots, emerges just west of the roof's apex. Another hearth and chimney, also constructed of red bricks, is engaged to the southwest corner of the rear addition.**
