**WASTEWATER BUDGET 2012
CAPITAL PROJECT PHOTO CAPTIONS**

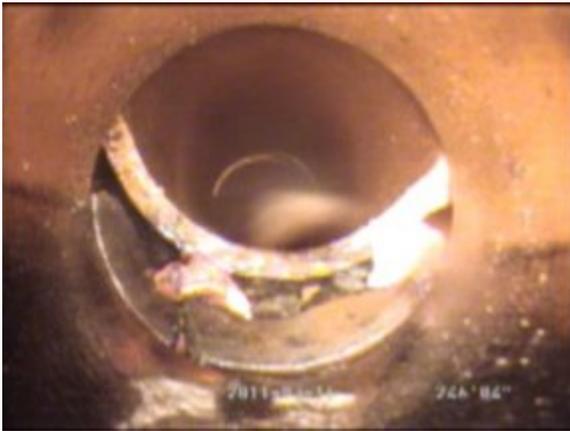
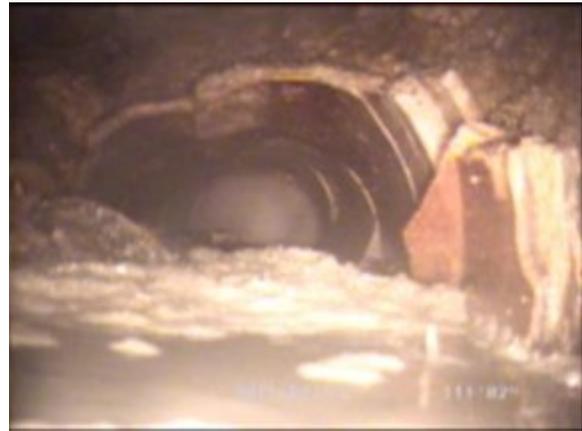
Photo ID: WW-01-2011Budget; WW-02-2011Budget
Capital Project: Annual Large Main Rehab

Broken sanitary sewer mains, viewed via closed-circuit television inspection apparatus, demonstrate locations where sanitary sewer mains are broken and in need of rehabilitation.

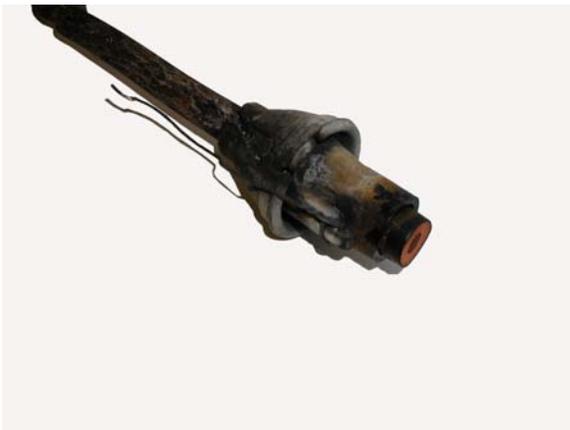
Photo ID: WW-03-2011Budget
Capital Project: WRF Electrical Upgrade

Photo of a transformer terminal connector from the Water Reclamation Facility that was replaced due to significant electrical arcing

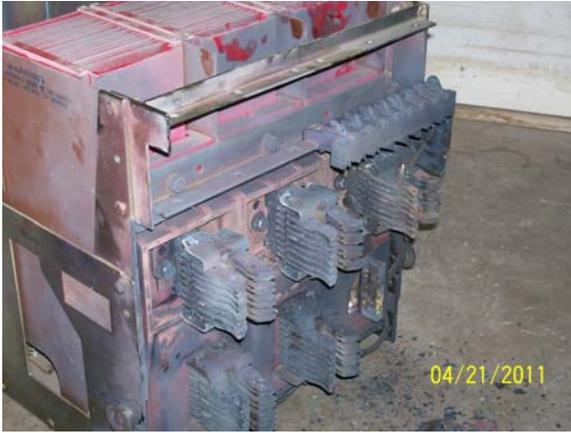
Photo ID: WW-04-2011Budget
Capital Project: WRF Electrical Upgrade

Photo of a damaged circuit breaker from the 480-volt electrical system at the Water Reclamation Facility. The breaker failed because of corrosion that caused electrical arcing.

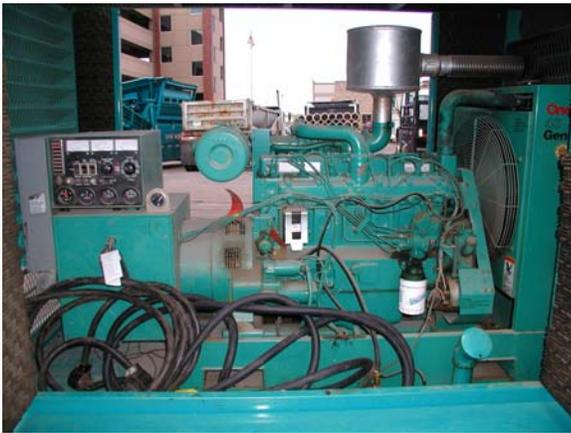
Photo ID: WW-05-2011Budget
Capital Project: Trailer Mounted Generator

Photo of a trailer-mounted electrical generator. The existing generator lacks sufficient power to operate the pumps at the lift stations serving the Airport Industrial Park. A new trailer with sufficient power to operated the largest lift station pumps provides needed backup capability, and complies with a recommendation from the Colorado Department of Public Health and Environment.

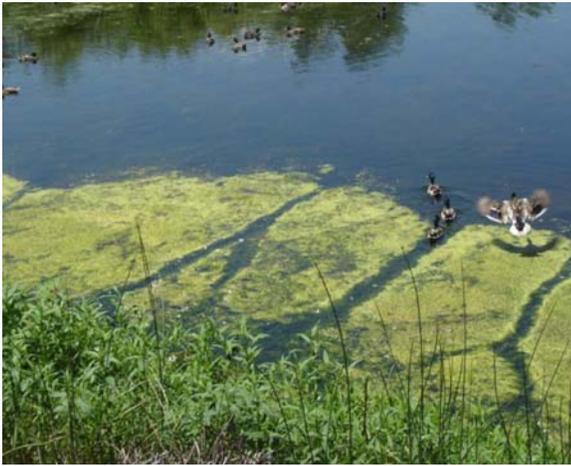
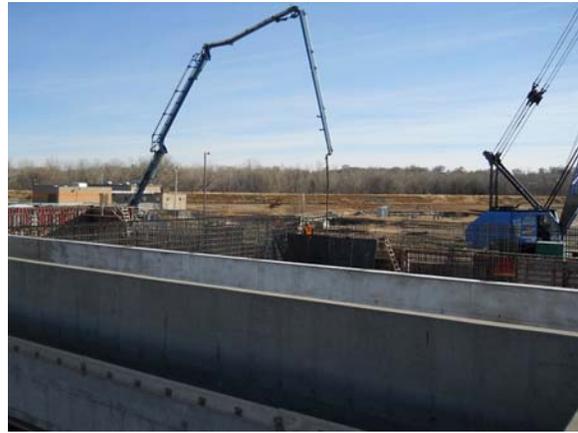
Photo ID: WW-06-2011Budget, WW-07-2011Budget
Capital Project: Nutrient Master Plan for the Water Reclamation Facility

The U.S. EPA is pushing Colorado to adopt water quality criteria for nutrients. Excessive nutrients can cause algae blooms in water bodies. Depending on the numbers adopted, attaining compliance could require another multi-million dollar upgrade to the Water Reclamation Facility.

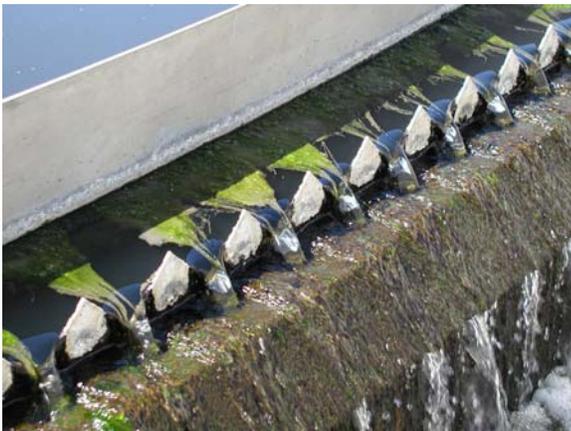
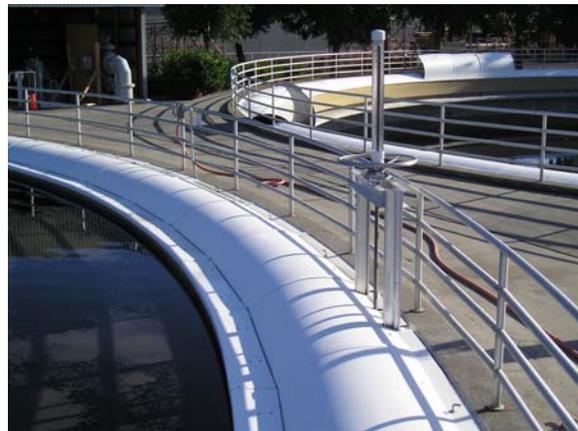
Photo ID: WW-08-2011Budget, WW-09-2011Budget
Capital Project: Laundry Covers

Algae grows in the final clarifiers of wastewater treatment plants, feeding on the nutrients in the wastewater (left). Over time, algal growth sloughs off, creating particulates that decrease the efficiency of disinfection. Laundry covers (right) reduce algal growth by shading the launders, increasing the efficiency of disinfection.
